Failure of a Small Gravity Dam and the Repair

David F. McCarthy

SYNOPSIS Late in the summer of 1980, the dam for Snowbird Lake in Forestport, New York, U.S.A., experienced a serious foundation leak made evident by a suddenly erupting geyser near the downstream toe. Subsequent investigation indicated that a severe piping condition had occurred in the soil foundation. Some degree of erosion had effected the foundation earth for more than half of the dam length. Repairs were performed after dewatering the dam work area. The original dam was retained but provided with a new concrete foundation which included a constructed underdrain. A clay blanket was installed on the dam's upstream side to retard future underdam seepage. An emergency spillway circumventing the dam area was established to protect the dam abutments from being topped should the lake reach flood levels.

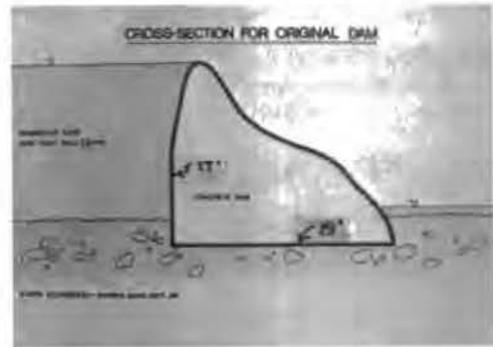
Fig. 4. Diagram of dam cross-section before repair.

of the present Snowbird Lake dam was also the siting of an earlier cribdam, established for a former lumber and tanning industry to create a waterway for loggers to transport cut trees. A new, larger, concrete gravity structure (Figures 3 and 4) on the order of 65 feet long and 17 feet high, constructed in the period 1967-8, was responsible for creating the present 2½ mile long by 1/2 mile wide (4 km by 1 km) Snowbird Lake. This recreational lake served as the focus for an on-going commercial development of the surrounding 1500 acre, approximately, wooded area (600 hectares), whereby private parcels for residential and campsite use have been offered. The new dam had been in service for approximately 12 years when the foundation failure occurred.

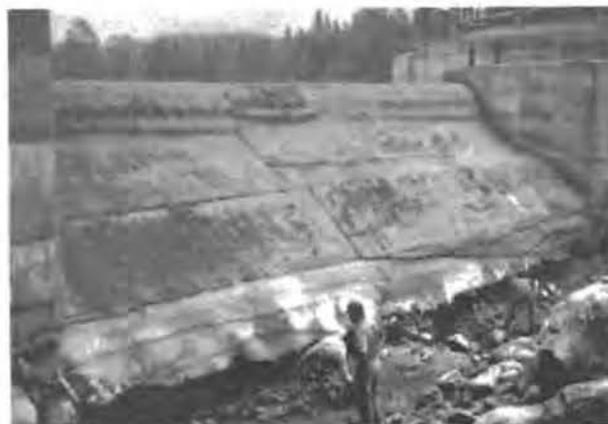
Fig. 6. Extent of foundation erosion at downstream toe.

foundation seepage and subsequent underflow had indeed caused loss of earth materials from beneath more than half of the dam length, see Figure 6. Some continuous void spaces extended between the upstream and downstream sides of the dam, Figures 7 and 8. The path for what apparently was the original piping channel was

close to three feet (1 meter) in depth. However for the entire zone effected by the seepage and underflow, the base of the dam also remained supported at numerous random locations on large boulders embedded into the concrete base as well as the underlying earth. Foundation materials under the abutments and beneath the southerly quarter of the dam's length were noted to be intact and firm/compact, and apparently unaffected by the underdam flow.

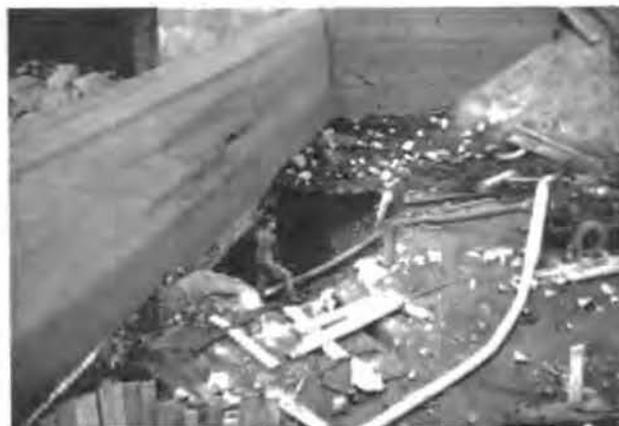
Fig. 7. Cavity in foundation earth behind dam, leading to piping channel.

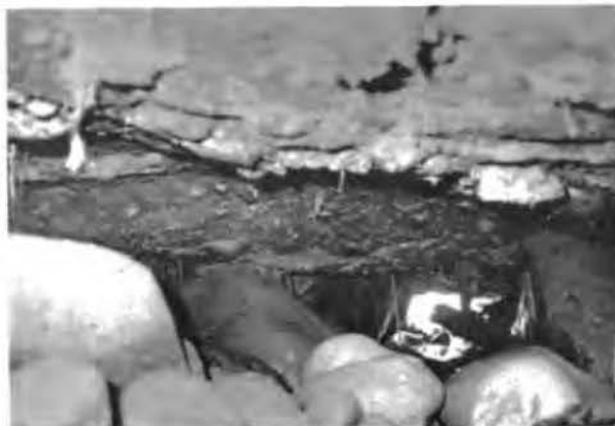
Fig. 8. Piping channel beneath base of dam viewed from downstream toe. Light in lower center area of photo is daylight from upstream side of dam.

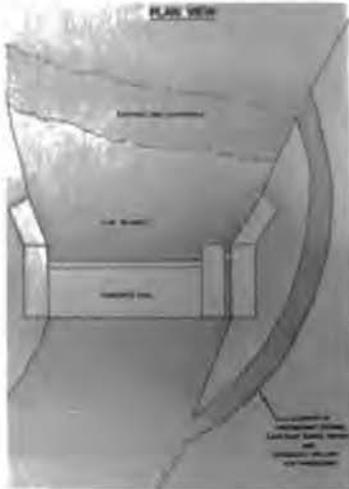
Fig. 9. Plan composite showing relative locations of temporary earthen cofferdam and diversionary channel utilized for the repair operations, and extent of clay blanket finally placed behind dam.

Repair and improvement-changes to the dam and surrounding site were undertaken over the summer of 1981. To enable the dam repair to be performed in a dry setting, a diversionary channel circumventing the south abutment was excavated to establish a route for lake inflow to bypass the work area, Figure 9. What were considered as the most feasible plans for repair, as well as the least costly, required that the dam area be temporarily isolated from the lake. A dry work area would permit better inspection and evaluation of foundation conditions beneath the dam, and better control of construction activities.

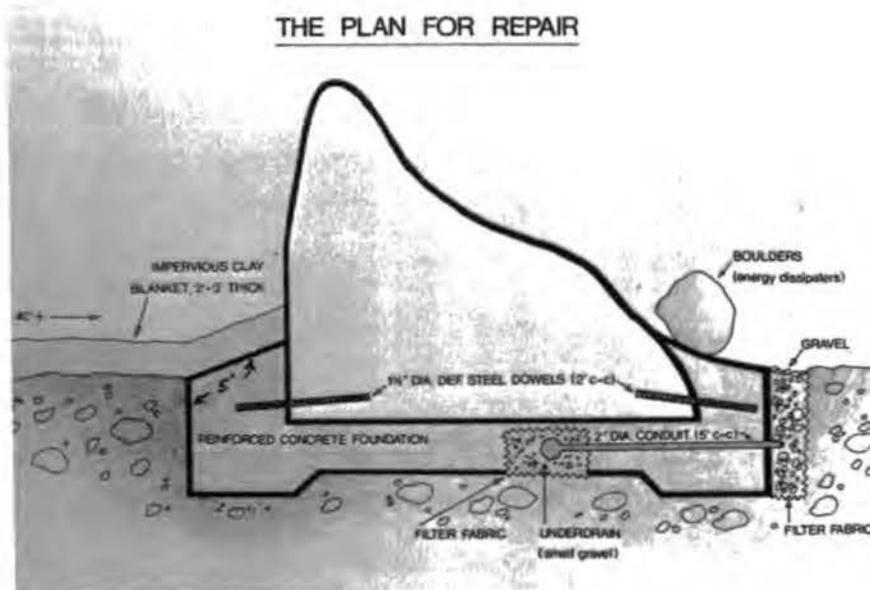
Fig. 10. Diagram showing planned changes to the dam section so to improve stability and retard foundation seepage. Clay blanket actually placed is greater than shown on plan.

The accomplished plan for repair retained the original dam but involved providing a new reinforced concrete foundation beneath most of the original dam base and having this new foundation extend upstream and downstream in a manner to envelope the lower section of the original dam, see Figure 10. Foundation materials under the southerly section of the dam, observed to be intact and compact, and apparently unaffected by the past underflow, were left in place. Steel dowels embedded into the original upstream and downstream dam face, and projecting into the new foundation, enhanced the integrity between old and new concrete sections. The foundation modification increased the base dimension of the original section by close to 40 percent, and increased the weight/mass of the dam by a similar percentage.

The foundation improvement included an underdrain system to intercept possible future seepage (Figure 10). This underdrain, positioned one-third of the base dimension back from the downstream toe, utilized a permeable geofabric (Mirafi-140) as a wrap to provide separation between the foundation earth and the fine gravel in the underdrain. A series of two-inch plastic conduits, placed at approximately 5-foot centers along the longitudinal axis of the dam and provided with a T-shaped screened end opening within the underdrain, extend to outlet in front of the downstream face as a means for discharging seepage which reaches the underdrain.

Means for countering future tendency toward underdam seepage included the placement of a two to 4 feet thick clay blanket behind the upstream side of the dam. An upstream seal was considered as an essential feature of the repair undertaking, and early thoughts for using an impervious liner-fabric were dropped when a source of clay was located on the development property. The clay blanket overlaid the newly constructed upstream foundation projection, and extended approximately 50 feet upstream, as described by Figure 10.
