Consideration of Earthquake Damage to Earth Dam for Irrigation in Japan

SYNOPSIS: There are many small earth dams for irrigation called "TAMEIKE" in Japan. Most of them were constructed before modern soil engineering were established on the basis of empirical techniques. Earthquakes in the past gave much damage to these earth dams. This paper surveys damage of earthquake for those remaining on records again, and as for Nipponkai-Chubu Earthquake, detailed investigations such as in-situ test, laboratory test, analysis were made to clarify causes of the damage to earth dams. From the result of survey, the following matters were found; i.e., large damages occur at a high rate on earth dams whose foundation ground and embankment are consist of loose sand, and the major cause of the damage is liquefaction. When the embankment and the foundation ground are made of cohesive soil, the degree of damage is relatively small.

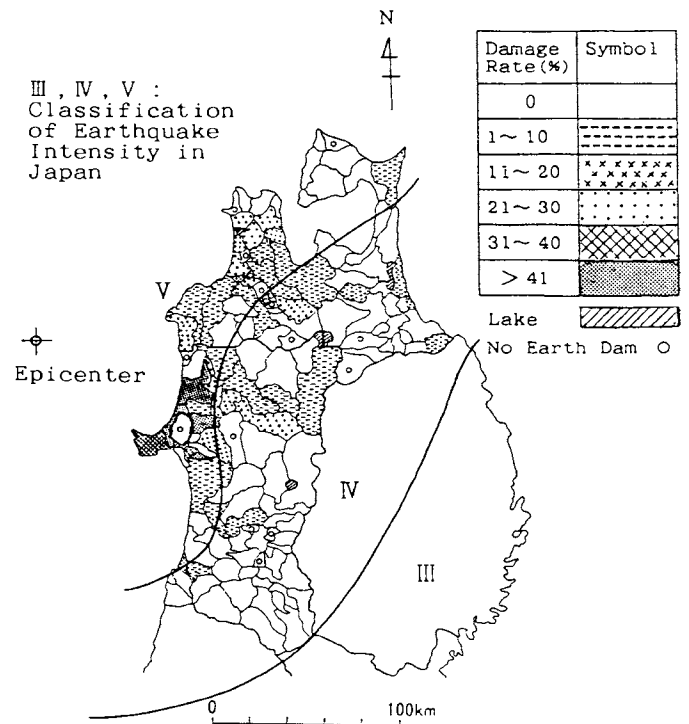
Fig.2 Distribution of Earth Dam Damage Caused by The Nipponkai-Chubu Earthquake

Figure 2 shows the earth dam damage distribution caused by Nipponkai-Chubu Earthquake. The distance from epicenter was divided by every 20 to determine the damage rate (Total number of damaged earth dams divided by total number of earth dams) of earth dam in each area. Figure shows the relation between the distance from epicenter and the damage rate. The same relation was determined for other earthquakes to find the distance from epicenter corresponding to 1% damage rate of earth dams (hereinafter referred to as critical distance from epicenter). Figure 4 includes data of earth dams and analogous structures; river dikes and railway embankment. Rivers and earth dams have a similar relation. The relation between magnitude and critical distance from epicenter for earth dam was determined by the least square method as shown below.

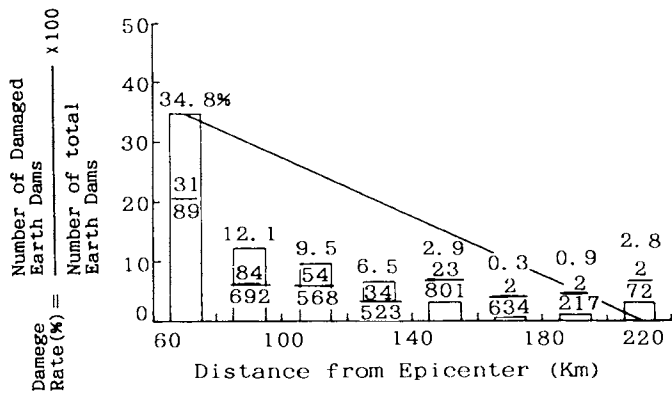
Fig. 3 Damage Rate (%) versus Distance from Epicenter in The Case of The Nipponkai-Chubu Earthquake

The value of equation (1) depends on property of earthquake, ground conditions, and earth dam conditions. However, the approximate distance from epicenter at which a damage starts to occur can be determined by providing the distance from epicenter and the magnitude.

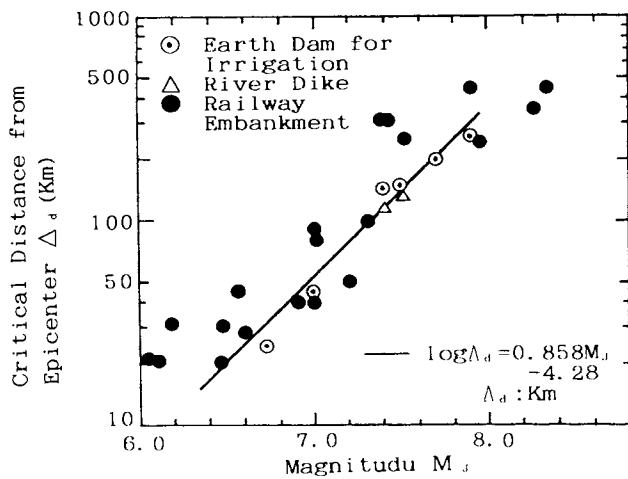
Fig. 4 Magnitudo versus Critical Distance from Epicenter

$$\log \Delta_d = 0.858 M_j - 4.28 \quad (1)$$

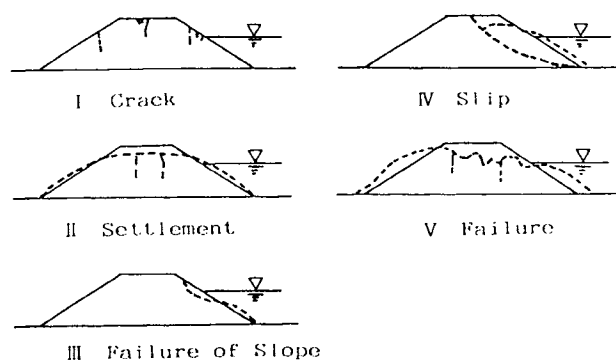
Fig.5 Classification of Damage Type

Table 5 shows classified types of damage. Type I and III occupy 30% respectively, and followed by types II, IV and other types. Type V was only 1.8%. Type I (crack) almost keeps the shape of dam body with a little settlement, and cracks alone are generated. The feature of this type is that many dam bodies are made of clay on good foundation ground. There were three examples of cracks generated along the line grouted in the past. Type II (settlement) was produced keeping the shape of dam body with accompanying cracks. This type occurs frequently on a weak ground, and its major cause is thought to be the settlement of foundation ground.

Type III (failure of slope) and type IV (slip) are basically of the same type of damage, but type III is more slight in damage than type IV. Most part of the dam body remains sound and a large damage is not reached in type III. An evident slip is recognized in type IV, though this type is only few in the number of damages. But most part of the dam body is settled by slip in type IV, frequently causing large damage such as failure.

In type V, the dam body and the foundation ground are broken. Though the number of damage is very few, the earth dam failure occurs in many cases like type III. The estimated cause are liquefaction of dam body and foundation ground. Besides these, outlet works, spillway, abutment break, and damage to only covering block occupy about 10% of all.

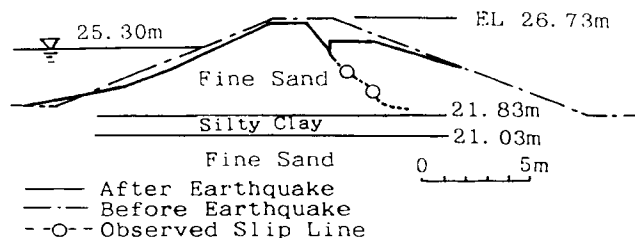
Fig.6 Observed Slip Line of Unoki Dam Caused by The Nipponkai-Chubu Earthquake

A clear slip surface is recognized in the dam body of two earth dams, Unoki and Ichinosawa failed in Nipponkai-Chubu Earthquake, though this slip surface is not definite within the ground. Figure 6 shows the slip line confirmed by excavation of dam body after the earthquake in Unoki. (Akita pref.) The slip line not clearly seen at the lower part, but it can be estimated that the slip line passes through the shallow part of the silty clay layer directly under the dam body. This applies also to the case of Ichinosawa (Akita Pref.) It is estimated that liquefaction has occurred in the counterweight fill and the sand bed.

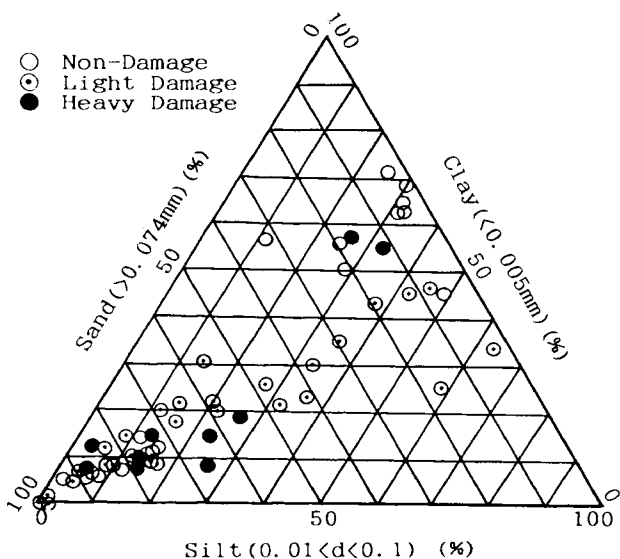
Fig.8 Grain Distribution of Earth Dam Materials Surved in The Case of The Nipponkai-Chubu Earthquake

This is nearly twice the rate of clay and gravelly clay. This tendency is more obvious with the damage rate of largely damaged earth dams. Dam body soil was sampled at 39 places of a damaged earth dam and at 18 places of a non-damaged earth dam, and subjected to physical tests. As for the non-damaged earth dam, the one which belongs to the similar region, geography and height was selected as far as possible. Figure 8 shows grain sizes of the damaged and non-damaged earth dams in the triangular diagram. Many data of damaged earth dams are located at left bottom of the triangular diagram. These grain sizes are roughly classified into coarse grain soil and fine grain soil according to the unified soil classification system as shown in Table 10. The tendency that many damaged earth dams consist of coarse grain soil is found from Table 10. Those earth dams with particularly large damage mostly consist of coarse grain soil. Similarly in the survey of Oga Earthquake, many damaged dams were of coarse grain soil, and it was pointed out that this tendency was remarkable among failed earth dams.

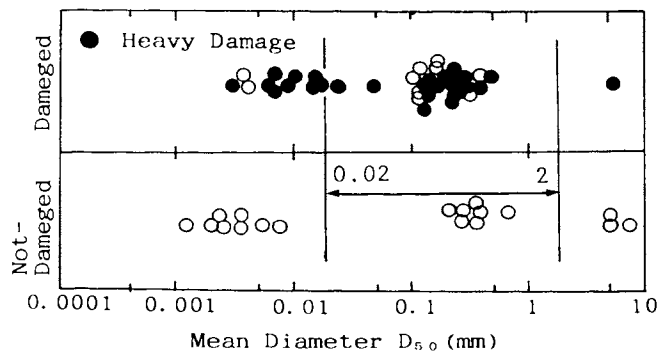
Fig.9 Mean Diameter of Earth Dam Materials Surved in The Case of The Nipponkai-Chubu Earthquake

The relation between the mean diameter of grain (D_{50}) and damage will be examined next. D_{50} values of dam body soil of damaged and nondamaged earth dams are plotted in Fig.9. The range of D_{50} that can cause liquefaction ($0.02 < D_{50} \leq 2\text{mm}$) is indicated in Fig.9. As for a non damaged earth dam, only 7 places (39%) out of 18 places are in this range, while 27 places (69%) out of 39 places are within the range for a damaged earth dam. This tendency is particularly strong with largely damaged earth dams.

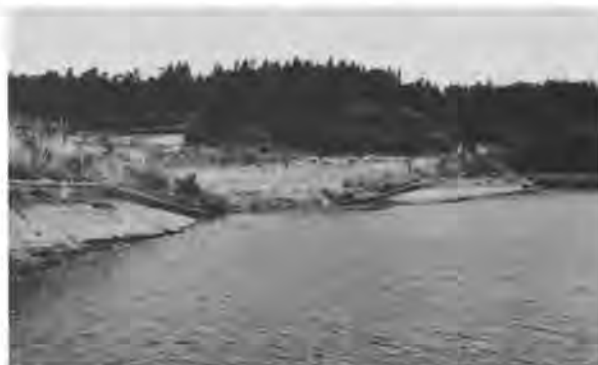
Fig.10 Kansuke Dam after Emergency Repair

In Nipponkai-Chubu Earthquake, Kansuke dam (height 5.4m) in Aomori pref. was damaged obviously by liquefaction. Detailed study and investigation were made for this earth dam using boring survey, sampling by insitu freezing method, soil tests, and dynamic response analysis to determine damage causes. There was a subsidence of about 1.8m at the center of the dam body which may lead to failure. The subsidence was repaired by banking at the center. Figure 10 shows the emergency repair after the earthquake. In the body of this earth dam, a trace of sand boil from the bottom of dam body is confirmed. Figure 11 shows the boring date of the dam body and the foundation ground. The dam body and the foundation ground are loose sand. (N<15) down to 17m). The dynamic response analysis was performed (1987) for this earth dam by the finite element method considering the excessive pore water pressure. The earthquake wave observed in the vicinity was adjusted to 119 gal of maximum the acceleration and used as the input wave. Figure 12 shows the liquefaction region after 6 seconds. This analysis result proves the damage was caused by liquefaction.
