Earthquake Damage Done at Right Angles to Epicentral Direction

Makoto Nasu

Chief, Geotechnical Engineering Laboratory, Railway Technical Research Institute, Tokyo, Japan

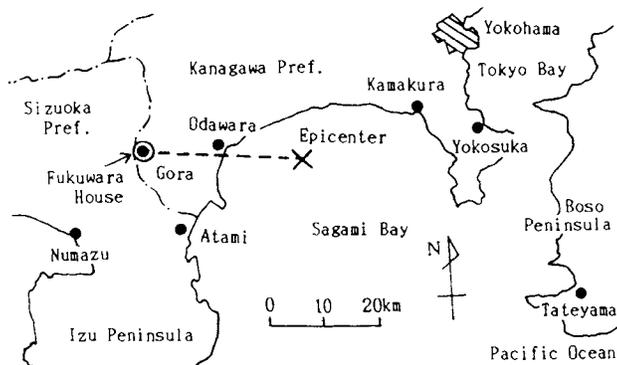
Fig.1 Damaged site of The Fukuwara House (1923 Big Kanto Earthquake)^{8) 10)}

(a) The Fukuwara House in Hakone Gora
This house failed on a small valley on the north slope.^{7) - 10)} The ground seems to be made of a talus cone deposit. The flow line of this slope runs approximately at right angles to the epicentral direction, as shown in Fig. 1.

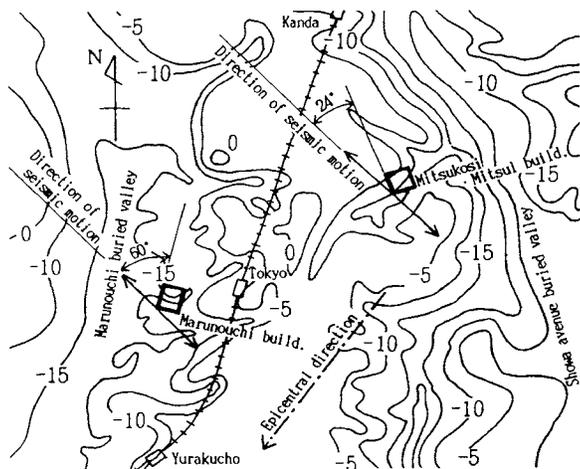
Fig.2 Equi-Depth Line (T.P., m) of Alluvium Bottom near the Tokyo Station (1923 Big Kanto Earthquake)^{7) 8) 11)}

(b) The District near Tokyo station
In the Marunouchi Building and the Mitsukoshi-Mitsui Building, as shown in Fig. 2, the direction of the predominant seismic force to the former building coincided with that to the latter, and two had worked approximately at right angles to the epicentral direction and to two buried valleys lines of the Marunouchi buried valley and the Showa-Dori buried branch valley.^{7) - 11)} In the Marunouchi district, the ground had been said to tend to shake in the east-west direction. Namely the ground was liable to shake in the direction that alluvium deposit became thicker. The direction coincided with the seismic motion direction and so in the comparatively large valley of the former the damage seems to have turned out heavier than in the latter valley.^{6) - 12)}

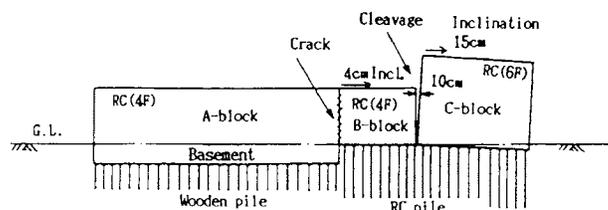
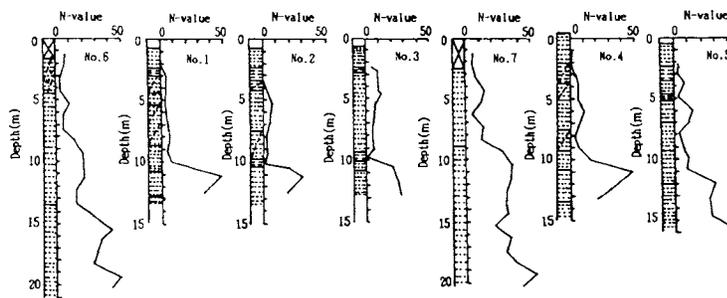
Fig.4 The Niigata Station (1964 Niigata Earthquake)^{2) 7)}

As shown in Fig. 4, the soft ground bottom under the non-damaged A-block of this building was approximately horizontal. And B-block and C-block on the inclined bedrock tilted in the inclined direction of the bedrock²⁾. This inclined direction is approximately at right angles to the epicentral direction.^{7) - 14)}

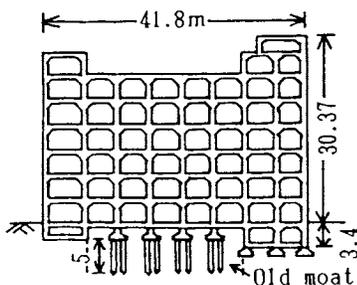
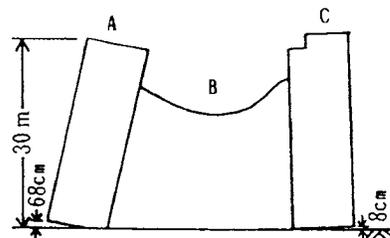
Fig.3 The Daiwa Department Store (1948 Fukui Earthquake)^{2) 7)}

In the Daiwa Department Store building with different foundations, as shown in Fig. 3, the ground under the center part with pile foundation which was deformed largely was a reclaimed land of an old moat which extended from east to west, and was softer than the ground under both outside parts of the building with spread foundation.²⁾ Also, the old moat extended approximately at right angles to the epicentral direction as shown in Fig. 2.^{6) - 7) - 13)}

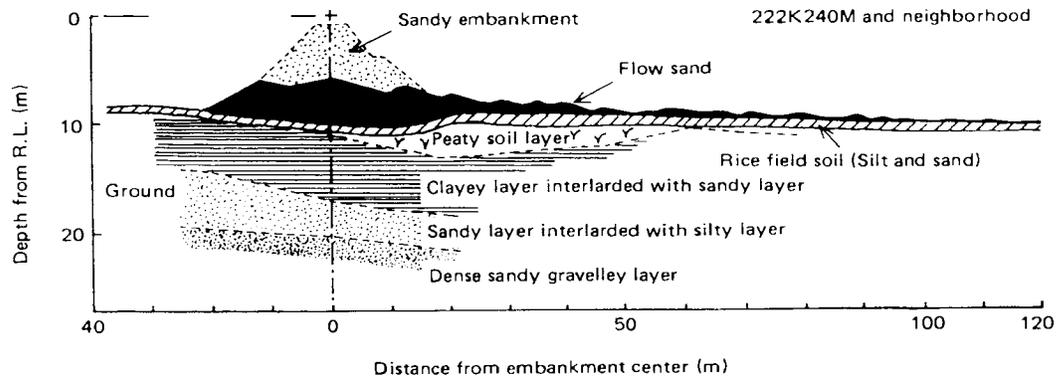
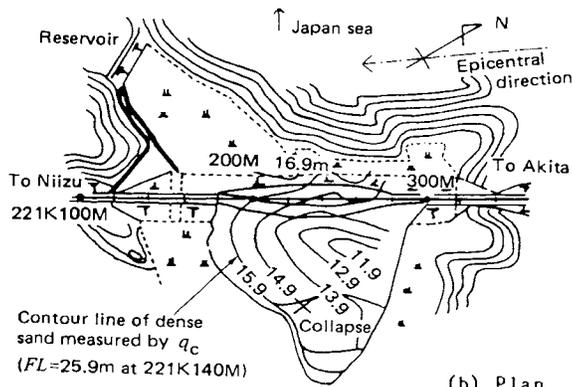
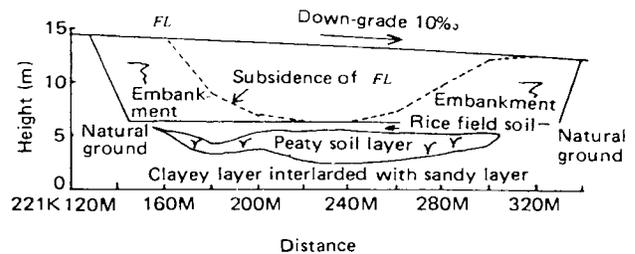
Fig.5 Railway Embankment in Deto (1964 Niigata Earthquake)^{1) 7)}

As shown in Fig. 5, this embankment soil flowed out 120m long approximately at right angles to the epicentral direction.¹⁾ This embankment straddled soft ground of peaty soil and hard ground, and this peaty layer and soil layers under it had been inclined in the flowing direction of the embankment soil. Also, the deformed zone of this embankment coincided with the existing zone of peaty soil.^{6) - 7)}

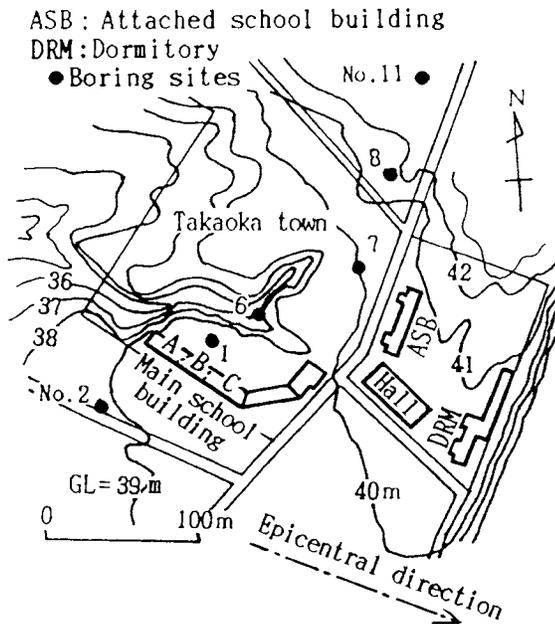
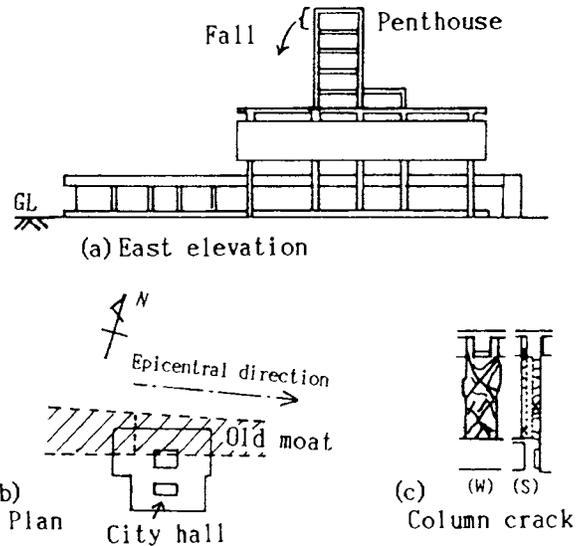
Fig.7 The Hachinohe City Hall (1968 Tokachi-Oki Earthquake)²⁾

(b) The Hachinohe City Hall
The ground under the northern part of the building with pile foundation which had been damaged by both this earthquake and Iwateken-Chubu earthquake in 1987, is a reclaimed land of an old moat, as shown in Fig. 7.²⁾ Predominant

seismic force direction in the former earthquake is estimated to have worked in the south-north direction with column crack etc., and also the top story the penthouse fell down in the southern direction of which the ground was good. The direction of the predominant seismic force in this case is approximately at right angles to the epicentral direction.^{6) 7) 19)}

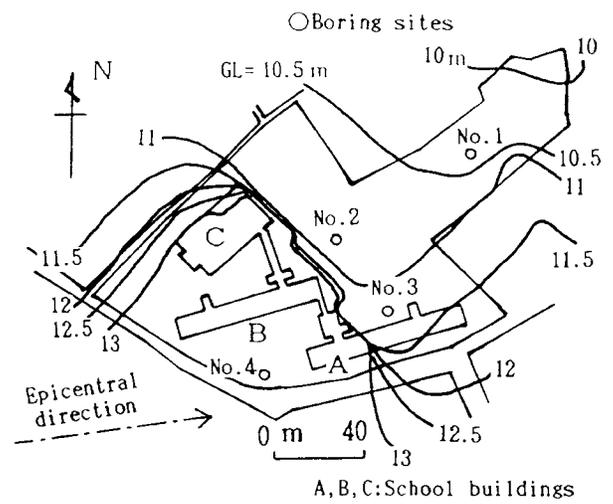
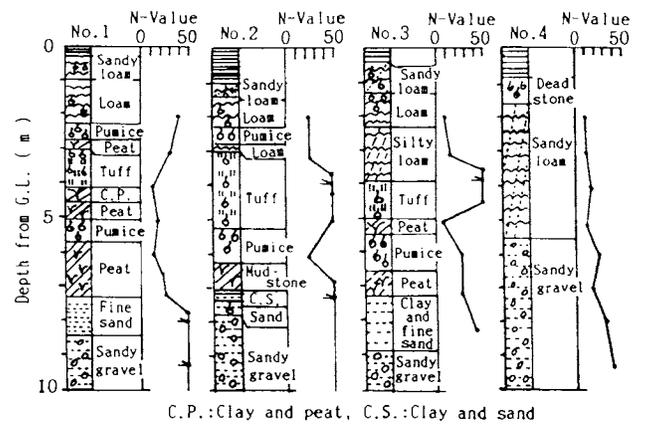
Fig.8 The Hachinohe East Senior High School (1968 Tokachi-Oki Earthquake)^{2) 7)}

(c) The Hachinohe East Senior High School (with different foundations)
As shown in Fig. 8, the ground under the east part with pile foundation of A-building, which was heavily damaged, had the deposits of swamp

soil including peat or peaty soil layer.²⁾ The predominant seismic force to the east part of the A-building had worked approximately at right angles to the epicentral direction, and the building was twisted from the original ground surface.^{6) 7)}

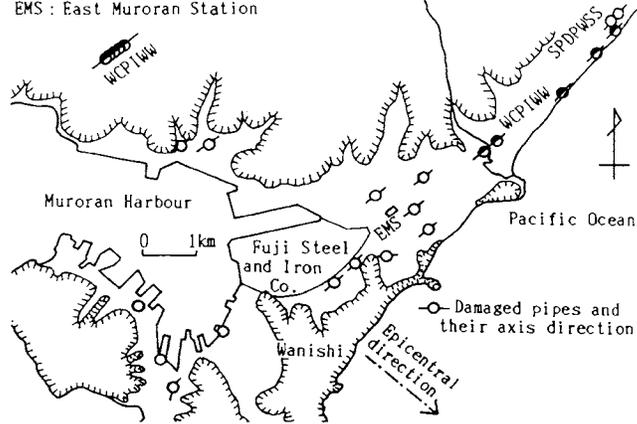
Fig.9 Main Damage of Pipe Lines of Industrial Water Works and Water Supply System in Muroran City (1968 Tokachi-Oki Earthquake)^{1,2)}

(d) In Hakodate, Muroran and Tomakomai Cities, the service pipe lines and distributing pipes of water supply system and water conveyance pipes of industrial waterworks, pipes buried approximately at right angles to the epicentral direction had been damaged mostly, as shown in Fig. 9.¹³⁾

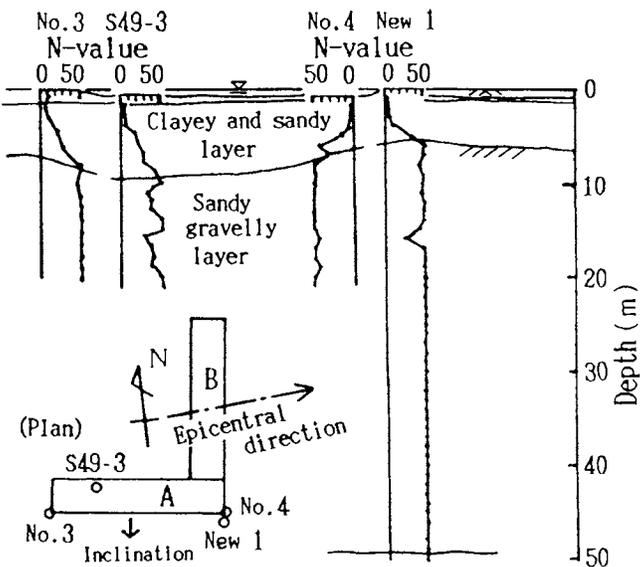
Fig.10 Ground of the Nagamachi Koriyama Housing Complex (1978 Miyagiken-Oki Earthquake)^{2) 7)}

(a) The Nagamachi Koriyama Housing Complex
In the southern end of the reclaimed land of an old swamp which extends long in the north-south direction, as shown in Fig. 10. A building with pile foundation was inclined in the span direction, namely to the south. This inclination had occurred in such a direction that the inclination bedrock surface becomes shallow²⁾, and it was at right angles to the epicentral direction.^{6) 7) 19)}

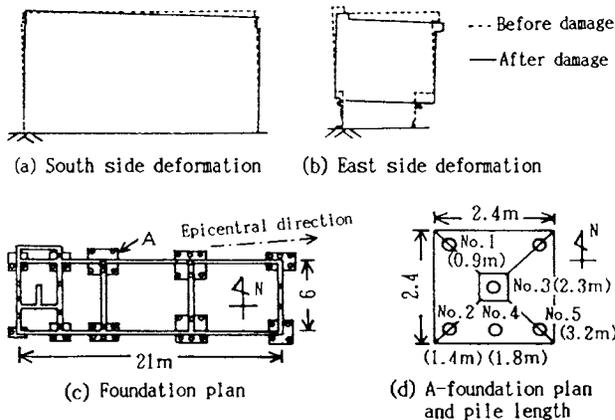
Fig.11 The Maruyoshi Building (1978 Miyagiken-Oki Earthquake)^{2) 7)}

(b) The Maruyoshi Industrial Building
In this building with pile foundation, piles in one foundation had various lengths as shown in Fig. 11.²⁾ The ridge direction approximately follows the epicentral direction, and especially the inclination of the building is larger in the span direction, being approximately at right angles to the epicentral direction, than in the

ridge direction.^{6) 7)} Also, the inclination of the span direction is such that piles become short and the bedrock surface does shallow.¹⁹⁾

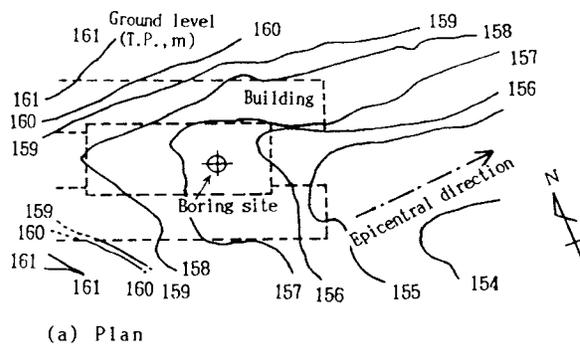
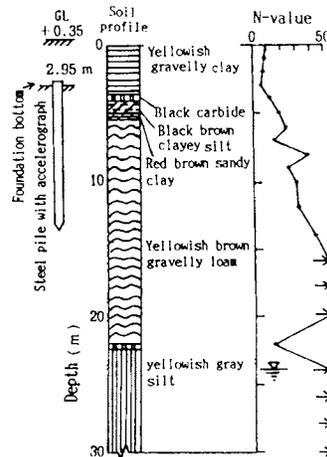
Fig.12 The Tohoku University Building (1978 Miyagiken-Oki Earthquake)^{2) 7)}

(c) The Tohoku University Building
As shown in Fig. 12, the ground underlying this building had shown a small valley type topography on a terrace, and ridge direction was approximately parallel to valley axis. This building had been constructed straddling the valley, and shear cracks had occurred both in the east gable and the west gable.²⁾ This ridge direction approximately coincides with the epicentral direction, and a predominant seismic force works approximately at right angles to the epicentral direction.^{6) 7)}

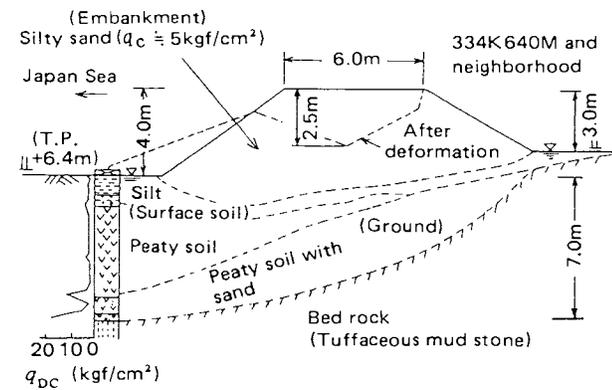
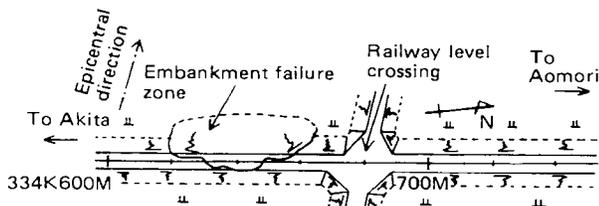
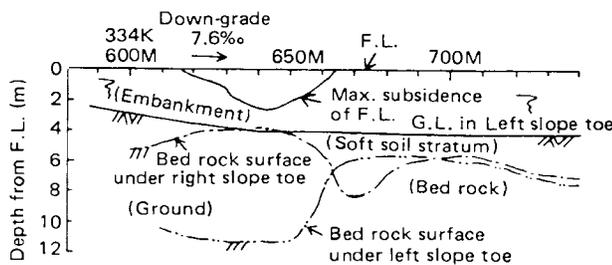
Fig.13 Railway embankment in Koikawa (1983 Nipponkai-Chubu Earthquake) ^{1) 7)}

(a) The railway embankment between Koikawa and Kado on the Ou Line
This embankment failed on the ground in which the bottom of the soft soil stratum including a thick peaty layer greatly tilted, as shown in Fig. 13¹⁾. Considering the damaged zone and the ground structure, it is estimated that the soft soil stratum bottom near 334K680M inclined

toward embankment axis and toward the starting point rather than the soft soil stratum bottom inclined at right angles to embankment axis influenced the failure first,^{6) 7)} whereas a neighboring 334K720M embankment underlaid with very soft and almost horizontal soil layer did not subside nor was it deformed.¹⁾

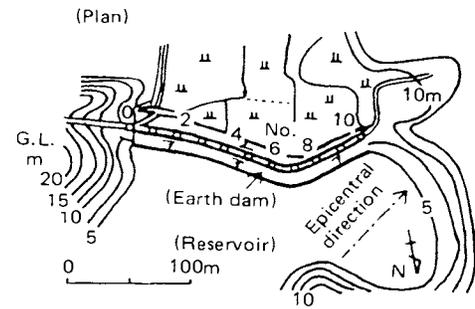
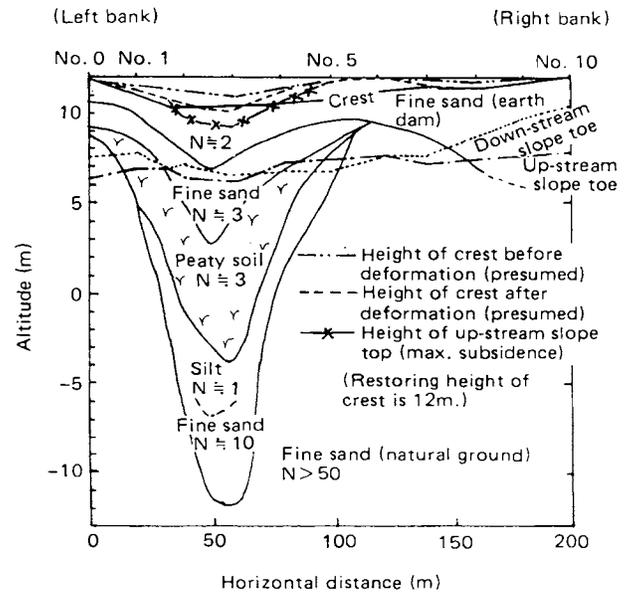
Fig.14 Relationship between earth dam subsidence and ground condition in Kansuke reservoir (1983 Nipponkai-Chubu Earthquake, revised original figure) ^{1) 7)}

An embankment near the left shore of which the up-stream side subsided especially largely, crossed the valley line that approximately coincided with the epicentral direction, and the inclination of both side slopes of its valley was comparatively steep, as shown in Fig. 14.¹⁾ Also, an embankment on hard ground near the right shore had deformed in the inclined direction of the embankment bottom and approximately at right angles to the epicentral direction.^{1) 6) 7)}

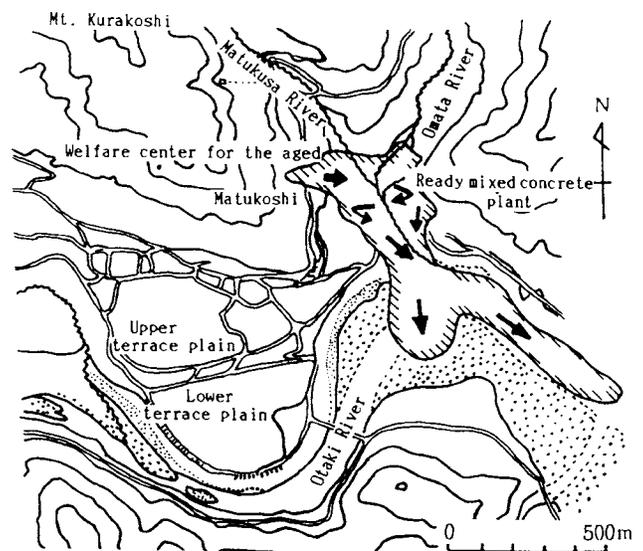
Fig.15 Slope Collapse in Otaki Village Matukoshi (1984 Naganoken-Seibu Earthquake) ^{7) 14)}

Additionally, natural slopes in Nakagi(1974) and Otaki Village Matukoshi(1984, see Fig. 15), embankments in Kotobukiyama(1978) and the Mochikoshi mine(1987) have collapsed exactly or approximately at right angles to the epicentral direction.^{6) 7) 14)}

(1) The epicenter is exactly north from collapsed site.
(2) Arrows show the flowing direction of collapsed soil.

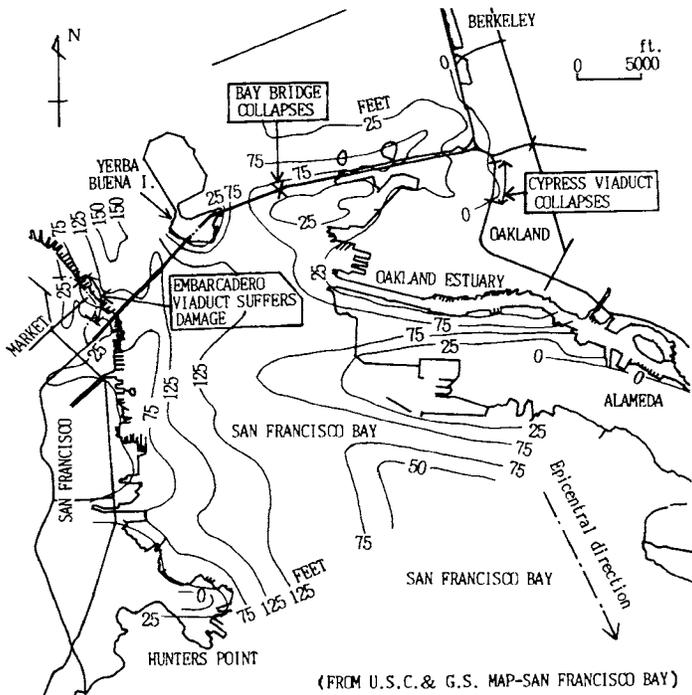
Fig. 16 Equi-depth line of Bay Mud base in San Francisco Bay (1989 Loma Prieta Earthquake)^{7) 15) -17)}

The bridge axis direction of the San Francisco-Oakland Bay Bridge in which upper and lower decks fell down, and the directions at the right angles to the bridge axis of the collapsed Cypress viaduct, of the Embarcadero Viaduct of which piers were damaged, and of the Struve Slough Bridge of which girders and piers were damaged, were commonly approximately at right angles to the epicentral direction, as shown in Fig. 16.^{7) 15) - 19)} Namely, the predominant

seismic force had worked at right angles to the epicentral direction, and this direction was at right angles to the Bay axis. ^{7) 18)} The ground shook largely approximately at right angles to the epicentral direction and approximately at right angles to the valley axis, ¹⁸⁾ and the phenomenon was the same as occurred in Tokyo Marunouchi district during the Big Kanto Earthquake in 1923 and so on in Japan. ^{7) 19)}

(b) Both the Embarcadero Viaduct where shear cracks have occurred in some piers at right angles to the bridge axis and the remarkably collapsed Cypress Viaduct has crossed the buried valley in the neighborhood of its exit to the Bay. As shown in Fig. 16, the bottom of the soft Bay Mud overlying these buried valleys was inclined toward the Bay.^{3) 16) 17)} Especially, the ground of the zone where the Cypress Viaduct collapsed remarkably was a soft ground reclaimed from the swamp, and the most of it seems to be old river beds or old lagoons, and there is included a very soft clayey or silty layer etc. within the ground.^{17) 19)}

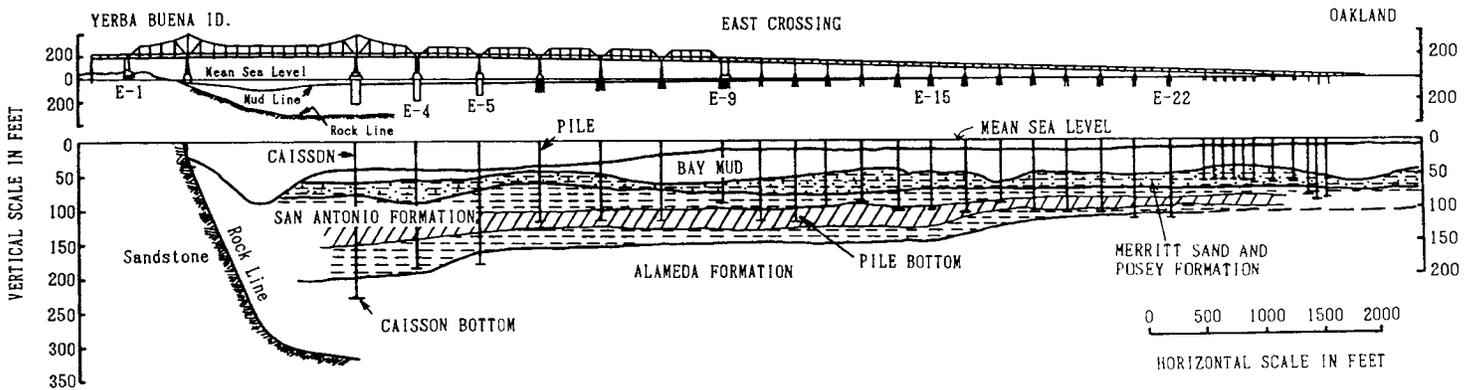
Fig. 17 The San Francisco-Oakland Bay Bridge (revised original figure)^{3) 15) 16) 19)}

(a) Because the damaged Bay Bridge had been constructed straddling both thick and thin parts of soft Bay Mud in the bridge axis direction as shown in Fig. 17 ^{15) -17) 19)} and a differential displacement occurred largely in its direction, the bridge decks are considered to have fallen down. ³⁾ Moreover, the Bay Bridge moved largely at right angles to the bridge axis, ¹⁷⁾ namely in the radial direction of the equi-depth line of the Bay Mud. This can be expected from Fig. 15 showing the equi-depth line of the Bay Mud base. ^{3) 16)}

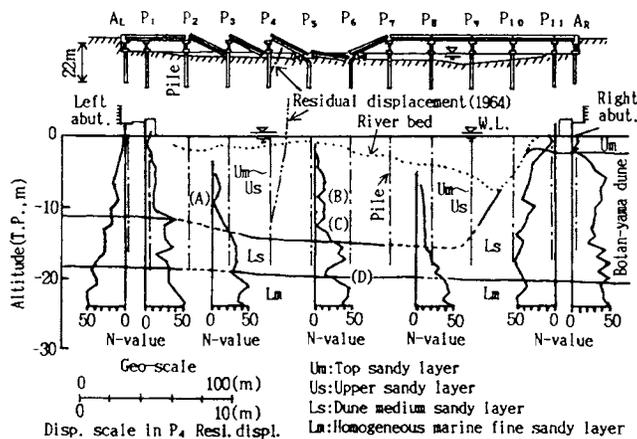
Fig. 18 The Showa-Ohashi Bridge (1964 Niigata Earthquake)^{3) 20)}

Bridge (see Fig. 18),²⁰⁾ the Yachiyo Bridge (1964, commonly), the Kin-o Bridge (1978) and so on were deformed in the bridge axis direction. Many of them had been constructed straddling thin part and thick part of soft soil layer,^{1) -3) 6) 7)} and their grounds were similar to the Bay Bridge ground.¹⁹⁾

In Japan, in grounds whose subsoil layers include soil layers(A ~D in Fig. 18) of less strength than about 15 in N-value like the Showa-Ohashi Bridge(1964)²⁰⁾ or the Hakodate University(1968), earthquake-induced damage has occurred in many spots, and most of the grounds had inclined sedimentary structures.^{1) -3) 19)} Also, the grounds of the Marina district, of the district along the Market Street and of the South Market district in San Francisco where various damages occurred during the Loma Prieta Earthquake(1989), have included clayey soils with soft peat etc., or the soft Bay Mud.^{17) 19)}
