## Behavior of Buildings in August 21, 1988 Bihar-Nepal Earthquake

S. K. Thakkar, D. K. Paul, S. Mukerjee,  
S. Bandyopadhyay, Ashwani Kumar, and  
B. V. K. Lavania

Department of Earthquake Engineering, University of Roorkee,  
Roorkee, India

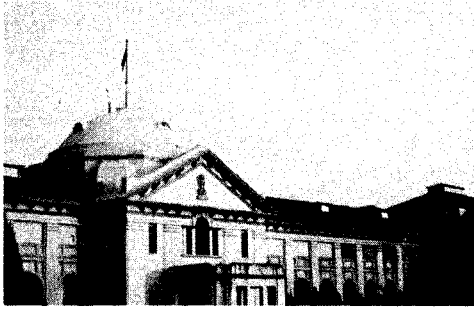
High Court Building, Patna (Photo 1) : This is a massive two storeyed structure constructed in 1917-1918 having 50 cm thick brick wall in lime mortar. The cracking occurred on the outer surface of dome, inner and outer walls. The separation of walls at corner was also observed.

Photo 1(a) High Court Building, Patna  
(Cracking of dome, walls, roof)

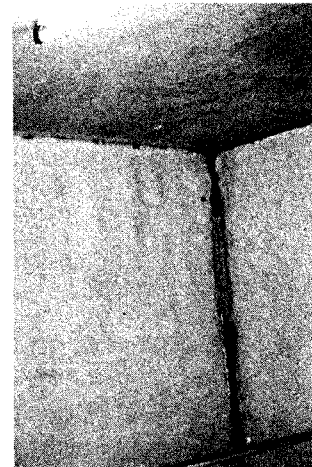
Photo 1(b) High Court Building, Patna  
(separation of walls at corner)

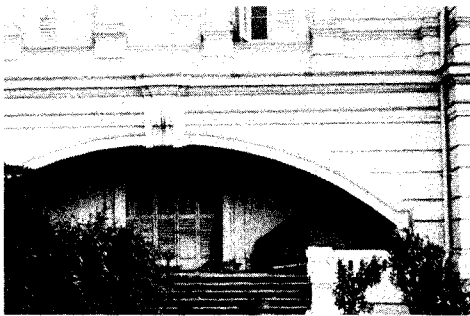
Governor's Residence, Raj Bhawan, Patna (Photo 2) : The massive three storeyed structure was constructed during 1916-1918. It consists of several load bearing arches. This structure withstood the 1934 Bihar-Earthquake which had cracked the dining hall on the first floor in N-S direction. Nearly, all the verandah arches about 10 m span on all floors oriented in approximately E-W direction suffered damage in this earthquake. The damage was in the form of fine cracks. The 15 m span arch in the western side of the building developed a large horizontal shear crack on one side just above the crown.

Photo 2 Raj Bhawan, Patna (Horizontal Crack over the arch in right half)

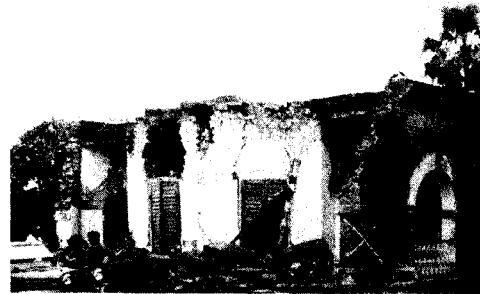
Land Mortgage Building, Darbhanga (Photo 3) : This is about a 100 year old building with arches constructed in lime mortar. The front arches failed and as a consequence the building was severely damaged.

Photo 3 Land Mortgage Building, Darbhanga  
(Failure of front arches, walls and roof)

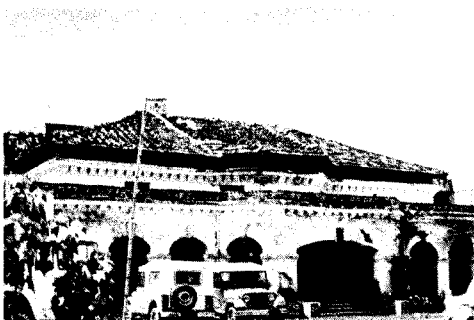
Civil Surgeons House, Darbhanga (Photo 4) : This is an old building in lime mortar. This was severely damaged and the building was abandoned. The masonry arch at the entrance developed severe diagonal cracks. The roof was also badly damaged and in one of the rooms, the roof collapsed because it was supporting a water tank over it.

Photo 4 Civil Surgeons House, Darbhanga  
(Severely damaged, building abandoned)

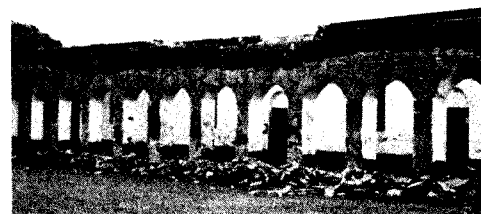
Madarsa Hamedia, Qila Ghat, Darbhanga (Photo 5) : This is an old single storey building of L shape constructed in 1927. There were fourteen class rooms in either wing of 6.5m x 6.5m size, approximately. The main walls of buildings were load bearing, made up of brick masonry in lime mortar. There was verandah corridor consisting of brick masonry arches resting on brick pillars in the front of the class room. The roof of class room consists of four small arches resting over iron girders. The 3.0m span arches of a verandah got damaged completely in one wing and the rooms were damaged beyond repair. The longitudinal and cross walls got separated at the corners. The reasons for damage were : (i) failure of verandah arch due to release of lateral thrust; (ii) additional shears induced due to torsion of L-shape

buildings, (iii) deterioration of strength due to age and (iv) absence of earthquake resistant measures.

Photo 5 Madarsa Building, Darbhanga  
(failure of arches)

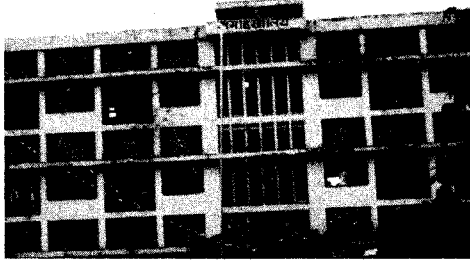
Collectorate Building, Samastipur (Photo 6) : The three storeyed building constructed in 1974 showed heavy cracks in the cross walls in E-W direction. The three storeyed collectorate building of same design existing in Madhubani relatively did not show much damage. In this building, the cracks occurred in one of the extreme blocks possibly due to torsion. The difference in behaviour of building of same design at two different places in the same earthquake is attributed to difference in intensity, quality of construction and variation of local soil condition.

Photo 6 Collectorate Building, Samastipur  
(Walls showed heavy cracks)

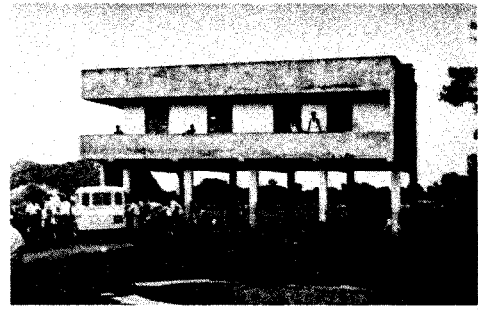
Photo 7 Cycle stand cum canteen R.C.  
structure, Munghyer.

Cycle stand cum Canteen structure (Photo 7) : This is a two storey reinforced concrete structure. The bottom storey consisting of several columns framed with the beam was open and used as a cycle stand, the upper storey housed a canteen. The structure of the same design was constructed at Darbhanga and Munghyer. The structure at Darbhanga completely collapsed while the structure at Munghyer survived with the cracking of columns near the top. The structure at Munghyer received relatively less severe ground motion because of its greater distance from the epicentre as compared to Darbhanga. The soil at Munghyer was relatively firm than at Darbhanga. The lack of continuity of steel in beams and inadequate stirrup spacing seemed to be the reason of collapse of this structure at Darbhanga. No measures were taken to incorporate ductility provision in the structure.

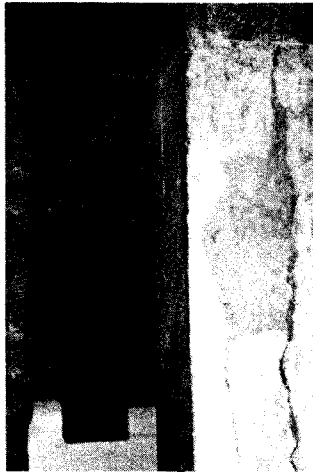
Surgical Ward building of DCHS, Darbhanga (Photo 8) : This is a three storeyed concrete structure constructed in early 70's. The following types of damages were observed :

- (i) The reinforced concrete columns developed diagonal cracks in the ground floor. In one of the columns, the rusted reinforcement was exposed due to spalling of concrete. The spacing of ties was quite apart. One of the columns had significant vertical crack in the lower portion.
- (ii) Cracks were also observed in concrete on the face of the column concealing the pipe.
- (iii) There were horizontal and diagonal cracks on the cross wall in the first and second floor.

The reasons for damage of this building were (i) poor quality of construction and poor maintenance; (ii) dampness in the building causing corrosion in reinforcement; (iii) lack of detailing of reinforcement.

Photo 3 Surgical ward, Darbhanga  
(Cracks in r.c. column)

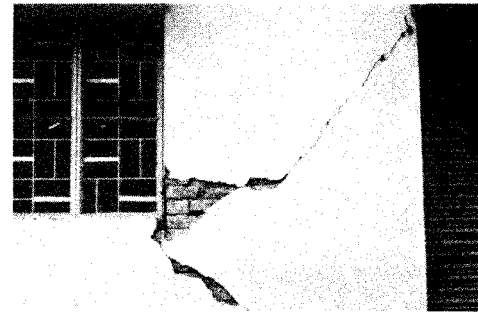
Telegraph Office, Munghyer (Photo 9) : This is a three storeyed reinforced concrete frame building constructed in 1984. The ground floor was damaged much more than the first and second floors. The walls got cracked badly between lintel and plinth. There was practically no damage to beams and columns of frame. The twelve and half centimeter thick partition walls were cracked badly. The reasons for damage was the inadequate connection detail between partition wall and the frame.

Photo 9 Telegraph Office, Munghyer  
(wide spread cracks in inner walls)

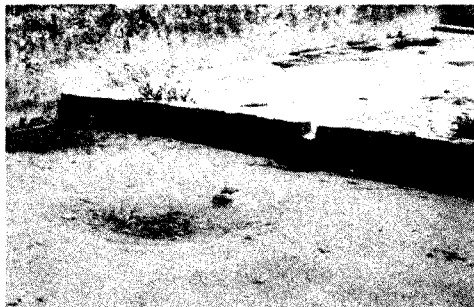
Photo 10 Jail Building, Darbhanga  
(Circular patch of sand left over after  
liquefaction)
