Ground Failure During Loma Prieta EQ - Downtown Santa Cruz

Proceedings: Second International Conference on Recent Advances in Geotechnical Earthquake Engineering and Soil Dynamics, March 11-15, 1991 St. Louis, Missouri, Paper No. LP37

Alan Kropp and Michael Thomas

Principal and Project Engineer, Alan Kropp and Associates, Incorporated, Berkeley, CA, USA

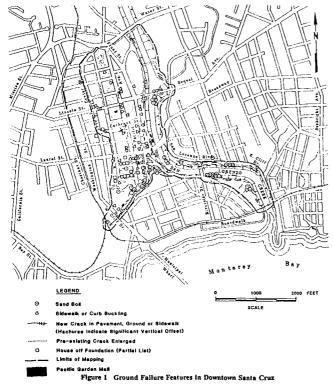
The authors of this article, in conjunction with engineering geologist Michael Scullin (of RSA Associates, Van Nuys, California), were volunteer members of the ASCE disaster evaluation team. They arrived in Santa Cruz on October 18, 1989, and continued work through October 20. Although other geotechnical evaluation work was performed during this period, the primary focus of these investigators was the ground failure in the downtown area. A map summarizing the general observations recorded is presented as Figure 1.

Generally, relatively little ground failure was observed in the Pacific Garden Mall where serious structural damage occurred to many buildings. Varying amounts of damage were mapped in other downtown areas with the most severe ground damage located in the levee areas along San Lorenzo River. A detailed discussion of the ground failure features observed is presented in Kropp and Thomas (in press).

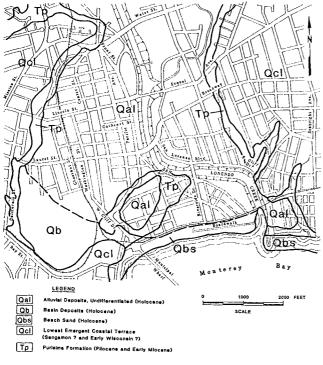
Figure 2 Geologic Map of Downtown Santa Cruz (After Dupre, 1975 and Brabb, 1986)

As seen on Figure 2, the majority of the downtown area is underlain by Quaternary Alluvium. These materials are described as undifferentiated, Holocene age materials. Dupré further describes "unconsolidated, them as heterogeneous, siltmoderately sorted and sand with discontinuous lenses of clay and silty clay. Locally include large amounts of gravel." In the southwestern corner of the area there is also a section of basin deposits. These Holocene-age described by materials are Dupré as "unconsolidated, plastic, organic-rich clay and Locally contain interbedded thin silty clay. layers of silt and silty sand. Deposited in a variety of environments included estuaries, lagoons, marsh-filled sloughs, flood basins, and lakes." Along the beach area, Dupré indicates beach sands are present which are said to be "unconsolidated, well-sorted sand. Local layers of pebbles and cobbles." The final unit in the main downtown area is the Pliocene and upper Miocene-age Purisima Formation materials. These are described by Brabb as "very thick-bedded, tuffaceous and diatomaceous yellowish-grey siltstone with thick interbeds of bluish-grey semifriable, fine-grained and andesitic sandstone."

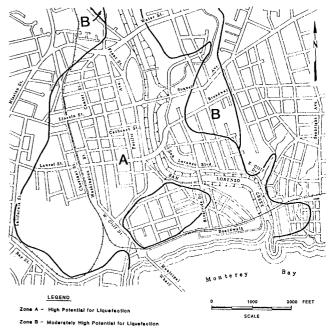
Figure 3 Liquefaction Potential Areas in Downtown Santa Cruz (City of Santa Cruz, 1976)

Dupré zoned the liquefaction potential of the Quaternary materials in four categories. Zone A was said to have a high liquefaction potential, Zone B a moderately high potential, Zone C a moderately low potential and Zone D a low potential. Most of the alluvial materials, as well as the basin materials in the downtown area, were placed in a high liquefaction potential zone (Zone A). A portion of the alluvial materials near the northwestern and the northeastern portions of the downtown area were placed in a Zone B, or moderately high potential area, because Dupré believed that groundwater was present at greater depths in this area. The City of Santa Cruz Seismic Safety Element duplicated the Zone A and Zone B areas on a special map for incorporation into the general plan. This general plan element was adopted in 1976, and Figure 3 indicates the limits of these zones in the downtown area. The Seismic Safety Element stated that during a great earthquake (such as the 1906 event), liquefaction could occur and "tremendous damage could resultfrom liquefaction-induced failures, not only to buildings, but to utility and communication lines, roads, bridges and overpasses, and other vital facilities." A comparison of the observed damage features following the Loma Prieta Earthquake shown on Figure 1 with the Zone A area on Figure 3 indicates a good correlation between the anticipated and actually-occurring areas of liquefaction.

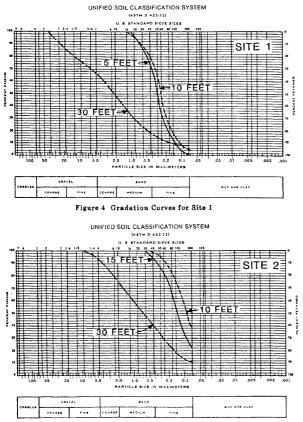
Figure 5 Gradation Curves for Site 2

Liquefaction potential was assessed for each of the samples presented on Figures 4 and 5 using the updated Seed-Idriss procedure (Seed and Harder, 1990). In the evaluation, it was Harder, 1990). determined that the sampling equipment for the Standard Penetration Tests relatively were similar to the standardized equipment and procedures and therefore no correction was applied. The blow counts were also corrected for overburden pressures to obtain the "equivalent" penetration resistance at an overburden pressure of 1 ton per square foot.
