## June 20, 1990 Earthquake of Northern Iran: An Overview

F. Nateghi and S. Eshghi

Senior Research Associates, International Institute of Earthquake Engineering and Seismology, Tehran, Iran

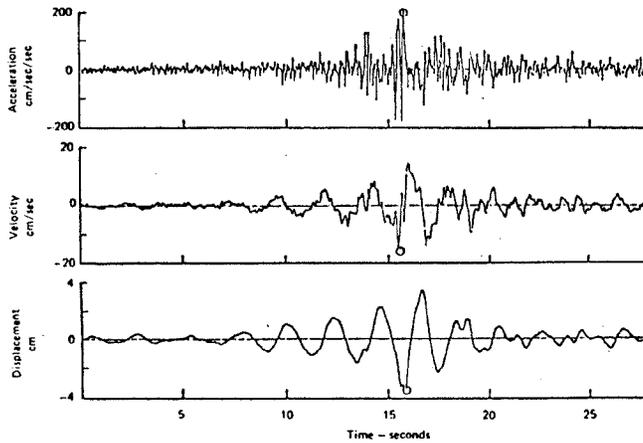
Figure-2 Time-Histories of the Event

Sequence of aftershocks were reported immediately after the main shock, the largest being reported in the order of  $M_b = 6.0$ . Acceleration, velocity and displacement time-histories of the event (UNDP, 1990) registered at the Gazvin Station is shown in Figure-2. The maximum recorded peak ground acceleration was reported at the village of Ab-Bar at 0.65g and 0.23g in horizontal and vertical directions respectively.

Peak Values: Gazvin Station  
 Acceleration = 193.3 cm/sec/sec  
 Velocity = -16.0 cm/sec  
 Displacement = -3.50 cm

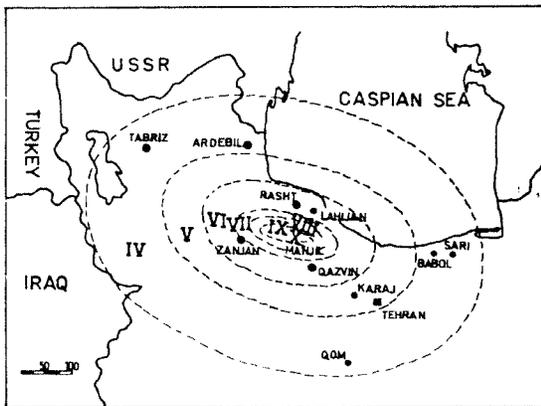
Figure-3 Isosismal Map of Manjil-Roudbar Earthquake

intensity estimated at Manjil at X on a Modified Mercalli Scale (MSK). The Isosismal map of the affected region is shown in Figure-3. Earthquake caused widespread geotechnical and structural damages covering an approximate area of 10,000 sq km resulting in 37,000 life losses, 100,000 injuries, and 100,000 building failures leaving 400,000 people homeless.

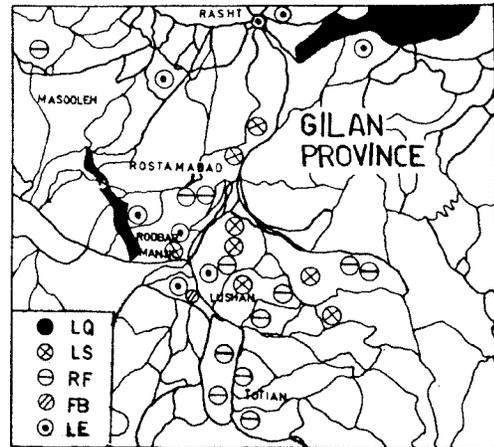
Figure-4 Extent of Geotechnical Failures

A number of geotechnical failures contributed to the destruction in this earthquake such as rock falls (RF), land slides (LS), foundation bearing deficiencies (FB) and liquefaction (LQ). Local site effects (LE) also played a major role in amplifying strong motion and contributed to the structural failures (IIIES, 1990). The extent of widespread geotechnical failures are shown in Figure-4.

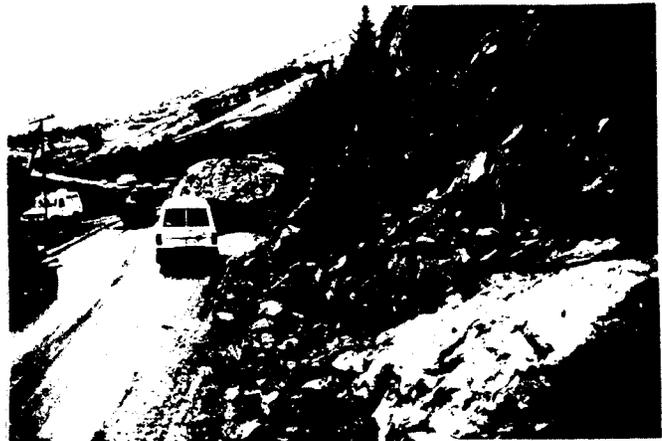
Numerous rock falls and land slides occurred in the region around the epicenter, covering an approximate radius of 60 km. They caused many road closures during and after the main shock and also destroyed many villages and towns in the region. The fallen rocks were some as heavy as a thousand tons or more.

Among the widespread land slides throughout the region, the one near the city of Roudbar (epicentral region) caused earth removal of approximately 10 to 20 million cubic meters. A typical rock fall is shown in figure-5.

Figure-5 Picture of a Typical Rock Fall

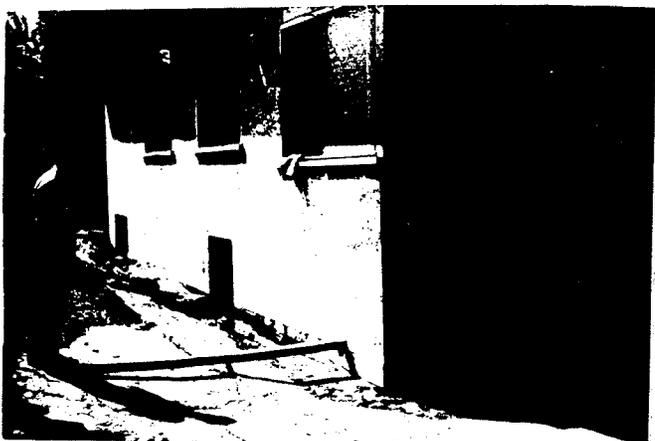
Soil liquefaction has caused extensive damages in a relatively vast area about 80 km to the north-east from the epicenter. It also occurred in an area near the epicentral region in village of Nasir-Mahaleh.

Liquified soil damaged foundations and disposition irrigation canals. It also broke pipelines, cracked pavements, and filled water wells with boiled sand (Eshghi, 1990). Hundreds of houses were unevenly uplifted, or sunken in the region due to liquefaction as shown in Figure-6.

Figure-6 Effect of Liquefaction

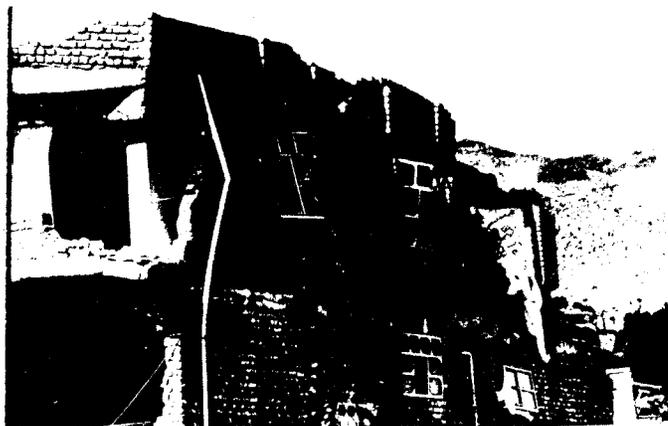
Residential buildings are mostly built as a non-engineered structures while some are built as partially engineered. These are buildings which are not designed in accordance with any seismic code, nevertheless have certain resisting members such as concrete ring-beams. Non-engineered buildings generally performed unsatisfactory resulting in total collapse while partially engineered buildings sustained severe damages but did not totally collapse as shown in Figure-7.

Figure-7 Picture of a Damaged Building

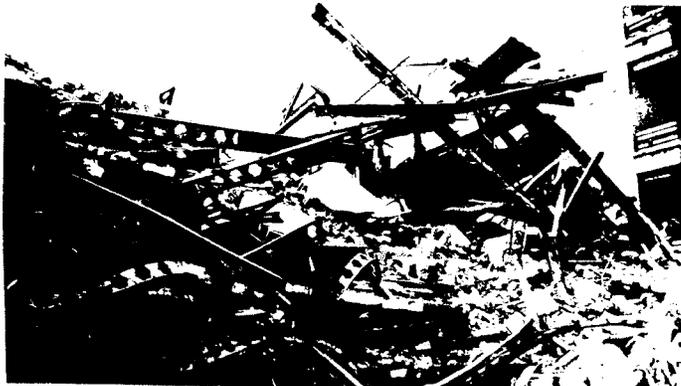
Most of the mid-rise buildings in the area are constructed using steel framing system. These buildings generally performed poorly. A typical damaged steel structure is shown in Figure-8. Lack of a proper seismic resisting system, unavailability of large steel sections, and poor welded connections can be named as the main reasons for unsatisfactory performance of steel structures during this earthquake.

Figure-8 Damaged Steel Structure
