Liquefaction of Soils in the 1989 Loma Prieta Earthquake

Raymond B. Seed

University of California, Berkeley, California

SYNOPSIS: The Loma Prieta Earthquake of October 17, 1989 was the most costly single natural disaster in U.S. history, resulting in losses of \$7 to \$9 billion, and claiming 63 lives. These damages were concentrated mainly at a number of distinct sites comprising a relatively small fraction of the affected region, as local site conditions and related geotechnical factors exerted a major influence on damage patterns and loss of life in this catastrophic event. This paper discusses one of these geotechnical factors, the widespread occurrence of soil liquefaction during the earthquake, as well as the associated damages and the resulting lessons learned. Additional significant geotechnical factors which exerted a strong influence on damage patterns during this event, including site-dependent dynamic response and seismically-induced slope instability, are discussed in companion papers in these proceedings.

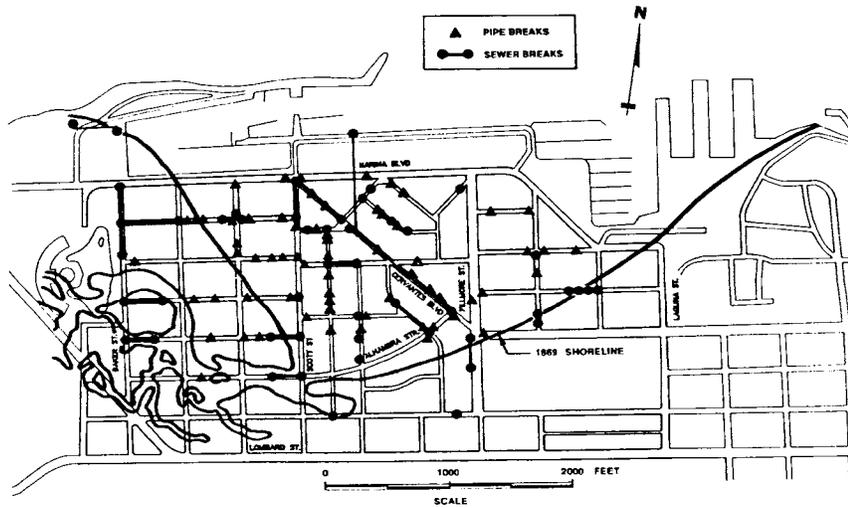
Figure 4 shows the locations of breaks in water pipes greater than 4-inches in diameter, as well as breaks in main sewer lines. Considerable damage to buried utilities occurred

Fig. 4 Location of Major Water Pipe and Sewer Breaks; Marina District, San Francisco

as a result of soil liquefaction in the Marina District during the earthquake. In addition to water and sewer breaks, numerous breaks in natural gas pipelines also occurred. It was, however, the water main outages which were most nearly catastrophic. Several fires occurred in the Marina District immediately after the earthquake, and water outages prevented rapid extinguishing of these.

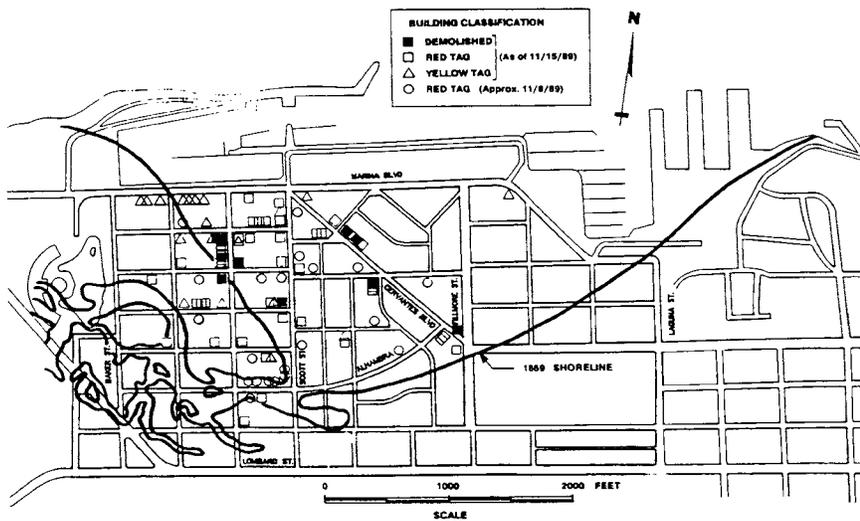
Fig. 5 Locations of Demolished Structures, and Structures Marked with Red and Yellow Post-Earthquake Inspection Tags as of Mid-November, 1989: Marina District, San Francisco

Figure 5 shows the locations of heavily damaged structures, as indicated by post-earthquake inspection "tags", roughly one month after the earthquake. As illustrated in Figure 5, a majority of the structural damage occurred near the heart of the Marina District. Much of this ground is underlain by the loose hydraulic fill placed in 1910-1912, and much of the rest is underlain either by fill placed to reclaim the perimeter marshes or by naturally deposited

loose to medium dense beach and dune sands which occur at the edges of the region. This does not mean, however, that this concentration of structural damages is due primarily to soil liquefaction. Instead, a majority of the damage to structures in the Marina District on October 17, 1989 was caused by strong shaking, as the fill in much of the region of heaviest structural damage is underlain by relatively soft and compressible recent clayey estuarine deposits which served to amplify the levels of shaking in this area. Although strong shaking was the primary cause of structural damage in this region, soil liquefaction also damaged structures, as a number of structures were wracked by differential settlements, lateral spreading, or partial bearing failures. Many of these structures were found to have sand intrusions in their garages and basements, and in some cases this sand spilled out so as to be visible from external inspection.

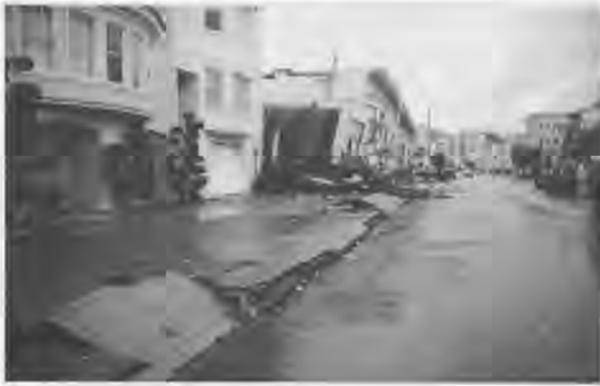
Figure 6 illustrates conditions near the center of the Marina District immediately after the earthquake. In addition to the collapsed structure, this figure clearly shows buckling of the sidewalk at two locations. This buckling is not the result of settlement, but rather of lateral compression of the pavement due to lateral spreading associated with liquefaction of the underlying fill in this area. Similar evidence of lateral spreading, including extension and/or compression of pavements, as well as massive and widespread damage to critical buried utilities, occurred throughout much of the District.

Fig. 6 Pavement Buckling Indicative of Lateral Compression; Marina District, San Francisco

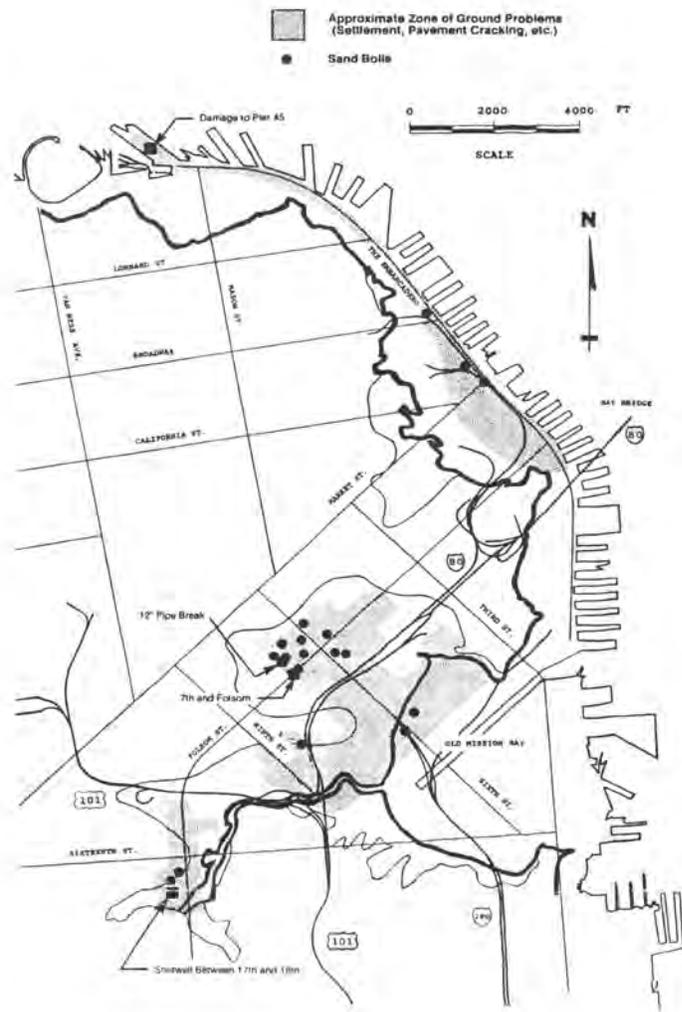
Fig. 8 Apparent Extent of Soil Liquefaction in San Francisco's Embarcadero and Old Mission Bay Regions on October 17, 1989

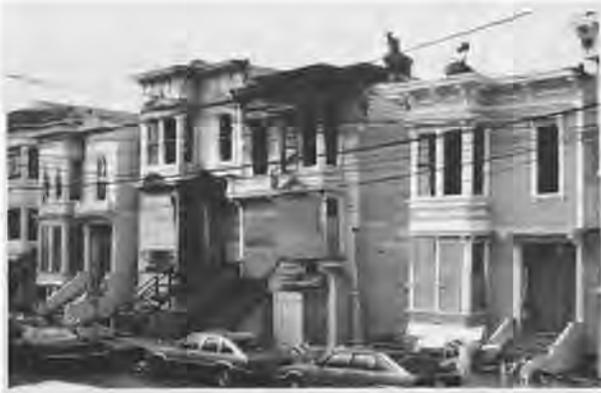
Despite the relatively moderate levels and short duration of shaking produced in these regions by the Loma Prieta Earthquake of October 17, 1989, soil liquefaction occurred again throughout much of these same areas, as shown in Figure 8. Much of this liquefaction was of moderate severity, representing ground softening and minor settlements producing cracking of pavements and utility breaks, but a number of buildings were also destroyed or damaged beyond repair as a direct result of liquefaction in these areas. In one 15-block area surrounding 6th and Folsom Streets, more than 50% of the structures were either significantly damaged or condemned, representing an overall level of damage not unlike that of the central Marina District.

Fig. 10 Four Buildings on Shotwell near 18th Street Damaged by Liquefaction-Induced Foundation Displacements in the Loma Prieta Earthquake

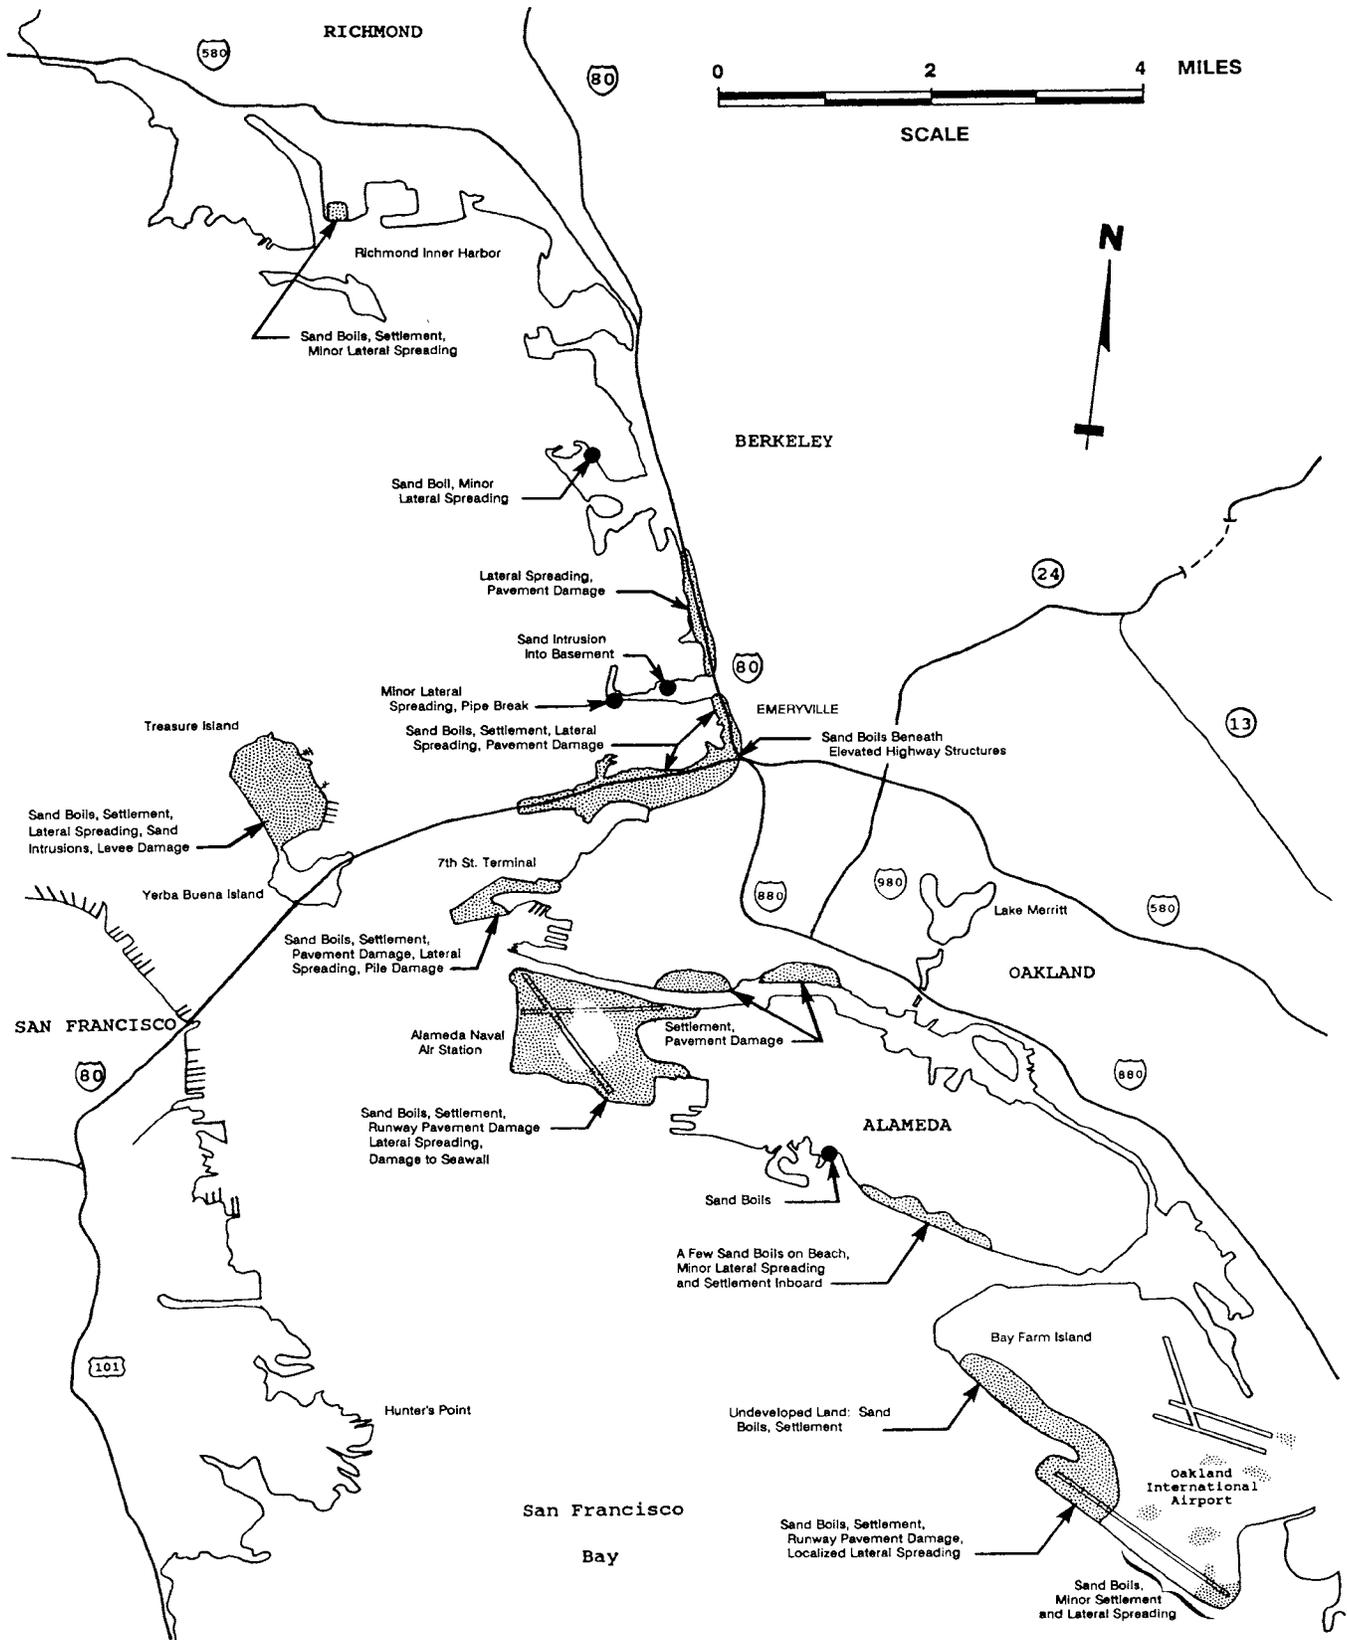
The central and east San Francisco Bayshore areas also suffered considerable damage due to liquefaction, as shown in Figure 12. Widespread liquefaction occurred over most of Treasure Island, a man-made island constructed by placing sandy hydraulic fill within rock containment dikes at the center of San Francisco Bay. In addition to producing numerous sand boils and large ponds, and damaging both structures and utilities, this liquefaction caused lateral movements and settlements of many of the levees surrounding this island. Among the most potentially ominous liquefaction-related features observed in the Loma Prieta Earthquake, these movements were indicative of the onset of liquefaction around most of the island perimeter. Studies are currently underway to evaluate the depths to which this liquefaction occurred, and the likelihood of more extensive liquefaction in stronger or more near-field future events producing full failure of the perimeter containment dikes.

Fig. 12 Map of Eastern and Central San Francisco Bay Area Showing Sites Damaged by Soil Liquefaction

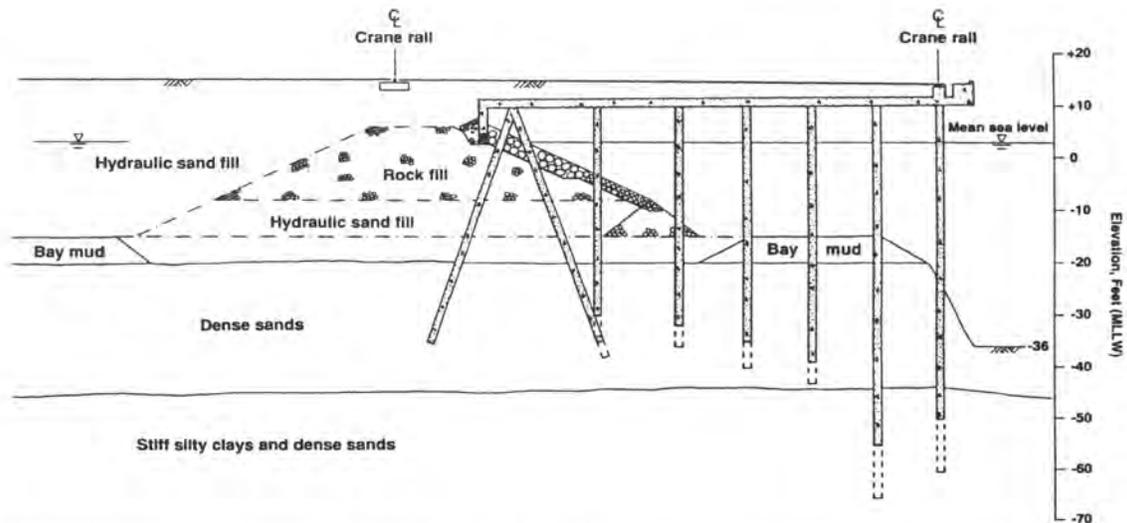
Immediately south of the Bay Bridge, extensive damage due to liquefaction occurred at the main Port of Oakland container cargo docks at the 7th Street, Matson, APL and Howard Terminals. Settlements and lateral spreading (accompanied by sand boils) damaged pavements and rendered many of these facilities at least temporarily inoperational as a number of massive cranes were unable to traverse railroad tracks rendered uneven by ground displacements. Figure 13 shows a cross section through the edge of a typical wharf at the 7th Street Terminal. The liquefaction-damaged harbor terminals in Oakland all consisted of hydraulic sand fill, placed behind containment dikes, and underlain by deep bay alluvium deposits. The section shown in Figure 13 is fairly typical of these.

Fig. 13 Cross-Section Through the Edge of the Fill, Dike and Wharf at the North Side of the 7th Street Terminal, Port of Oakland [Benuska et al., 1990]

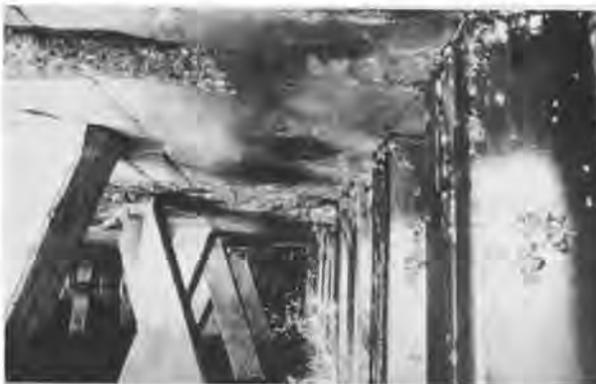
Most of the concrete wharves at the edges of the terminal fills were supported primarily on vertical concrete piles, but the inboard two rows of piles at the 7th Street terminal were battered to provide lateral load resistance as shown in Figure 13. These battered piles were massively damaged at their tips, as shown for example in Figure 14, illustrating the problems inherent in the use of battered piles to withstand seismic forces in an otherwise compliant soil system. Most of the terminal wharves at the affected Port facilities had at least one row of battered piles, and these consistently behaved poorly. The damaged piles (both battered and vertical) from the wharves supported on a combination of battered and vertical piles are currently being replaced by vertical piles only.

Fig. 14 Tensile Failures at Top of Battered Piles at the 7th Street Terminal [Photo courtesy of the U.S. Army Corps of Engineers, South Pacific Division]

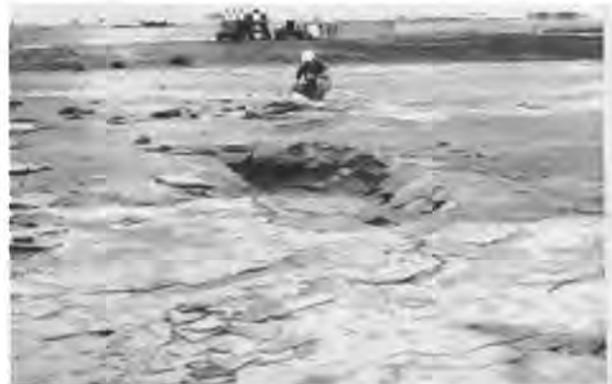
Station (NAS) and the Oakland International Airport were damaged by liquefaction of hydraulic fills. Figure 15 shows a sand boil adjacent to a runway at Alameda NAS. Lateral spreading, settlement, sand boils and pavement damage occurred at and near the runways at the northern end of Alameda NAS, though farther south in areas containing structures liquefaction was limited and damage to structures was relatively minor.

Fig. 15 Large Sand Boil and Sinkhole Adjacent to Runway at Alameda Naval Air Station

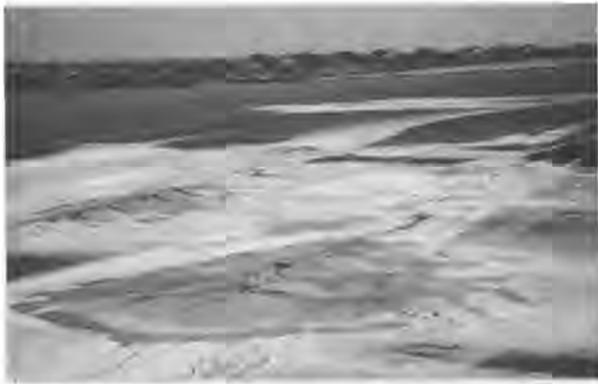
Soil liquefaction caused significant damage to the northwest end of the main runway at Oakland International Airport, as shown in Figure 16, and also damaged levees surrounding the edges of the airport's hydraulic fill. In addition to the damage to the main runway, sand boils and fissures resulting from lateral spreading occurred over significant portions of the airport fill, and a significant sand

Fig. 16 Fissures and Exuded Boil Materials, Main Runway, Oakland International Airport

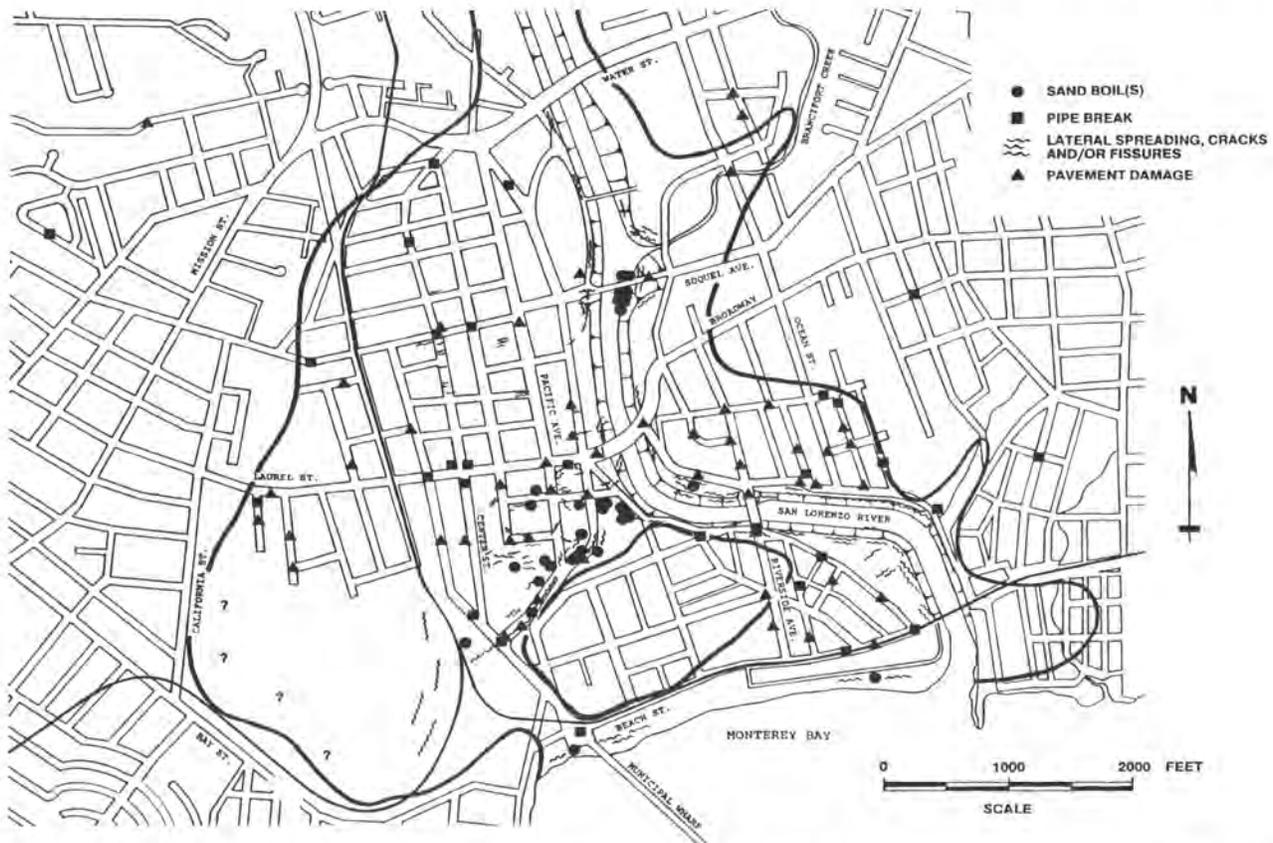
Considerable liquefaction (sand boils, settlement, cracking and buckling of pavements, lateral spreading, etc.) occurred in the City of Santa Cruz over an area roughly one kilometer wide and extending at least 1.5 kilometers inland at the mouth of the San Lorenzo River as shown in Figure 17. Considerable structural damage also occurred in this area, including the collapse of a major shopping mall. Additional lateral spreading and sand boils occurred, but caused little damage, immediately south at the edge of the Santa Cruz small craft harbor. The heavy solid line in Figure 17 outlines the zone predicted to be susceptible to soil liquefaction during moderate to strong levels of seismic shaking, based on studies (City of Santa Cruz, 1976) performed using SPT-based procedures (Seed and Idriss, 1971) to evaluate in-situ liquefaction resistance. As shown in Figure 17, these procedures well-defined the zone of liquefaction hazard.

Fig. 17 Map of Central Santa Cruz Showing Major Liquefaction-Related Features After the Loma Prieta Earthquake of October 17, 1989

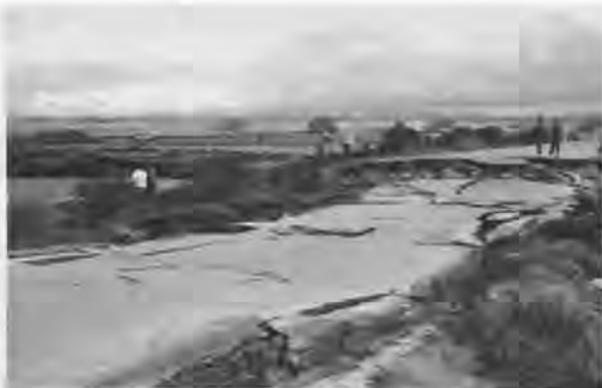
Fig. 18 Flow Failure of the Moss Landing Approach Road Embankment

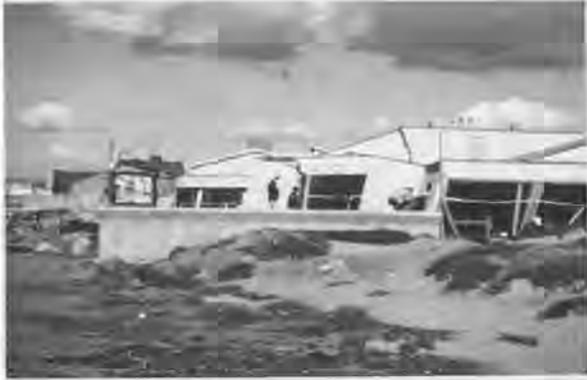
One of the clearest examples of the structural damage that can result from soil liquefaction was the destruction of the Marine Research Facility at Moss Landing. This facility was a group of low, modern 1- and 2-story structures founded on concrete slabs. The structures were grouped together to provide a series of classrooms and laboratories surrounding a central courtyard. The buildings do not appear to have been significantly damaged by shaking during the Loma Prieta Earthquake. This facility was, however, destroyed beyond repair by foundation displacements (settlement and lateral spreading) as a result of liquefaction of the foundation soils. The inboard roadway adjacent to this structure settled several feet, and lateral spreading deformations of the foundation soils stretched the facility by 6 feet, literally pulling it apart. Figure 20 presents an exterior view of this facility, clearly showing the massive damage caused by these foundation movements. Figure 21 shows a large warehouse which was destroyed at essentially this same site by similar lateral spreading in the great 1906 San Francisco Earthquake.

Fig. 20 Damage to the Moss Landing Marine Research Facility as a Result of Settlement and Lateral Spreading
