The Loma Prieta Earthquake: Implications of Structural Damage

S.A. Mahin

SYNOPSIS: The Loma Prieta earthquake provides a wealth of information on the seismic response of a wide variety of structures over a large metropolitan area. Soil amplification at sites distant from the epicenter contributed significantly to the substantial damages developed during the earthquake. Because of the large shaken area, the earthquake provides much useful information for all those interested in earthquake engineering. Structural damages resulting from the earthquake are reviewed herein with emphasis on buildings and bridges. Implications for modern design and retrofit methods are highlighted. Emphasis is placed on the need to carefully consider soil conditions, to treat the structure as a system rather than as an assemblage of independent elements, to explicitly define performance expectations, and to increase efforts to retrofit older seismically hazardous structures.

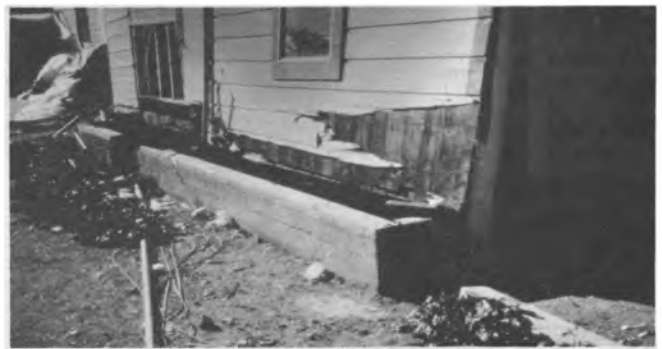
As indicated previously nearly 20,000 dwelling units were damaged during the Loma Prieta earthquake and 10,000 individuals were forced to relocate as a result. A majority of these displaced people lived in wood frame houses and apartments. Many homes located in the Santa Cruz mountains, in the immediate epicentral region, were damaged. Damages ranged from fallen chimneys and porches to partial or complete collapse. Many wood frame buildings in the hardest hit areas were overwhelmed by the seismically induced inertia forces. Sadly, the majority of the damage occurred in older wood frame buildings where the structures were simply not connected to their foundations. During the earthquake, as they have in innumerable past earthquakes, the structures simply shifted off their foundation with resultant vertical dislocation (Fig. 2).

Fig. 2 Damage to House Not Bolted to Foundation

The unfortunate aspect of both of these forms of damage is that simple and economical retrofit procedures, if implemented prior to the earthquake, could have prevented or significantly reduced the severity of the observed damages. Repair following the earthquake was generally extremely expensive as a result of not only the required structural repairs, but because of wide spread damages to architectural, electrical and mechanical features. Pre-earthquake retrofits to these walls and foundations were seen to be effective in several instances in Santa Cruz and elsewhere.

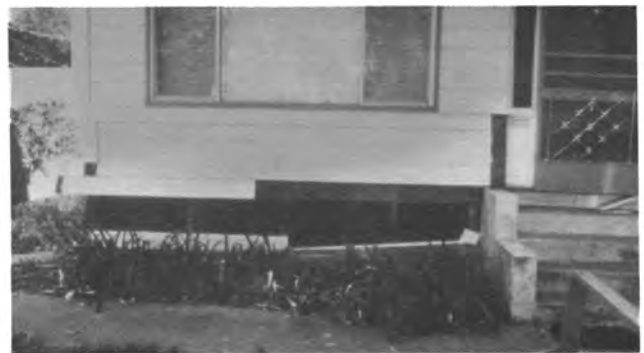
Another common type of failure that was observed related wood frame dwellings built upon short pony or cripple walls. These short walls provided a two to four foot tall access space that was used for storage, ventilation and to accommodate sloped sites. In many older buildings the framing between the ground floor and the foundation consisted of vertical studs and horizontal siding. Even though diagonal braces were provided in the upper levels to resist lateral loads, the braces were typically omitted from the pony walls. In addition, the horizontal siding covering these walls in most cases had badly deteriorated and effectively provided little or no lateral resistance (Fig. 3). The failure of these short support walls resulted in large vertical and lateral displacements of the supported structures (Fig. 4).

Fig. 3 Damage to "Pony" Wall

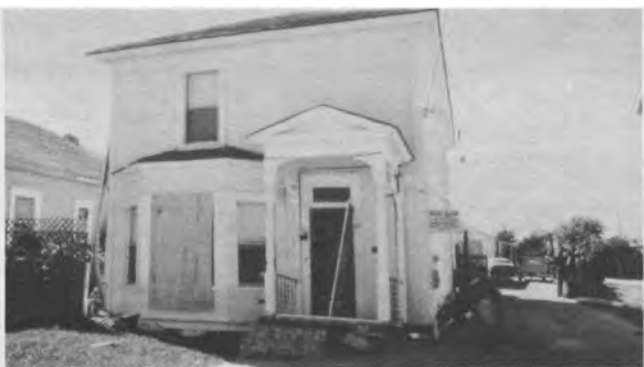
Fig. 4 Collapse of Home on "Pony" Walls

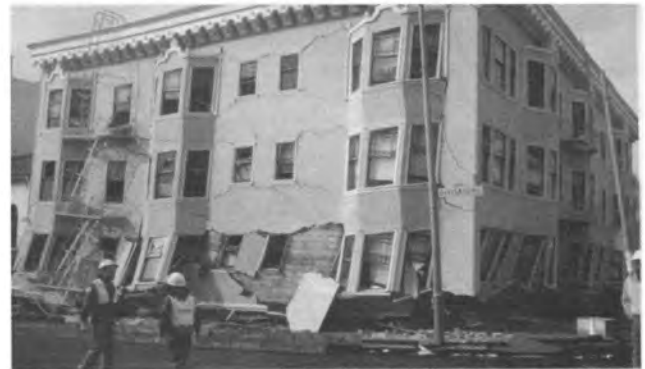
Many wood buildings were damaged or collapsed in this area. However, a detailed inspection of the damages indicates that the collapses concentrate in three or four story apartment buildings (Fig. 5) located on the corners of blocks (or where a structure was not sandwiched between two other adjacent buildings with little or no separation). These older apartment buildings were generally constructed with relatively massive apartment floors supported over a level of garages (Fig. 6). The bottom level thus was largely open to allow for multiple garage door openings. Typically, parking stalls were several cars deep and often extended out though the back of the building to provide for even more parking. This situation resulted in a soft first story. Lateral load resistance was provided by horizontal wood sheathing (covered by brick veneer) placed over only a few walls. This sheathing was observed to have decayed severely in many cases during the life of the structure.

The amplified seismic motions in the Marina District resulted in the collapse of the lower level of these corner apartment buildings in many cases. It is significant to note that these types of apartment complexes are quit common throughout San Francisco. Some apparently identical buildings located only a few blocks away from the heavily damaged area, but on firmer ground, remained virtually undamaged following the earthquake. Nonetheless, the potential hazard posed by these structures during future more severe earthquakes should be carefully investigated.

Fig. 5 Collapse of Apartment in Marina District

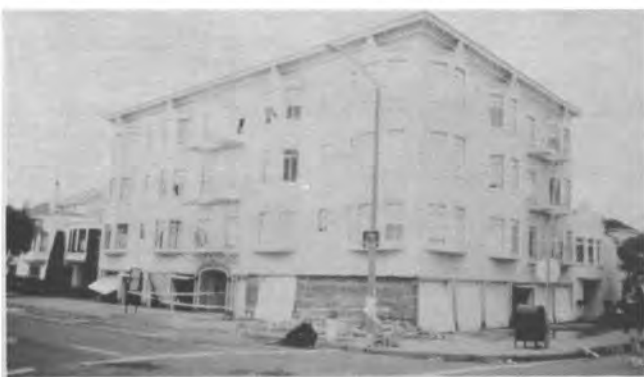
Fig. 6 Typical Marina District Apartment

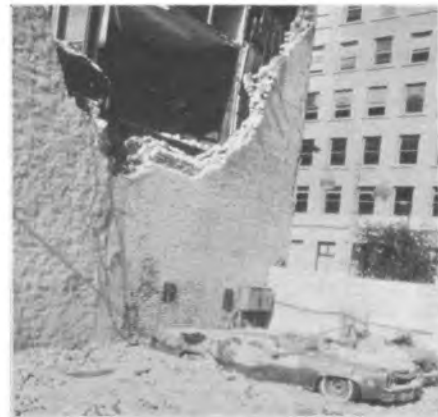
A particularly devastating form of damage resulted when the walls were not tied to the floor diaphragms. In many cases the walls failed out-of-plane, falling into the street (Fig. 7). In several notable cases the walls fell from upper floors of a building onto the roof of a lower adjacent structure (Fig. 8). The damage to the lower building resulted in two deaths in two separate buildings in Santa Cruz. In another instance, five casualties resulted as a wall collapsed in to the sidewalk area in front of an unreinforced masonry structure. For the level of shaking encountered, moderate amounts of tie

Fig. 7 Out-of-Plane Failure of Masonry Wall

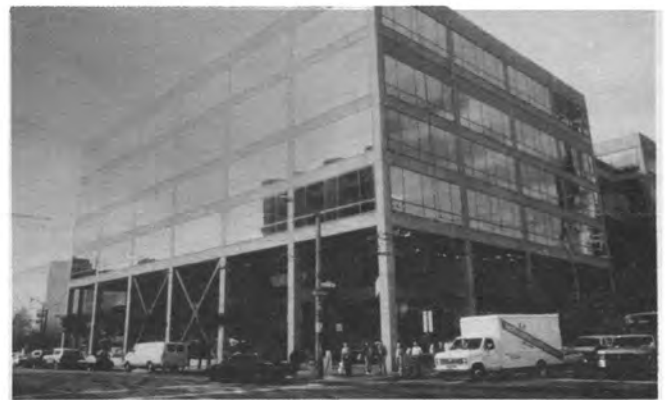
One example of this situation is a 6 story reinforced concrete building constructed in San Francisco at the order of corner and Fourth Street during the early 1980's (Fig. 11). During change of ownership a few years after it was built a number of seismic deficiencies were identified. These were remedied on the basis of

Fig. 11 Retrofit of New Reinforced Concrete Building

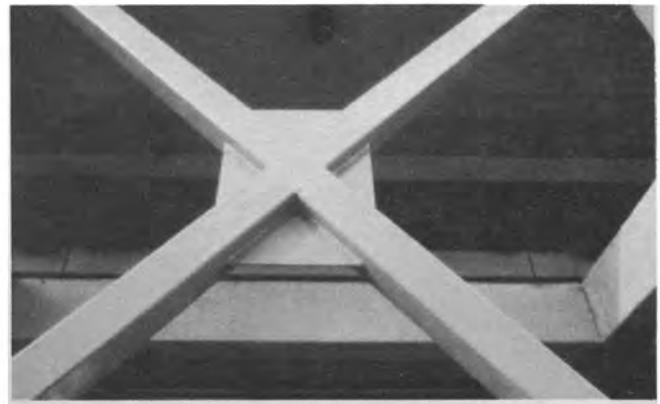
Fig. 13 Repair of Damaged Intersection

protection of the life safety of the occupants by adding steel braces and shear walls. Following the earthquake, the connections in the steel braces were observed to buckle (Fig. 12), the attachments of the braces to the concrete frame had slipped (in some cases due to faulty installation of anchor bolts), extensive cracking occurred in the shear walls, and initiation of punching shear failures in a few column to flat plate connections. The building has been since repaired (Fig. 13) to restore the capacity that existed at the time of the earthquake.

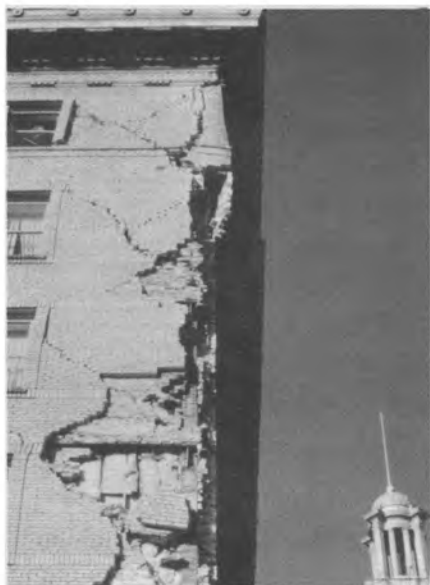
Another example, is the Hotel Oakland in Oakland. This is a steel frame building with extensive masonry infill panels. In retrofitting this structure new lateral load resisting elements were added and the exterior masonry elements were positively attached to the building to prevent large panels from falling into the street. As result of the earthquake nearly all of the masonry piers in the building developed distinctive x-shaped shear cracks. In addition, at a few locations masonry elements were dislodged from the building and fell to the street (Fig. 14). This building apparently preserved life safety as intended, but extensive and expensive repairs were required to restore the building fully to service.

Fig. 14 Damage to Retrofit Steel Frame Building with Masonry Infilled Walls

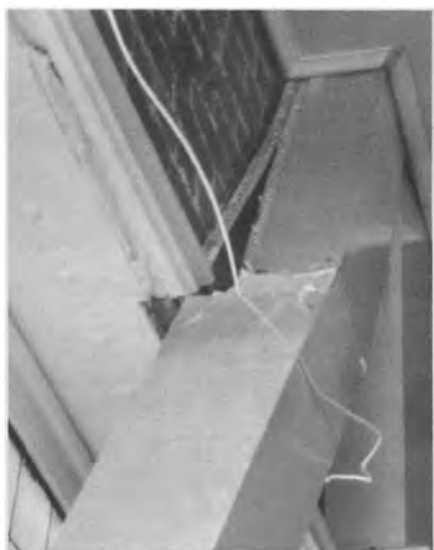
Fig. 16 Buckled Brace in URM Building

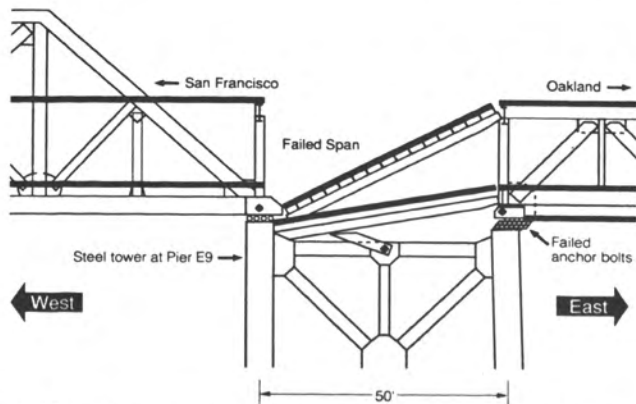
In addition, the bottom chords of the trusses were attached to the tower by means of twenty 1-in. diameter bolts. During the earthquake the bolts in the connection on the east side of the tower sheared completely and the bearing plate moved approximately 5-10 inches to the east. This was probably the proximate cause of the roadway beams slipping from their seats.

Fig. 18 Detail at Collapsed Section of Bay Bridge

The bridge was repaired by jacking the eastern segments back into place and providing new roadway beams and supports. The support seats were constructed about 50% longer than in the original design. A more extensive study is currently under way by Prof. A. Astaneh and his colleagues at the University of California, Berkeley and by Caltrans to assess more reliable long term retrofits.

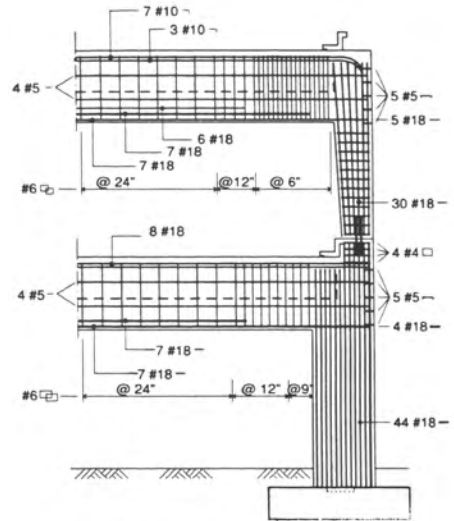
This bridge represented in many respects a substantial advance in the state of the art at the time it was built. Not only did it have two levels, it was one of the first major bridge structures in the U.S. to employ post-tensioning and large diameter reinforcing bars. In most cases the structural system incorporated a significant number of flexural hinges in order to simplify the future addition of access ramps, to reduce secondary forces resulting from deformations associated with post-tensioning and foundation settlement, to reduce computational effort and to control moments that could be transferred to the foundations. This resulted in a structure that was nearly statically determinate. In addition, detailing did not incorporate features needed to impart ductility to the elements (shear reinforcement sufficient to develop the flexural capacity of members, confinement of potential plastic hinge regions and inadequate development length on reinforcement), and joints were neither confined nor designed to resist the shear forces associated with realistic lateral loadings. Details of a typical transverse bent are shown in Fig. 21. In addition, in the longitudinal direction, frame action depended on the

Fig. 21 Detail of Typical Bent [from Housner (1970)]

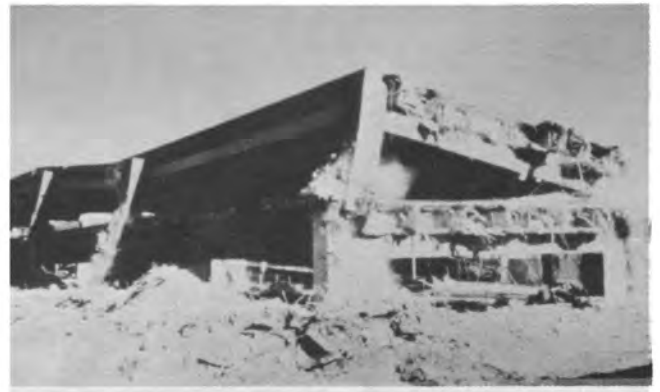
The sudden and catastrophic nature of this failure mechanism was demonstrated convincingly during the demolition of the Viaduct. A wrecking ball was used to initiate failure in a single column. Almost immediately progressive collapse occurred throughout the upper level not only extending transversely across the roadway, but also longitudinally for six bays to the end of the remaining standing portion of the viaduct. Clearly, such brittle structures are not compatible with seismic resistant design.

Fig. 23 Failure Mode Observed during Demolition
