On the breakage of rock drill steel

ON THE BREAKAGE OF ROCK DRILL STEEL

MASTER OF SCIENCE IN METALLURGY

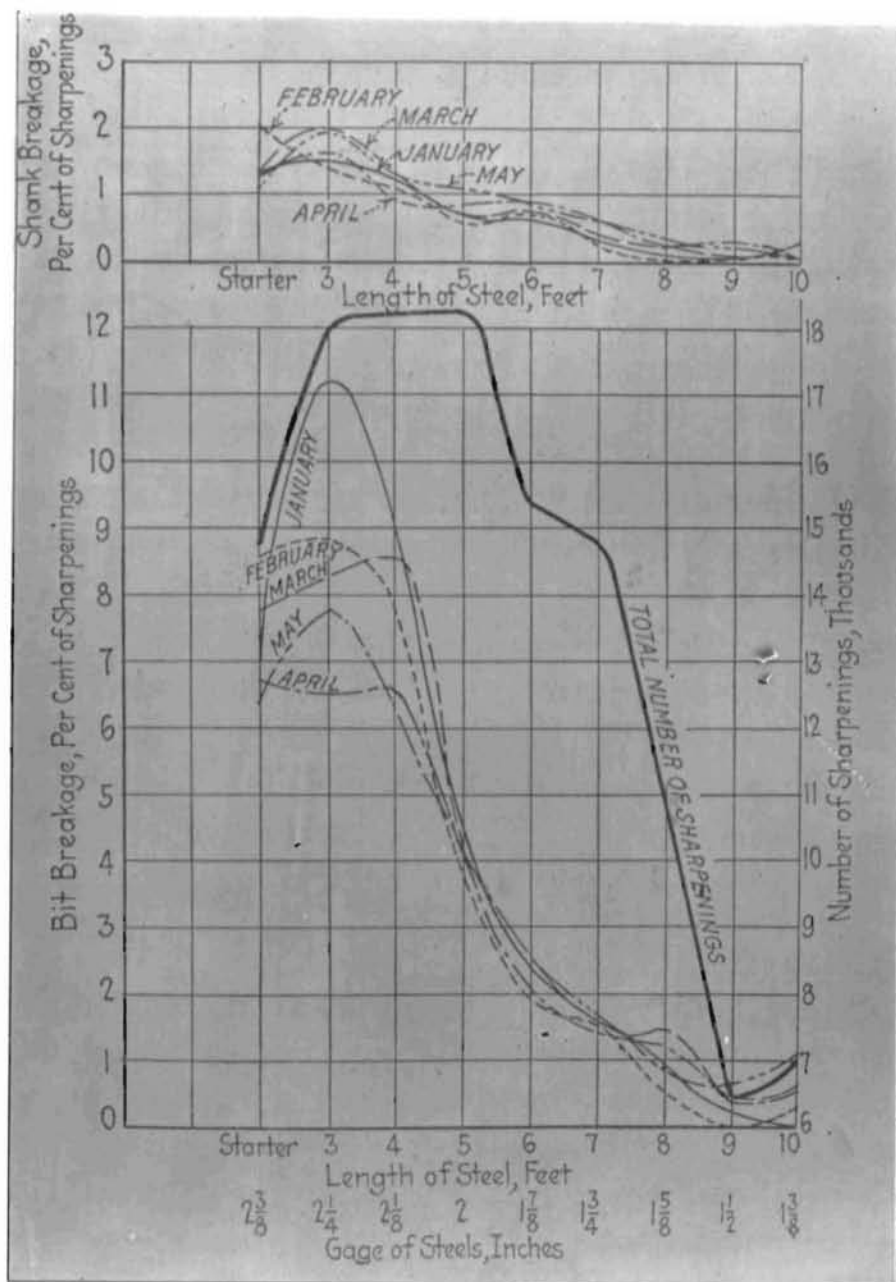
FIG. 1

particularly noteworthy because 80% of the failures occur within six inches of the bit, whereas, in nearly all other cases, the major portion of the breakage is at the shank end of the steel.¹ The reports from the company, it being one of the few that keep extensive records of performance, show that the majority of failures occur in the 3, 4, and 5 foot lengths, the gages of which are 2-1/4, 2-1/8 and 2 inches respectively. Figure 1 is a reproduction of a curve drawn from data furnished by the company.

Chart showing bit breakage as per cent of total sharpenings for the various lengths of drill steel, Homestake Gold Mines.¹

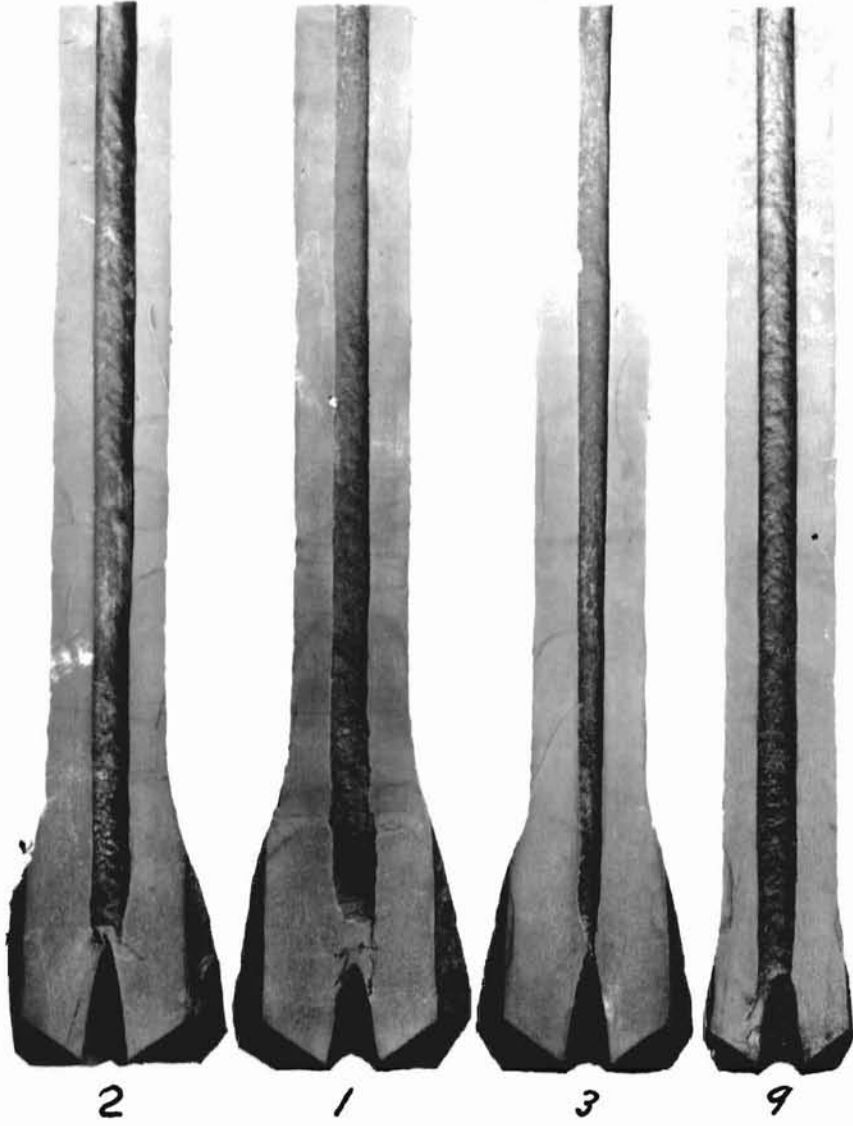
FIG. 2.

Bits 1, 2, 3, and 9. Macro etch, 7/10 actual size.

In bit No. 1 there are numerous crack areas a considerable distance above the metallurgical break but the deepest cracks occur in that latter region. Area No. 6, which is in the region of structural change, has the deepest cracks, two of which are 1.848 and 1.344 mm. deep and can be seen easily with the unaided eye.

In bit No. 2 there is apparently little relation between the cracks and the metallurgical break. This may be considered a relatively good piece of drill steel.

Bit No. 3 is very similar to No. 2 in that it has few cracks and may be considered relatively sound. Such unsoundness as exists is in the region of metallurgical break.

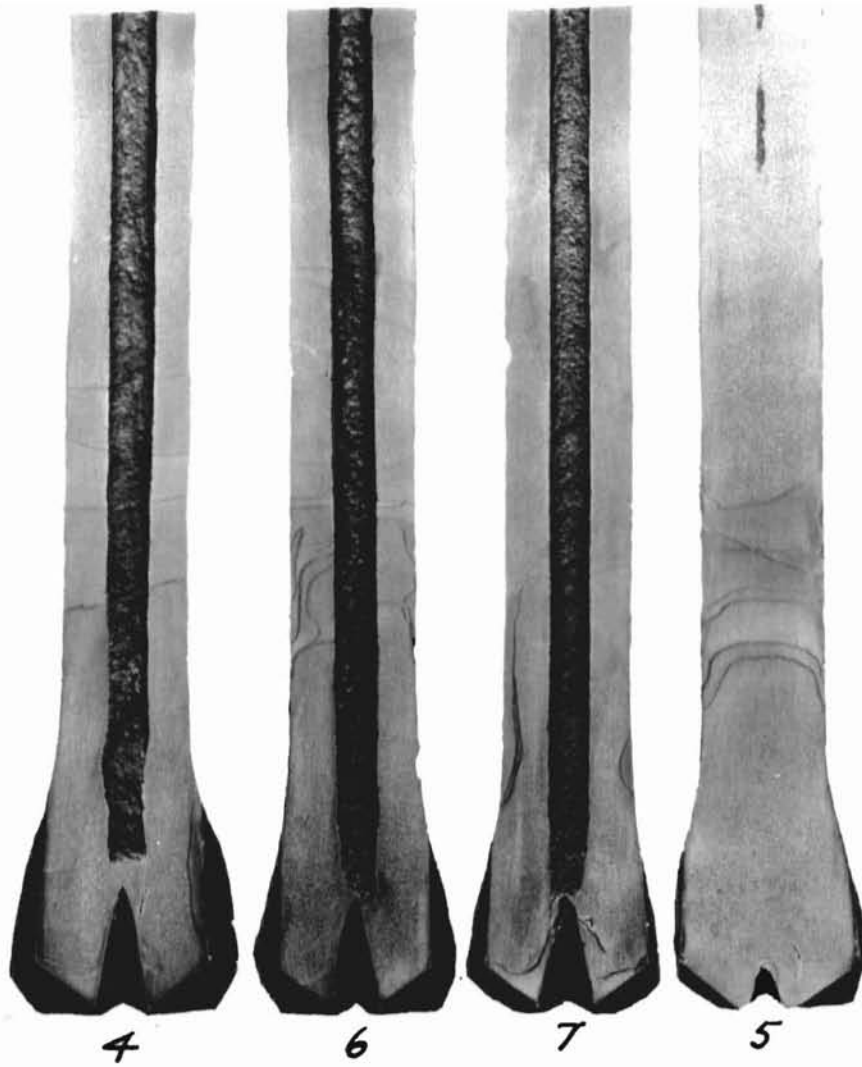
FIG. 3.

Bits No. 4, 5, 6, and 7. Macro etch, 7/10 actual size.

In bit No. 4 is found once more the semblance of a relation between the metallurgical break and the area of most cracks. However, the deepest cracks occur just beyond the region of structural change.

In bit No. 5, the worst condition with respect to cracks is in the region of structural change. There are five zones embracing areas in which there are numerous cracks, and four of these five zones are in that region. Practically all of the deepest cracks, also, are in this region. The bit is relatively in very poor condition. It may be cited as the poorest of the lot.

Bit No. 6 is poor but not as poor as No. 5. Here, too, the region of deepest and most numerous cracks coincide with the region of structural change.

As regards cracks, No. 7 is a fairly good specimen. There seems to be no connection between the metallurgical break and the location of the deepest crack. However, there are numerous small and incipient

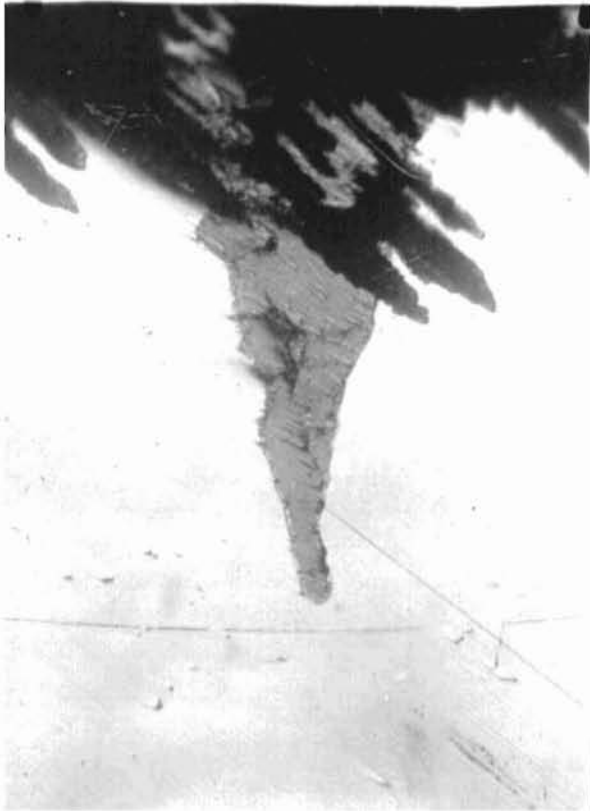
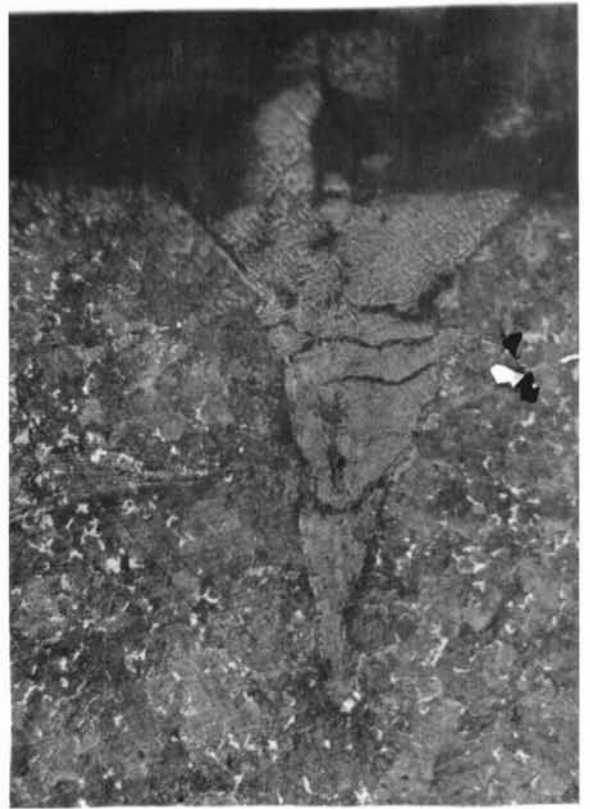
FIGURE 7.

A and B -- Two cracks from Bit No. 9, X 140.
C -- Etched view of B, X 140. Etched with 10%
HNO₃ in Amyl Alcohol.

The second class of crack, that filled with some foreign material, is illustrated in Fig. 7. The foreign substance may be either iron oxide, rock dust, or dirt and sediment from mine water. In all probability, rock dust and sediment is the filling material in most cases, since as will afterward be shown, such cracks form after the steel has been put into service. Such filled cracks are slightly more prevalent in the region heated for working and so the oxide filling, when such is present, could come from a slight oxidation of the steel when it is heated.

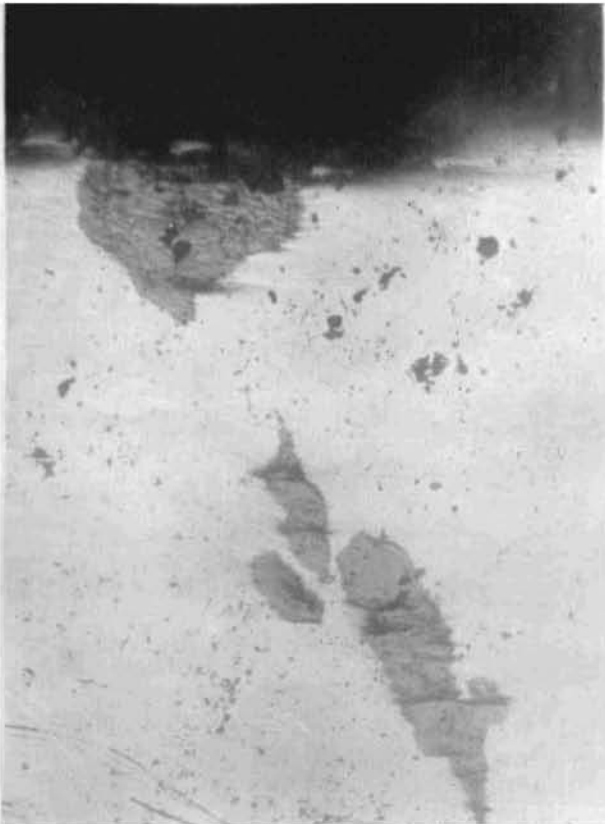
FIGURE 8.

Figure 8 shows what are apparently inclusions near the edge of the steel, but which undoubtedly are cracks. In the first place, these "inclusions" are elongated at right angles to the direction of rolling of the bar. Any inclusion in the steel would necessarily show elongation in a direction parallel to that of rolling. Second, cracks in steel almost invariably follow a tortuous path. From these two facts it seems logical to conclude that what may at first sight appear to be inclusions are, in reality, cracks

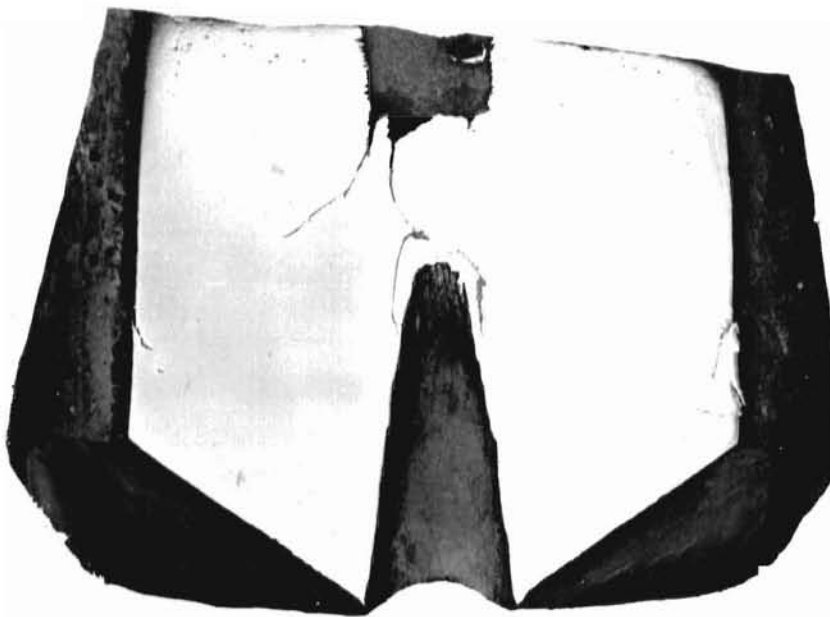
FIGURE 10.

Bit No. 2 as polished.
