Civil Engineering Study 83-8

Second Progress Report

TESTING OF STEEL ROOF DECK CONSTRUCTION

A Research Project Sponsored by RoofTex, Inc.

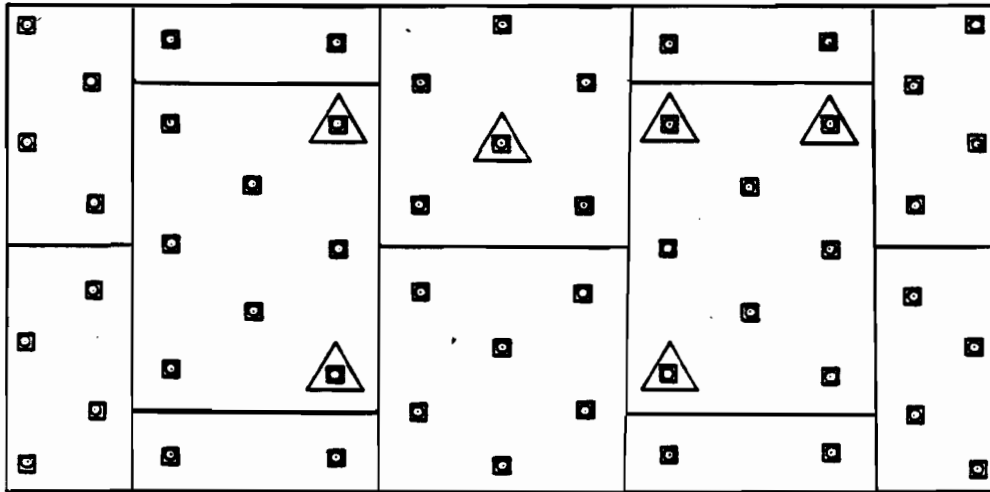
(a) Fiberglass Insulated Built-up Roof Deck System

noise and the appearance of a large amount of bowing. However, the system did not fail completely until the pressure reached at 162 psf. After the test was completed, the built-up roof was dismantled at the locations shown in Figures 12(a) and 13(a) for the purpose of observing the delamination of the insulation board. In addition, the failure mode of steel roof deck (Figure 14) was also examined. Examination of the assembly indicated that the system finally failed as a result of the flexure of the steel deck, because none of the fasteners had been pulled through the insulation board. Only six of the Roofgrip fasteners were tilted at the failure load, as shown in Figure 11(a).

Note: Symbol "Δ" indicates tilted roofgrip fasteners

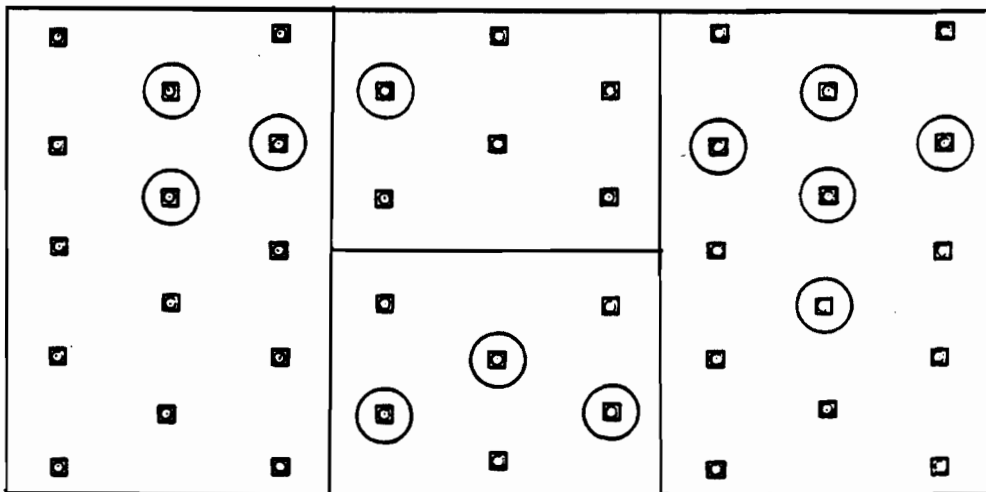
(b) Gypsum Board Built-up Roof Deck System

For the gypsum board built-up roof deck system, the complete failure of the system occurred at a pressure of 150 psf. During the test, noises were heard at different pressures as indicated in Table 2b. After the test was completed, the built-up roof was dismantled at the locations shown in Figures 12(b) and 13(b) for the purpose of observing the delamination of the gypsum board. In addition, the failure mode of the steel roof deck (Figure 15) was also examined. Examination of the assembly indicated that the system finally failed as a result of the flexure of the steel deck. It was noted that 12 of the roofgrip fasteners had been pulled through the deck (Figure 11(b)).

Note: Symbol "O" indicates the locations where fasteners pulled through

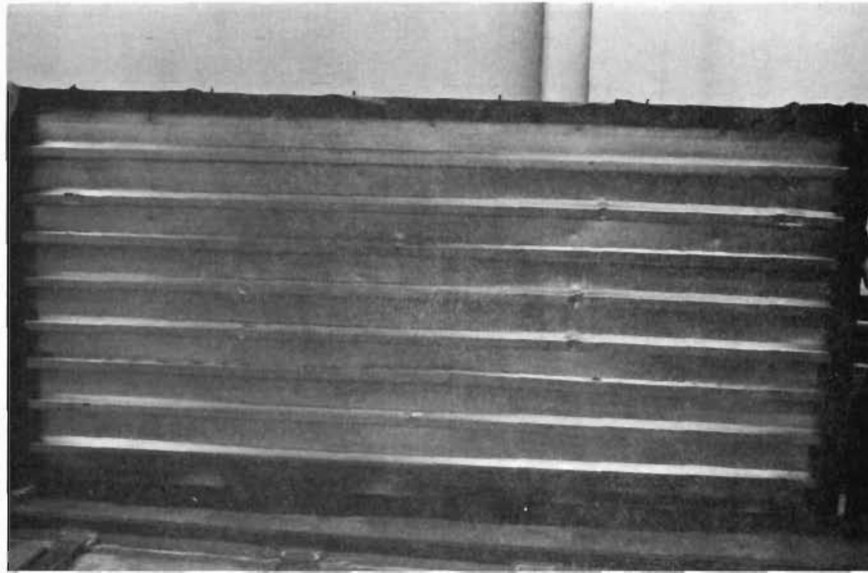
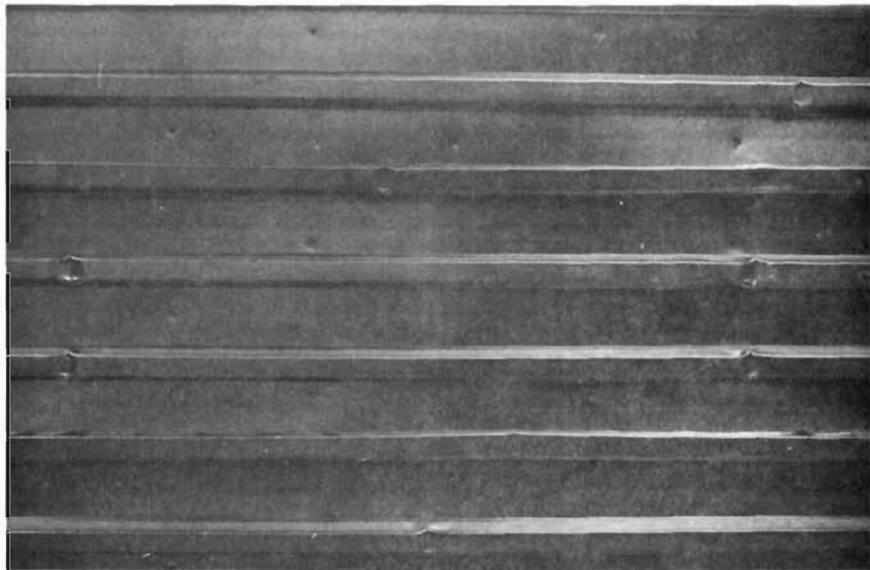
Fig. 14 Flexural Failure of Steel Deck for Fiberglass Insulated Built-up Roof Deck System

During the test, the roof system was carefully observed for the presence of bowing on the top of the assembly. It was noted that for the fiberglass insulated built-up roof deck system, the assembly began to fail at the pressure of 103 psf. This was evidenced by hearing a
