## Cornell University School of Civil Engineering Tests on light beams of cold-formed steel

SCHOOL OF CIVIL ENGINEERING, CORNELL UNIVERSITY  
TESTS ON LIGHT BEAM OF COLD FORMED STEEL  
FOR THE AMERICAN IRON AND STEEL INSTITUTE

SEVENTH PROGRESS REPORT, FEB. 28, 1940

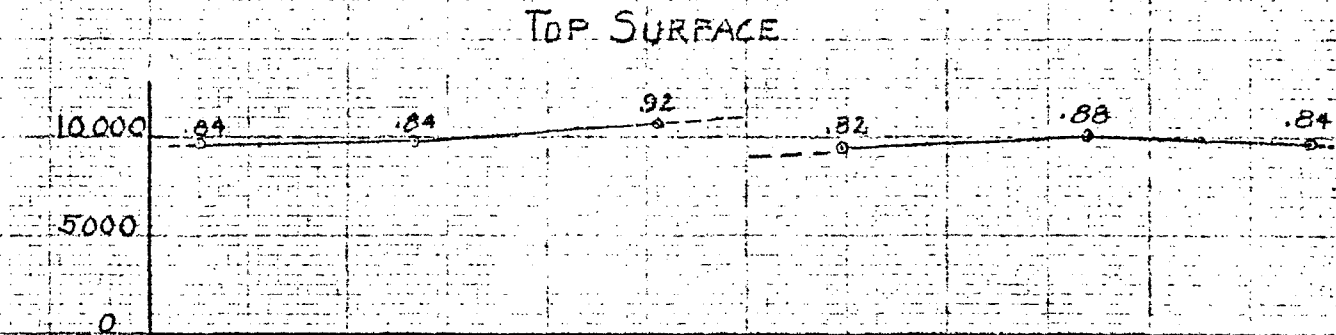
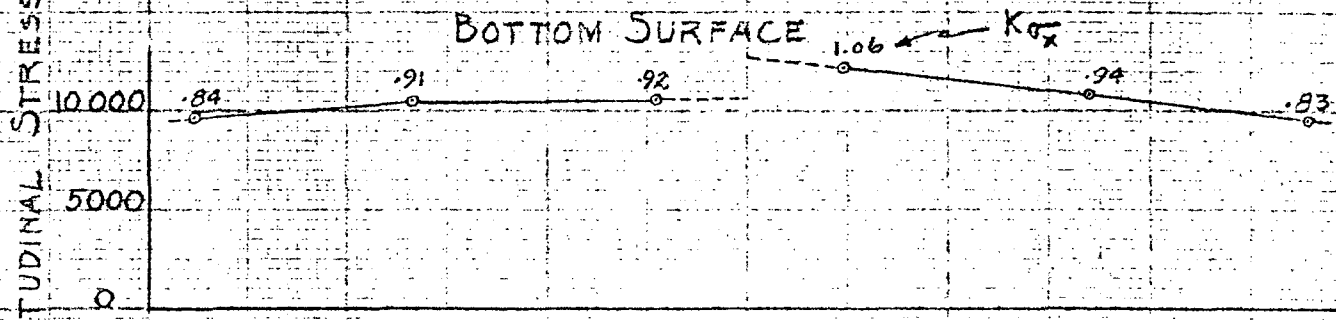
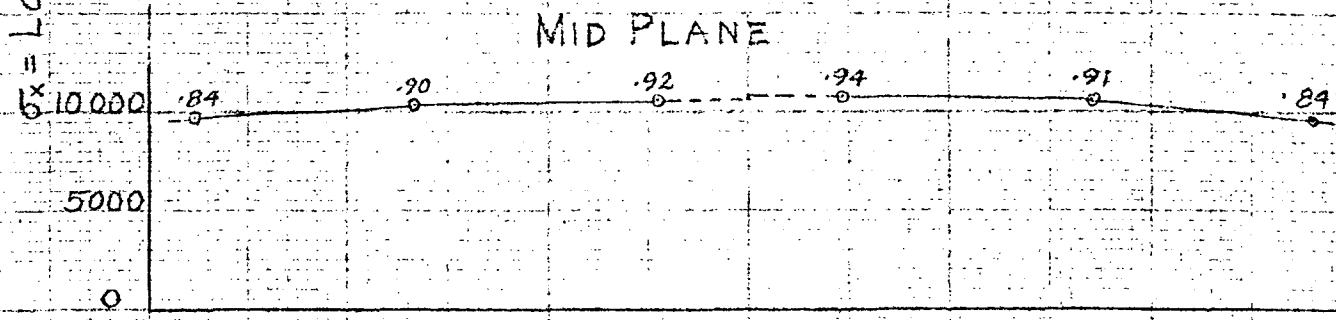
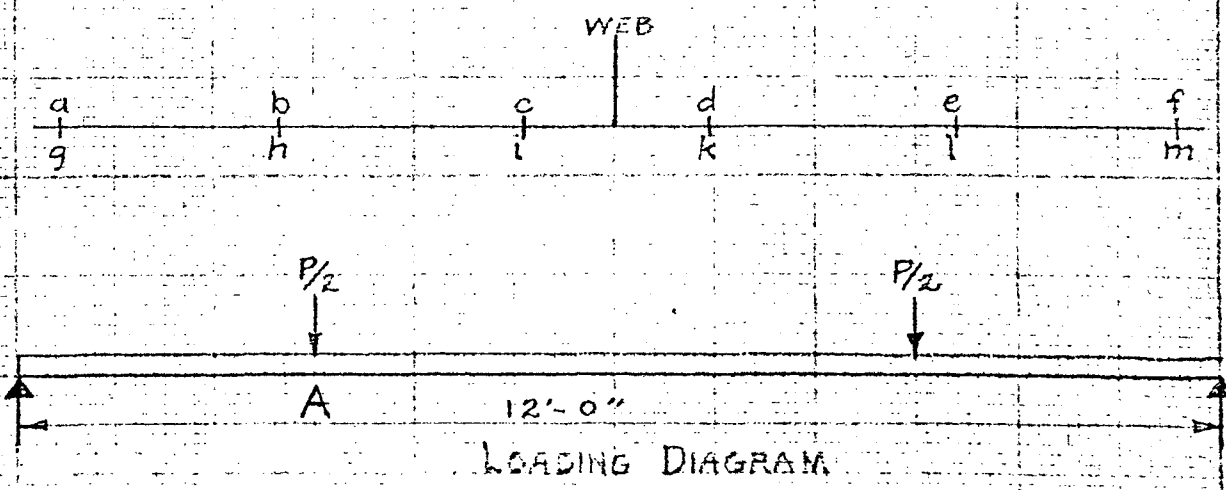
# STRESS DISTRIBUTION IN BOTTOM FLANGE AT LOAD POINT "A" A-14-612a

Stress investigations were made at both load points, the results of which are given on drawings 70 and 71. If these graphs are compared with the corresponding ones without bolts (drawings 38 and 39 of 5th Report), the difference is immediately seen. It is remarkable that the stress concentration near the web is very marked in the original beam (no bolts, some spot welds failed) but that very little concentration was observed after reconstruction (cf. especially mid-plane stress graphs). This fact is still more evident from the following table of stress ratios:

It is seen from this table that whereas before reconstruction the actual stress ratio is about twice as large as the theoretic stress ratio for the beam, after reconstruction these values are nearly equal. This proves the point predicted in the 6th report, namely, that in beams of present design the possibility of sideway motion is of great influence on the stress distribution.

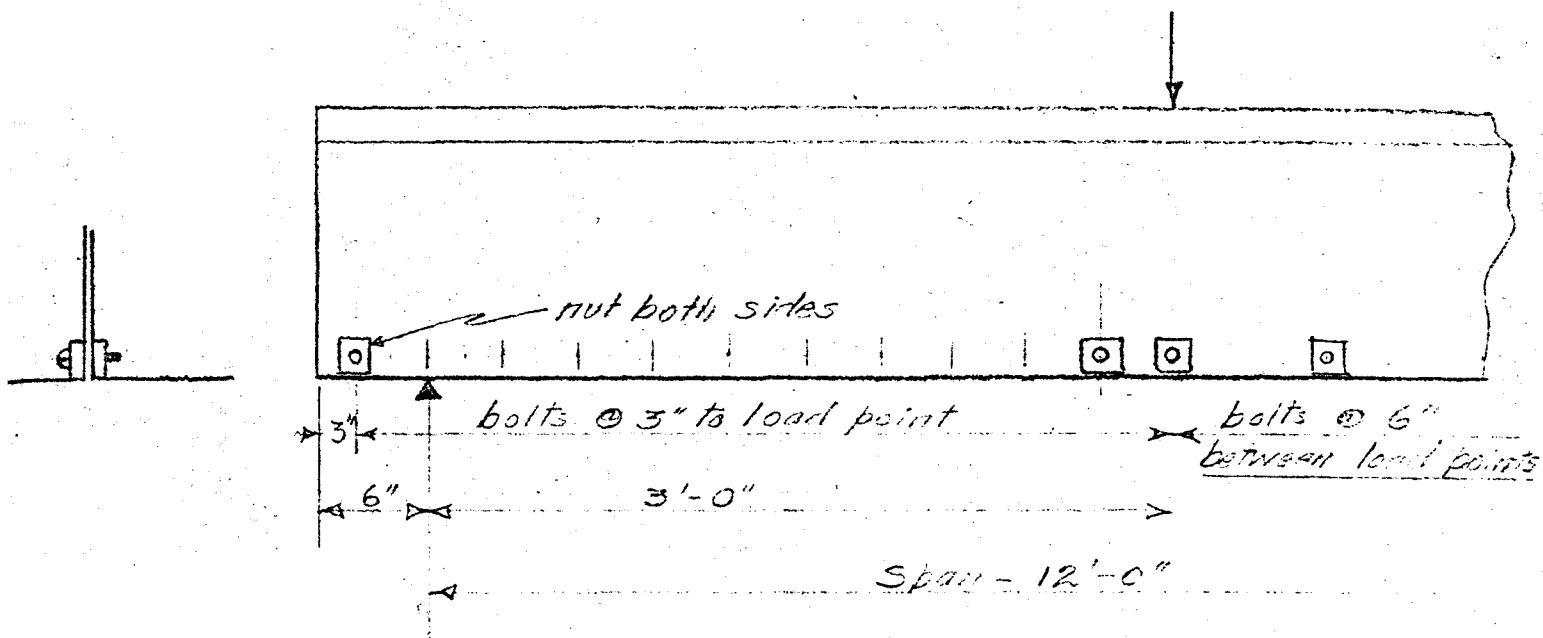
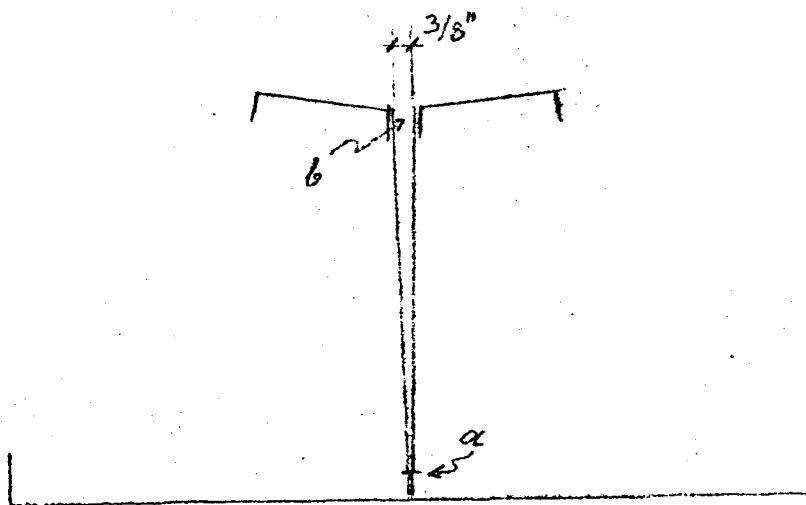
About half of the stress investigation of E-18-12-816a had been completed when this beam suddenly failed in a very peculiar manner. Welds "b" failed with a rather mild crack over about  $2/3$  of the length of the beam and the two parts of the beam spread apart as shown on drawing 72. The welds failed only between the two parts of the web which separated about  $3/8$  in. whereas the spot welds fastening the flange to the web did not fail except in a few isolated places.

Visual inspection revealed that along the whole length where failure occurred, only 5 or 6 of the welds joining the webs together had fused whereas all the other welds had not formed at all. Moreover some of those welds were placed right on the edge of the bent down portion of the flange and some of the welds were missing altogether. Inspection further revealed that welds "a" also were made very irregularly, their distance from the flange varying from  $3/8$  in. to  $3/4$  in. Another irregularity in this beam is that the top flange is not plane but bent up as shown on drawing 72. This makes correct loading exceedingly difficult.

It had been intended to proceed with the investigation on the twin specimen of this beam. However on inspection this beam showed even worse characteristics. The spacing of welds "a" was just as bad and so was the bent up form of the top flange. Moreover over  $3/4$  of the length of this beam there was not a single spot weld "b" joining the two parts of the web. It was therefore necessary to reconstruct this beam before any testing could be done on it.

Since it was not possible to make in our mechanical shop spot welds of the present type, the two parts of the beam were joined together by placing tack welds 4 in. c.c. on the top surface of the top flange. The metal of these welds went well down into the joint thus connecting not only the two parts of the flange but also welding together both parts of the web. In addition bolts were placed in the web along the bottom flange in the same way as on beam A-14-612a. The work on this beam is not yet completed and will be reported in the next report.

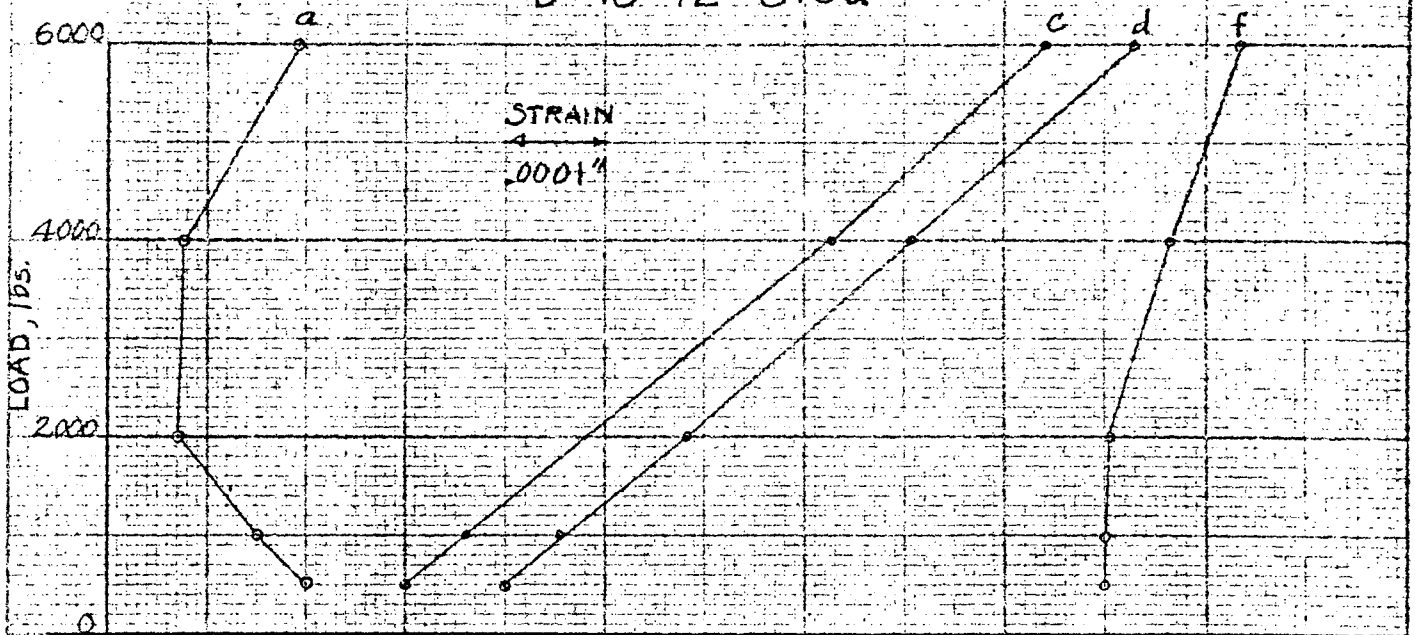
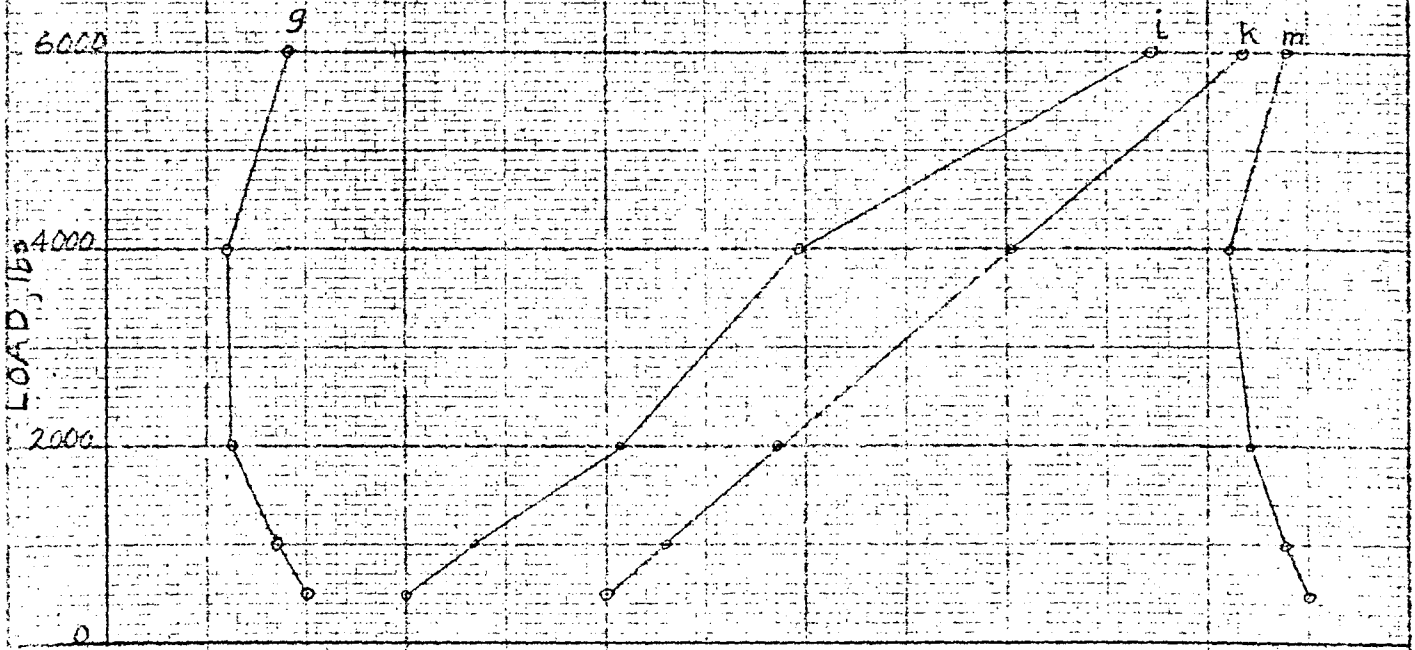
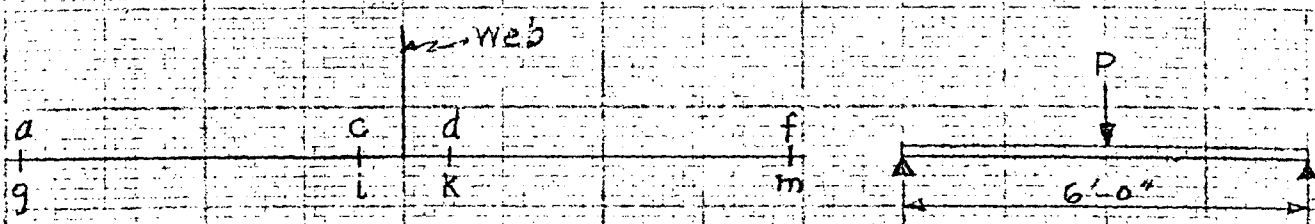
# STRAIN DISTRIBUTION IN BOTTOM FLANGE

The influence of this fact on the behavior of this beam is clearly seen from the load-strain diagrams on drawings 73, 74, 75. These graphs show the complete absence of proportionality between load and strain. It is seen that at lower loads the strains measured near the outer edges of the flange (i.e., where the waves are greater) either increase very slowly or, in some cases are even negative (compression). With increasing load the strains at these points gradually increase, and, in case of compression, become tension. The strains measured near the web behave more regularly since the waves usually do not extend close to the web. But even there it is seen that there is no proportionality. With some exceptions the slope of these curves is smallest at lower load and increases with load increasing. This indicates that at lower loads (maximum waves) the outer parts of the flanges take little part in carrying the load and hence more stress is thrown on to the inner parts of the flange. With flattening of the waves the outer parts gradually come into play thus taking over an increasing part of the total tensile force. As a result the slope of the curves for the points near the web increases with increasing load.

It is evident that it would be futile to draw any quantitative conclusions (magnitude of stresses) from these observations since their numerical values obviously are entirely accidental. They depend largely on whether the point where the strains are measured is located on the crest or in a trough or at any other part of a wave.
