# Liquefaction and Ground Failure During the 1998 Adana (Turkey) Earthquake and Lab Model Simulations

## LIQUEFACTION AND GROUND FAILURES DURING THE 1998 ADANA (TURKEY) EARTHQUAKE AND LAB MODEL SIMULATIONS

Paper No. 4.47

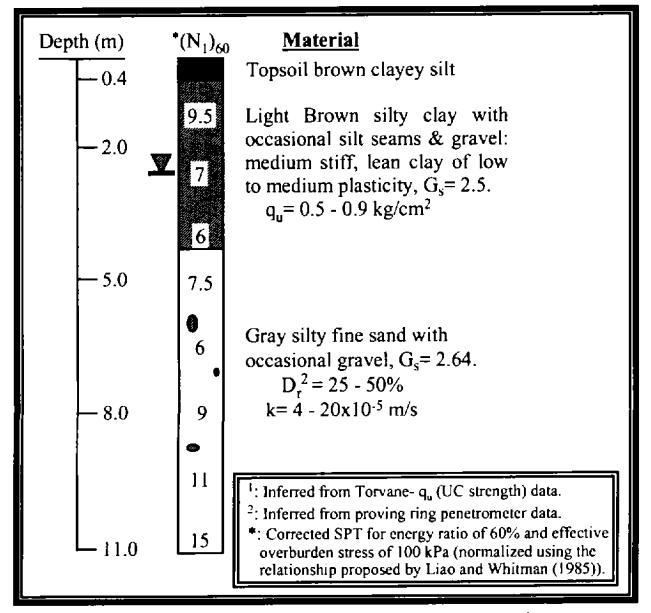
Most comprehensive field reconnaissance for surface and subsurface information was made in the areas around Abdioglu Village, where some of the most spectacular liquefaction effects were observed. Subsurface soil investigations included mainly trench studies and some laboratory testing. In determining soil information, maximum use of exposures such as riverbanks and fault/cuts caused by large lateral spread of thick blocks of soil was made. Such features provided a natural trench to study the nature and the thickness of soil strata in some cases as deep as 6 m. Torvane and proving ring penetrometer tests on the walls of the trenches were used (for preliminary strength classifications) to estimate shear strength of cohesive soil and density of the cohesionless soil layers respectively. Due to the rural nature of the zone affected by ground failures, pre-earthquake boring logs are very rare. One standard penetration test (SPT) profile was found dating back to about four years before the earthquake. The boring was done at a location less than a km away from Abdioglu about 100 m from the river. Based on this pre-earthquake SPT boring and the post-earthquake trench data Fig. 3 presents a typical soil profile near Abdioglu. The spatial variation of soil conditions around Abdioglu was practically insignificant. Furthermore, cursory field investigations revealed that the soil conditions at most of the sites liquefied during this earthquake bear close similarity to the ones around Abdioglu. Typical grain size distribution curves for the underlying loose sand layer and ejected sand boil material are shown in Fig. 4. As seen, the liquefied layer was composed of poorly graded fine sand with about 10% fines, a soil type that has been categorized as highly susceptible to liquefaction (Iwasaki 1986). The ejected material and the soil in the liquefied silty sand layer were almost identical with the exception that the ejected material had typically 3-5% more fines and did not contain any gravel. This was obviously expected as the upward flow of water in sand boil channels would usually erode and carry some material from the overlying clay layer to the surface. However, this channel flow is usually not strong enough to carry gravel size particles to the surface.

Fig. 3 A typical soil profile near Abdioglu.

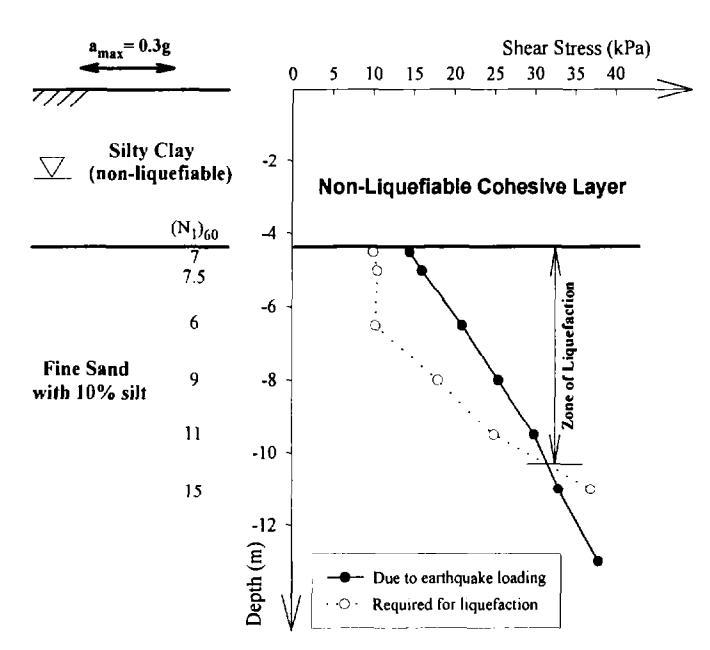
Where  $a_{max}$  is the peak ground acceleration, g is the gravitational acceleration,  $\sigma_{v}$  is the total overburden stress,  $r_{d}$  is a stress reduction coefficient that relates the behavior of a deformable soil mass to that of rigid mass. Within a close proximity of the epicenter and the fault line, this site is estimated to have experienced peak ground acceleration (amax) of about 0.3g. This estimate is based on the: ground motion record (Fig. 2) at Ceyhan Station (which sits on similar soil formation not far from the fault) and the effects of ground shaking on structures and their contents located in the area. The reduction factor  $r_d$  was approximated using the Japanese practice where  $r_d$ = 1-0.015z (where z = depth in meters). The cyclic shear strength was estimated based on SPT-N values as suggested by Seed et al. (1985). Figure 5 shows the variation of the earthquake induced cyclic shear stress and the cyclic shear strength with depth. Based on this analysis, liquefaction did occur in at least the upper 10 m within the underlying sand stratum (ele. -4.5 to 10 m). The conditions of this example are representative of those in the Abdioglu area and many other areas along the Ceyhan River. The extensive liquefaction predicted in this example is consistent with what was actually observed in the 1998 earthquake.

Fig. 5 Evaluation of liquefaction potential at Abdioglu.

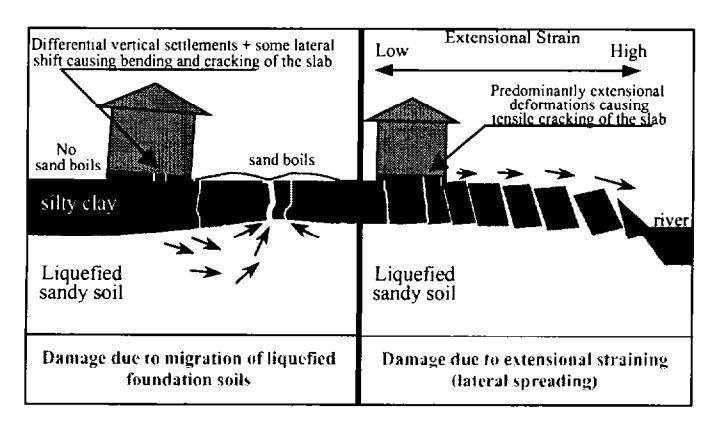
Sand boiling by itself caused minor structural damage in a few cases, but only when it led to localized differential settlements in foundation soils (e.g., due to sediment migration, Fig. 7). In some cases, sand boils emerged at the periphery of buildings or were forced through exceptionally thin unreinforced concrete floors of the houses and literally filled them with fine sand and water. The worst cases of lateral spreading (which involved not only large horizontal displacements but large vertical settlements as well) and slope failures were concentrated on the banks of the Ceyhan River. Since most of the riversides in the earthquake-affected area were used for plantation alone, damage to man-made structures from these types of ground failures was rather limited. At areas away from incised river channels (or any other free face) and any slope, where the principal effect of the liquefaction was vertical ground settlements, surprisingly little damage to man-made structures was observed. However, at areas not far from river channels or sloping ground, where liquefaction generated lateral ground displacements, foundation performance was typically poor. Tension cracks associated with lateral spreading and uneven subsidence displaced and fractured the foundations of several homes (Fig. 7), ruptured sewers, water pipelines and irrigation canals, and damaged small concrete bridges and pavements. In the vast majority of these cases, it was clearly observed that the specific locations of these types of damage closely matched the zones of ground failure, suggesting that ground failure rather than ground shaking was the dominant cause.

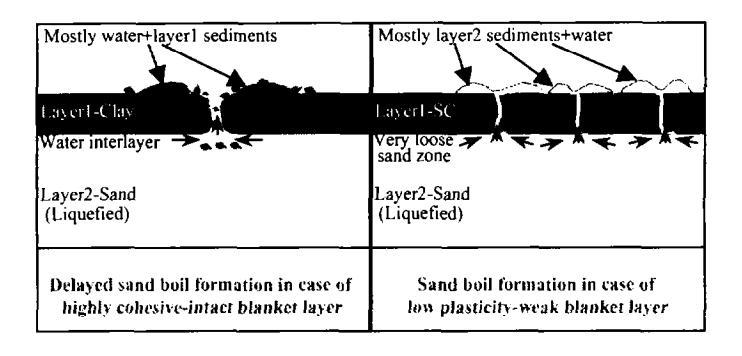
- i) Water gap or a very loose zone of soil develops at the interface between the sand (layer 2) and relatively impervious clay/silt layer (layer 1) as the liquefied sand reconsolidates. This accumulated water eventually escapes to the surface in the form of a sand boil (Fig. 9). Such loose zones in a soil domain with an initial static driving shear stress may lead to instabilities (e.g., slope failures and lateral spreading) as were observed during the 1998 Adana earthquake among others.

- iii) Highly plastic-cohesive and intact blanket layer is conducive to large and delayed (as cohesion inhibits the cavity formation) sand boils. Lesser amount of liquefied sediments is carried to the surface in delayed sand boils (as more pure water is available) as compared to sand boils that occur during or right after shaking (see Fig. 9).

Fig. 9 The two main sand boil mechanisms observed in the model tests.
