Proceedings: Third International Conference on Case Histories in Geotechnical Engineering, St. Louis, Missouri, June 1-4, 1993, Paper No. 8.13

Development on Florida's Phosphate Mine Lands

W. A. Ericson, L. P. Moore and L. D. Madrid Bromwell & Carrier, Inc., Lakeland, Florida

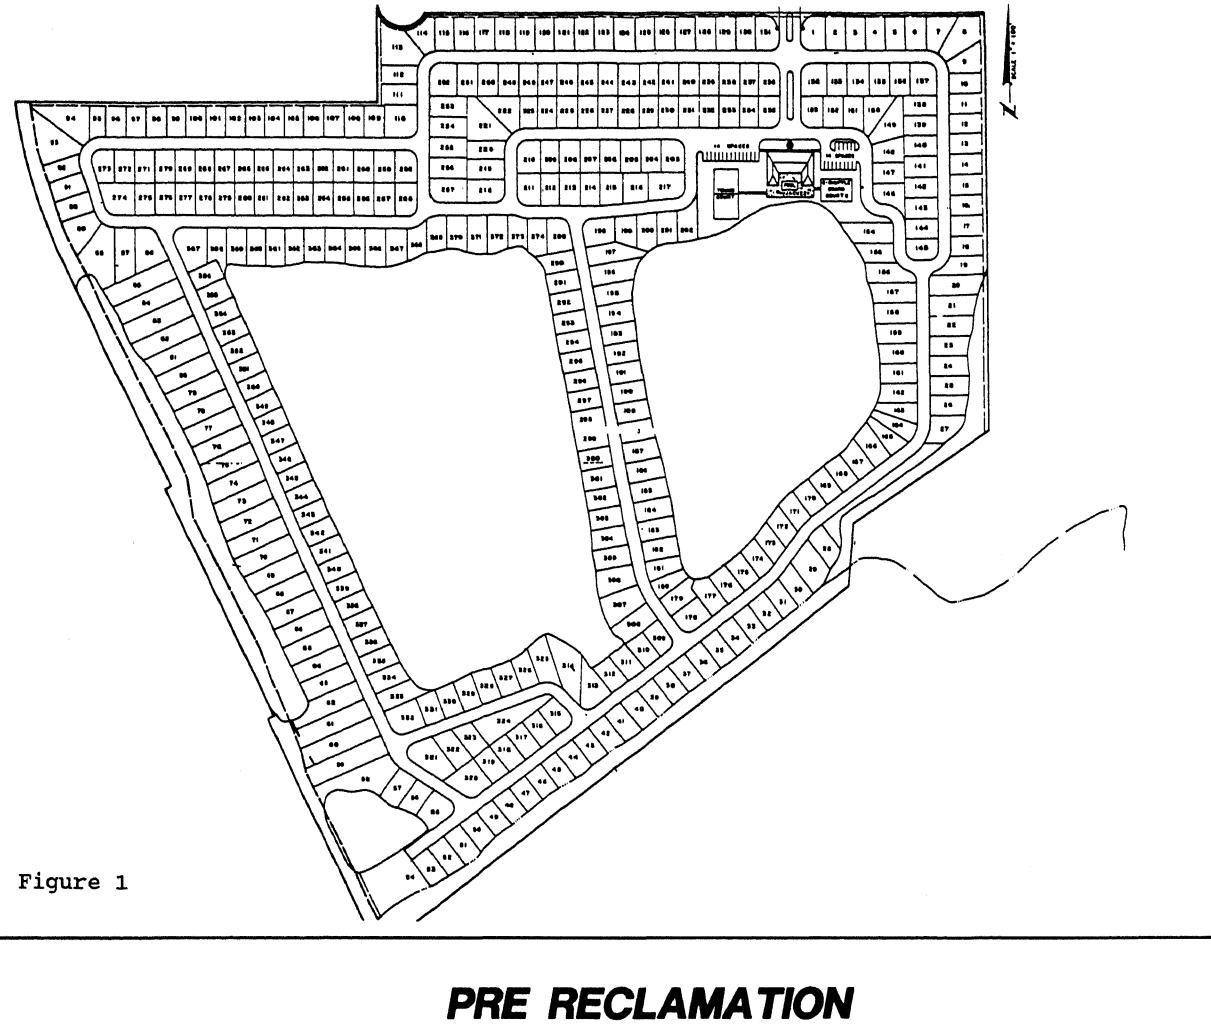
Within a few weeks, the developer began to realize the seriousness of the site conditions. Their original plan had lots and recreational facilities covering the entire property. However, the plan had to be amended to take into account the soft soil and prior drainage conditions. This modification reduced the number of available building lots by about 40 percent. The general site plan is shown in Figure 1.

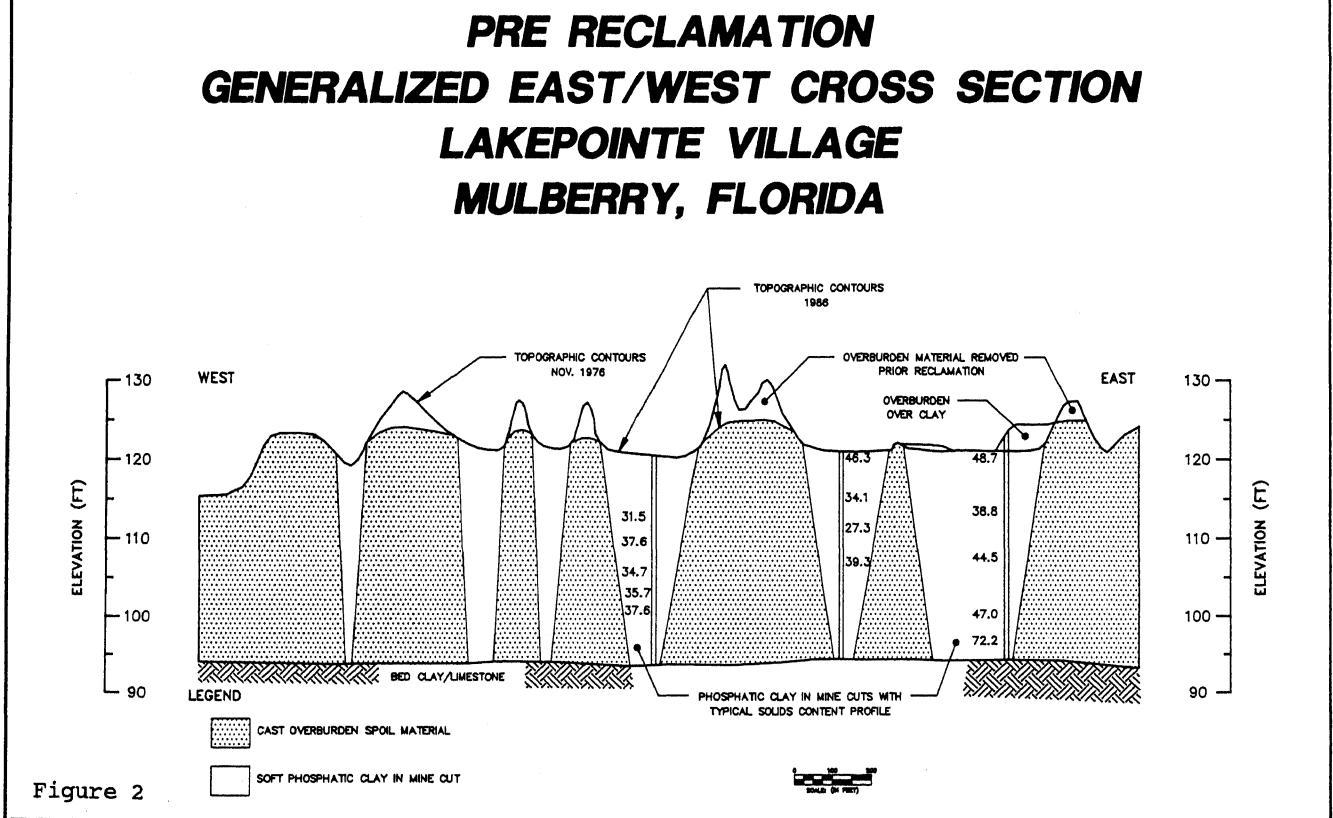
The geotechnical investigation confirmed our preliminary opinions regarding the presence of several semi-parallel mine cuts filled with soft, phosphatic waste clays. A typical cross section of the site conditions is depicted in Figure 2.

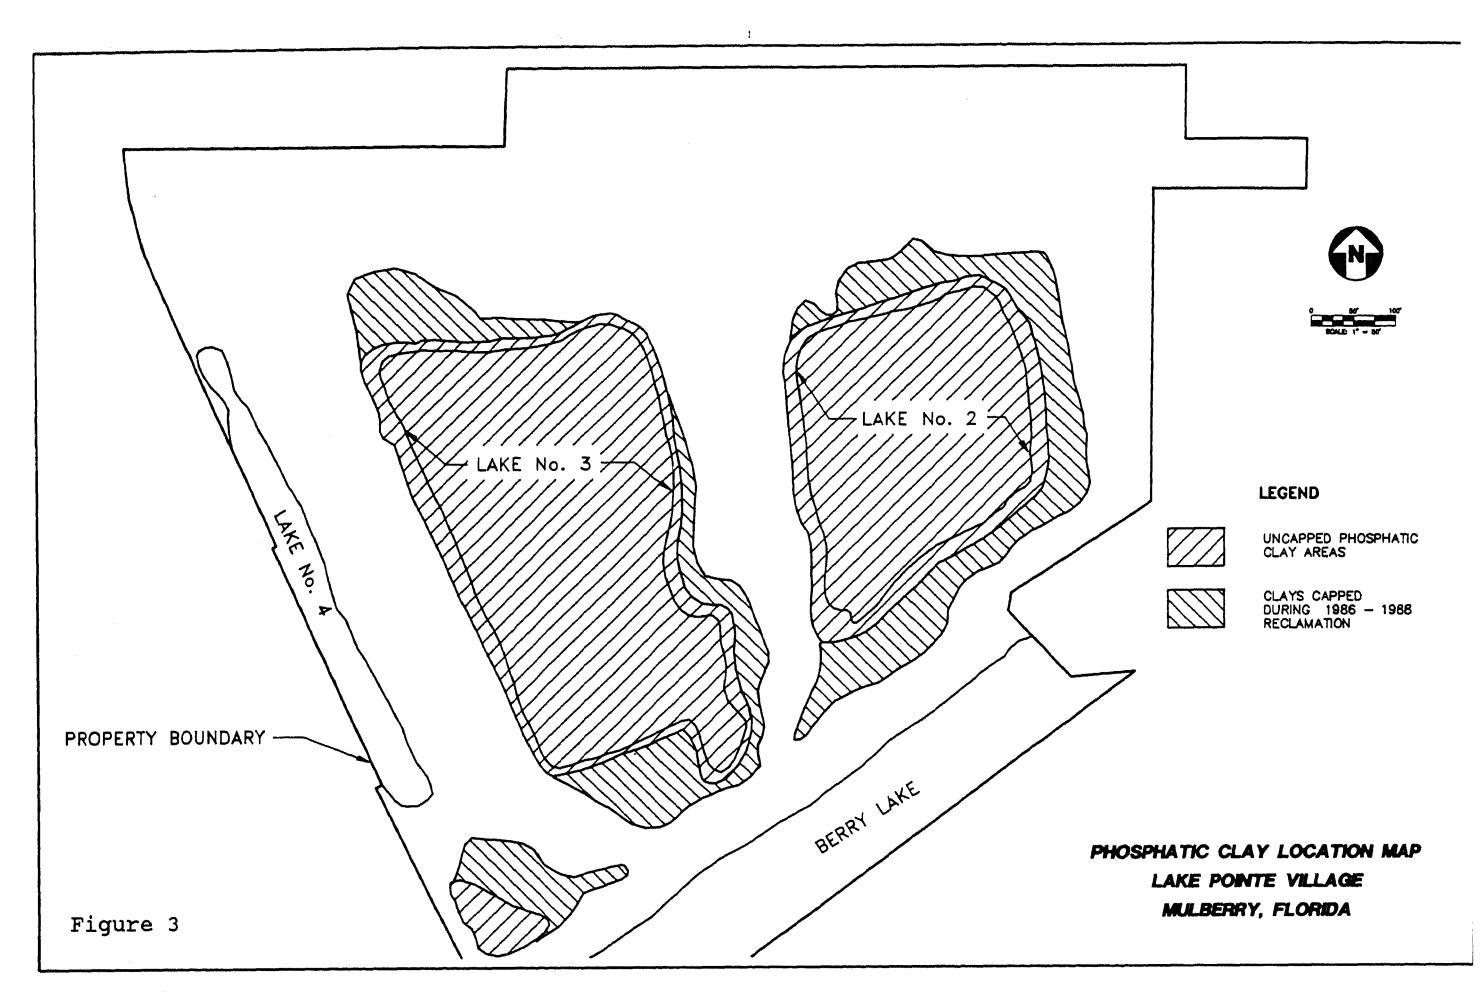
The reclamation efforts concentrated on isolating the clay filled mine cuts into two island-like areas, while grading the remaining spoil piles to accommodate the mobile home lots, streets, and utility corridors. To provided as much acreage as possible, sandy spoil materials were also used to cap the soft clays in perimeter areas of the clay islands, with the owner's understanding that these areas would settle with time and possibly present some difficulties for buried utilities. Figure 3 shows the general reclaimed landform configuration.

As part of isolating the phosphatic clays in Lake Nos. 2 and 3 (Figure 3), perimeter ditches were excavated in the clays to aid stormwater runoff control and treatment. The low shear strength of the clays often caused equipment mobility and stability problems. Low ground pressure bulldozers and small draglines working on mats had to be used. Even with these precautions, a dragline caused a bearing capacity failure of the clays and became stuck. As a result, an extensive, emergency effort by the contractor was required to save the equipment.
