# Anchoring of Little Quinnesec Falls Hydroelectric Dam

Aniruddha Sengupta, Ph.D., P.E.

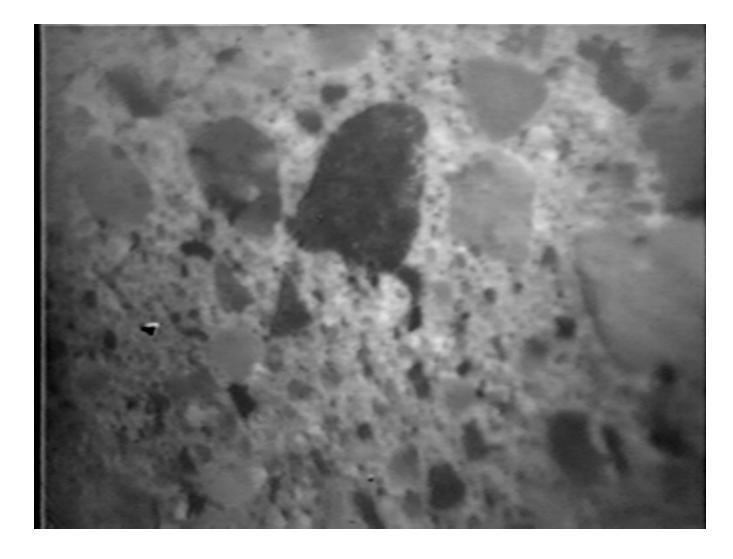
Fig. 4. A magnified view of the concrete portion of the dam.

The condition of the concrete portion was also inspected by the borehole camera. Figure 4 shows a magnified view of the concrete portion of the dam as observed from within one of the boreholes. The concrete aggregates were found to be of 25.4 mm to 152.4 mm in size. No prominent sign of deterioration and aging of the concrete could be noticed from the video. Based on these field investigations and subsequent stability analyses, stabilization measures were recommended. It included installation of vertical post-tensioned anchor system through the gravity portion of the dam and the power plant.

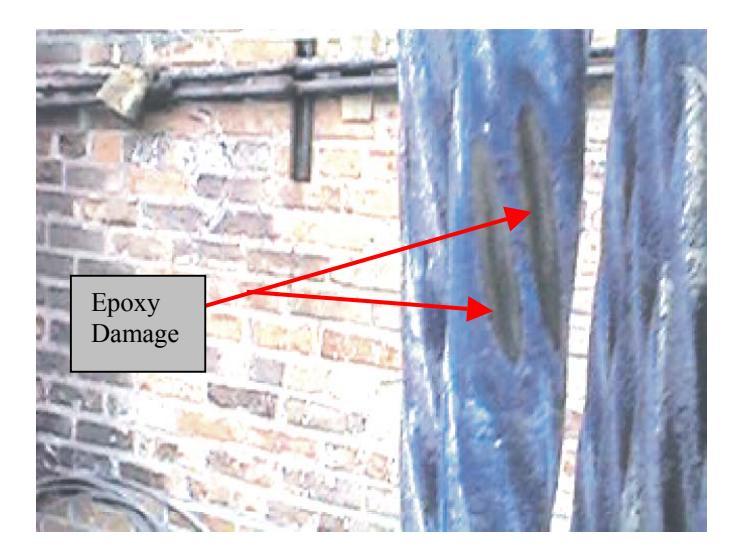
Fig. 8. Epoxy coating damaged by apparent abrasion.

Tendons for all the anchors were installed by crane. The tendons were inspected for any damage as they were being installed. All damaged spots were repaired with a epoxy repair kit recommended by the tendon manufacturer (see Fig. 8). Following installation of the tendons in all the drill holes, all the anchors were primary grouted.

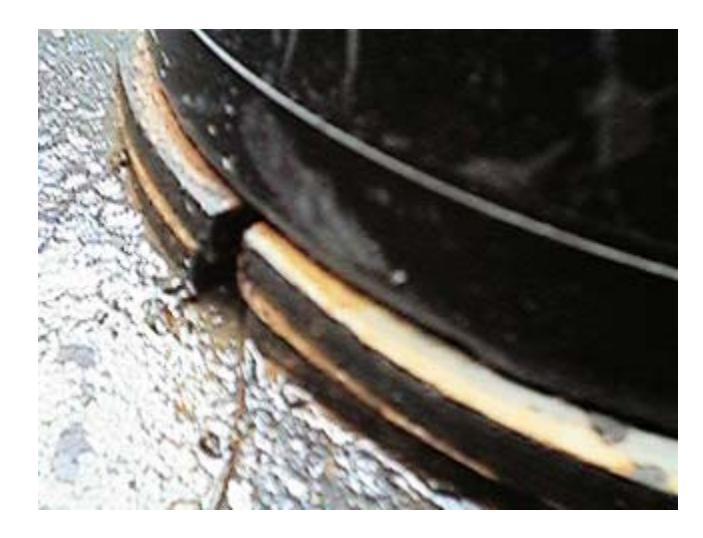
Fig. 14. Close-up view of semi-circular shims under an anchor head.

tolerances. Immediate lift off tests showed a need for shimming on both anchors. A shim is a donut shaped steel disk that is split diametrically to allow insertion under the anchor head to avoid transfer load loss. Transfer load loss happens when the jack grabs the strands to apply the desired stressing load and then let the load off. At that time some of the applied loads are lost as the strands get locked into the anchor head by the wedges in the anchor head holes, and this loss of load is compensated with a shim. The anchor on the right monolith was shimmed with two 9.5 mm plates and one 6.35 mm plate was used for the anchor on the left monolith. After shimming, the lock-off load was within acceptable tolerances. Figure 14 shows a close up view of the shim under the anchor head. An additional lift off test was performed about 1 day after lock-off, and showed no loss of load. A final lift-off test was performed about nine days after lock-off and again, no discernible loss of load were seen. The performance anchors meet all specifications and were accepted. Figures 15 through 21 show some of the details of the anchor installations.

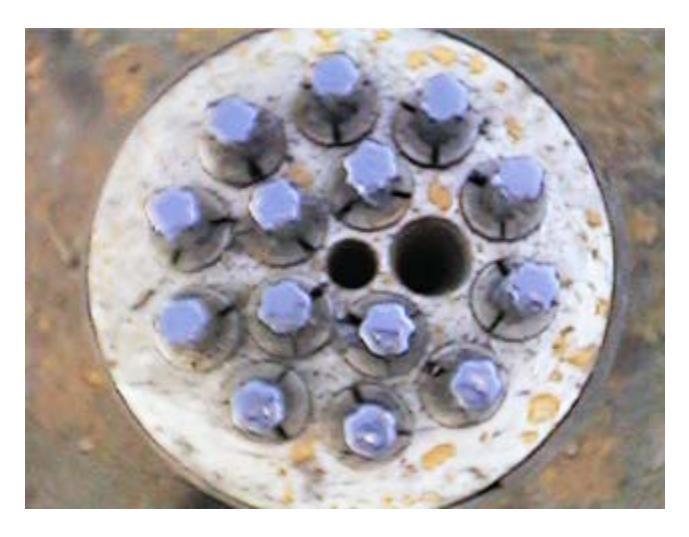
Fig. 20. Tendon tips after epoxy repair.

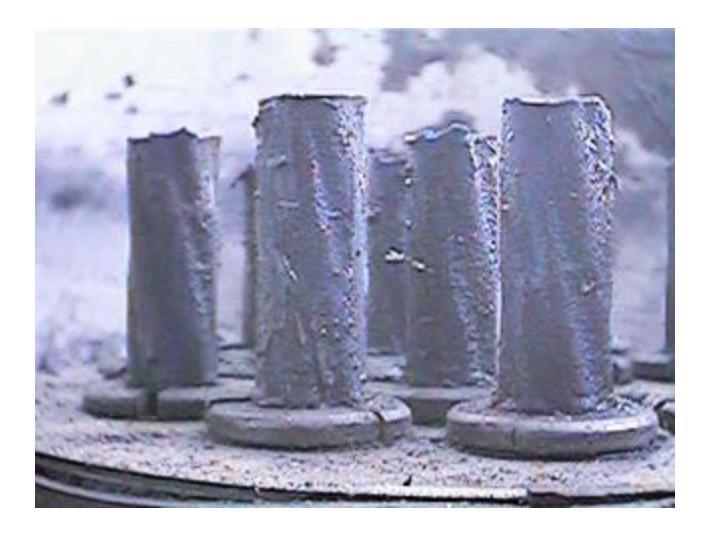
Fig. 21. Side view of epoxy repaired tendons after cutoff.
