Behavior of Reinforced Wall System During the 1999 Kocaeli (Izmit), Turkey, Earthquake

BEHAVIOR OF REINFORCED WALL SYSTEM DURING THE 1999 KOCAELI (IZMIT), TURKEY, EARTHQUAKE

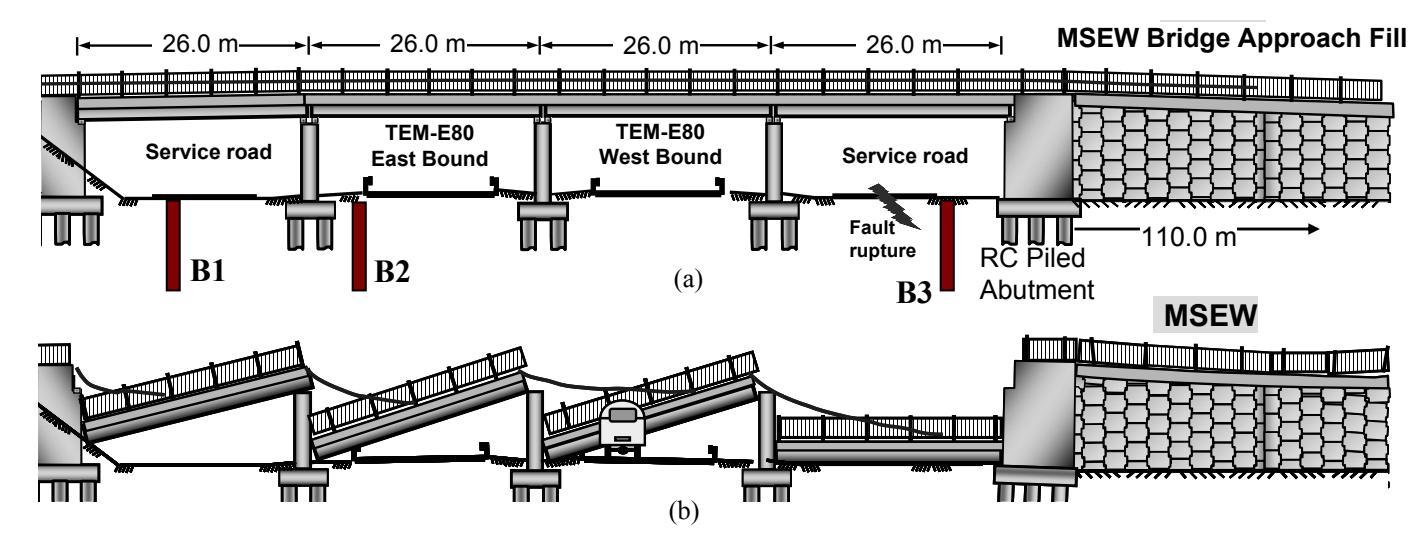
During the earthquake, the majority of the highway facilities performed well, except that the bridge overpass in Arifive (Fig.2), located less than 50 km eastward of the epicenter, collapsed due to tectonic movement along the fault zone. The surface fault rupture passed beneath the northernmost span of the overpass while causing substantial surface deformations. The collapsed bridge blocked the TEM and caused serious delays in transporting immediate disaster-caused emergency needs in the epicentral area. Moreover, nearly a dozen people died when a passenger bus crashed into a collapsed deck while passing under the overpass.

the earthquake. Major damage to the walls was not from seismic design, but a combination of adverse effects by the nearby fault movement and, possibly, bearing capacity problems associated with underlying foundation soil. Figure 2 depicts the overpass and the reinforced walls before and after the damage, respectively.

Fig. 2. The bridge overpass at Arifiye and mechanical stabilized bridge approach fill walls (a) before, and (b) after the earthquake.

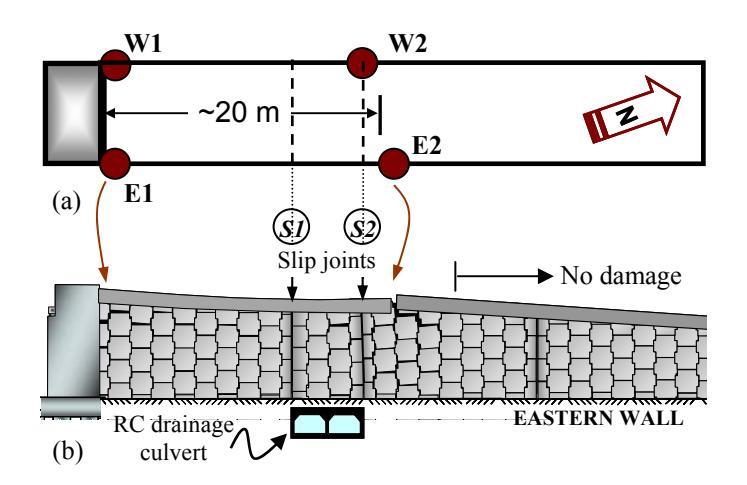
A reinforced concrete culvert was designed beneath the approach ramp possibly to facilitate storm or flood water discharge in approach ramp area (Fig. 5b). However, the culvert was not useful as it appeared inactive due to road fill at both sides of the approach ramp. Two slip joints (S1 and S2, Fig. 5) were also designed on each wall face on top of the rigid culvert to protect the walls damaged from differential settlement.

Fig 5. MSE bridge approach (a) plan view of approach fill with damage-concentration; (b) schematics of eastern wall after the earthquake.

Only a limited section of the MSEW approach ramp was damaged to a great extent in between the bridge abutment and RC culvert. This section constituted approximately 20% of the entire length of the reinforced earth structure. The most damage-affected locations within this section along the eastern and western wall faces are highlighted in Fig. 5a as E1 and E2, and W1 and W2, respectively, whilst their detailed views are presented in Figs. 6 and 7.

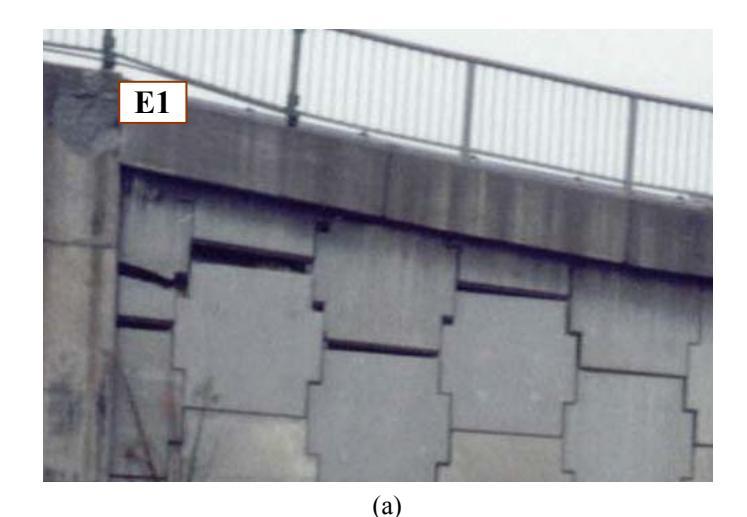
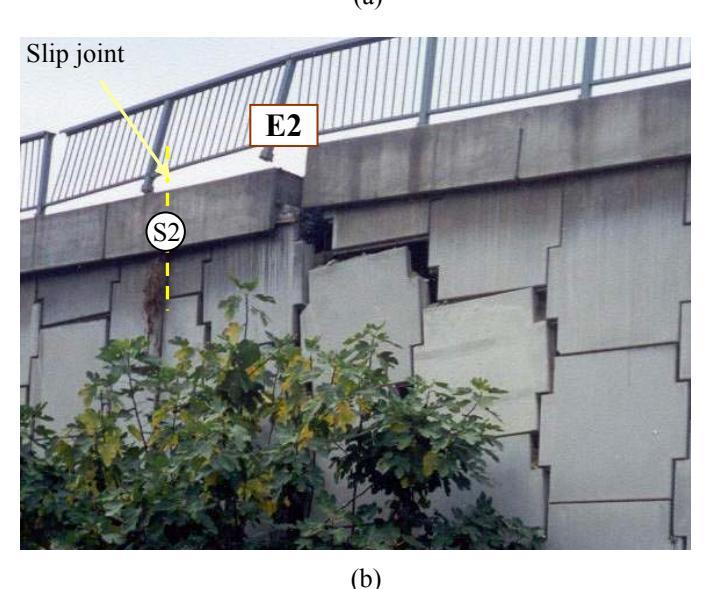
Fig 6. Damage details for (a) E1 and (b) E2 on eastern MSEW face (photos after Ozbakir).

The tilting in the cross section resulted in different damage states above the culvert at E2 and W2 such that the western wall buckled in the vicinity of W2 (Fig. 7a), whereas the eastern wall face were stretched outward (Fig. 6). The buckled side increased compression on the facing panels at W2, whilst crashing and forcing the panels displaced (Fig. 7b). On the other hand, the largest damage in the reinforced walls was observed at E2 as shown Fig. 6b. At this location, the wall displaced both vertically and horizontally for about 25-30 cm. The displacements at this locality was so large that they exceeded the allowable design limitations for an independent panel movement. Thus, the panels could not accommodate the ground deformation, and finally, large panel separations and cracks (especially at lower elevations of the wall) occurred. However, the facing panel connections with the metallic reinforcements did not fail, and their flexible joints allowed large displacements and differential settlements.

both locations were also different. At E1, the vertical ground deformation was so large that the flexible wall face was forced to be displaced both vertically and longitudinally. However, the movement in the longitudinal direction was greatly prevented by the rigid abutment. This caused large panel separations and cracks at the higher levels (Fig. 6a), but no damage observed at lower wall elevations.

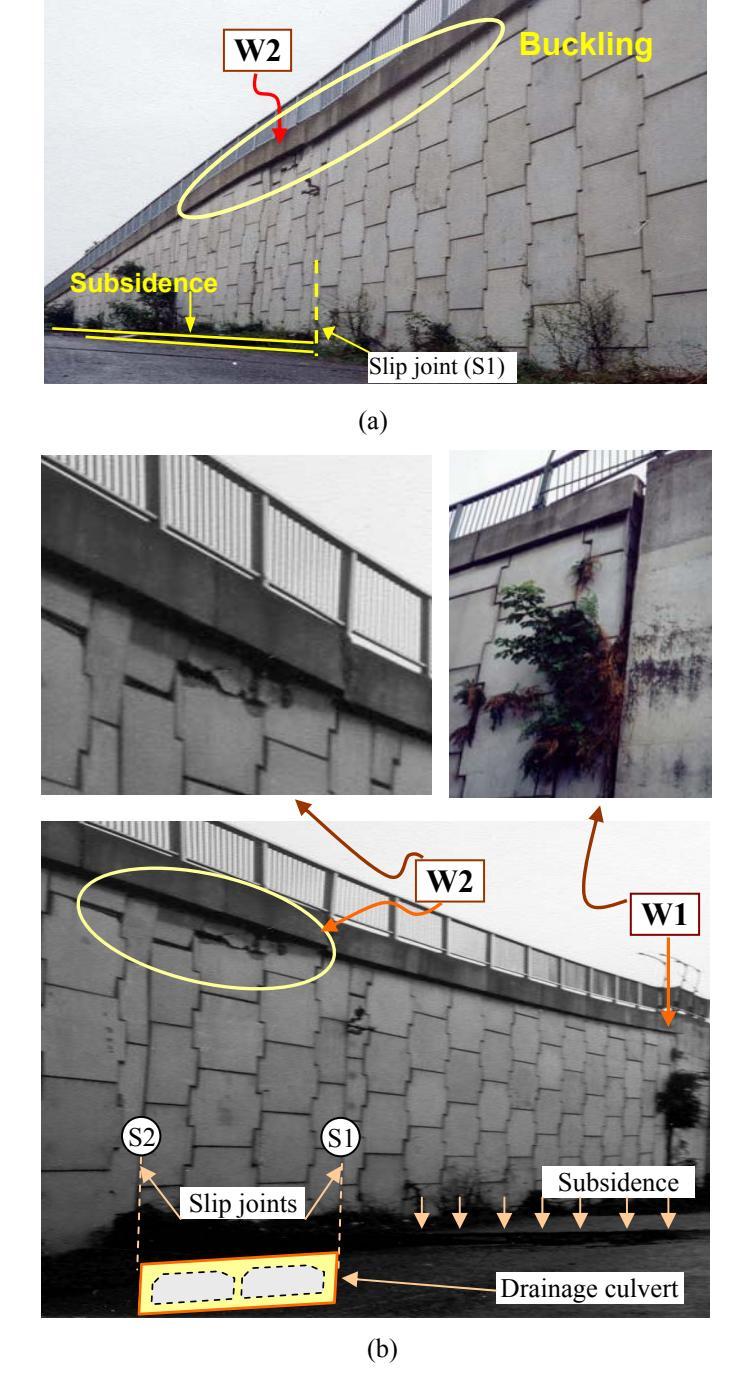
Fig 7. Western MSEW face: (a) buckled wall, looking from south to north; (b) damage details at W1 and W2, looking from north to south (photos after Ozbakir).

large compared to E1. On the other hand, a gap of about 10 cm occurred between the panels and the abutment as shown in Fig. 7b. This gap appeared to be resulted from the buckling in the same wall face in vicinity of W2 (Fig. 7a). That is, once the wall buckled at W2, the wall face was pulled longitudinally (northwardly) as a whole. This behavior along the western side of the approach ramp did not cause any damage in the facing panels between W1 and W2. This was an interesting observation indicating that the reinforced wall system was very flexible.
