FAILURE OF RETAINING STRUCTURES IN TOWN LEZHA AND THEIR CONSEQUENCE IN NEIGHBOURING BUILDING

Luljeta Bozo

Civil Engineering Faculty Tirana Polytechnics University, Albania

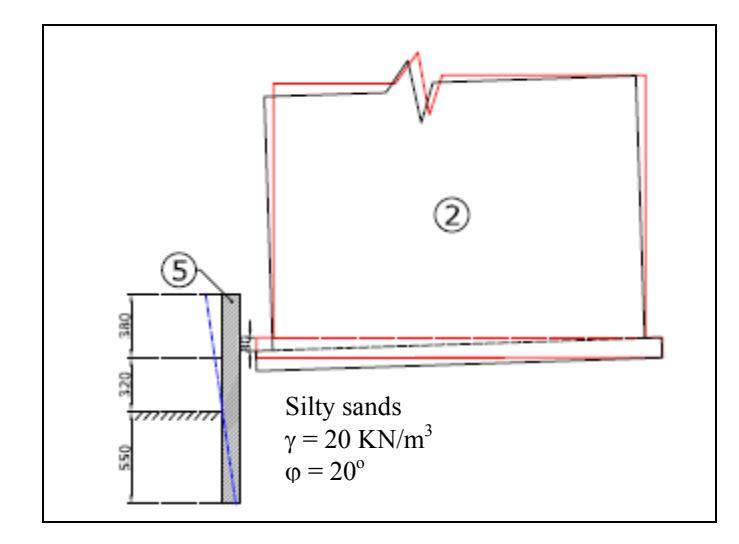
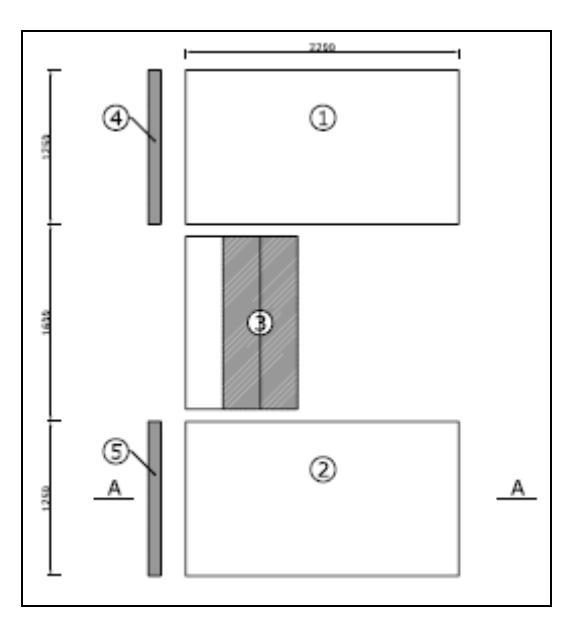
Fig. 2. a. Cross section A-A

Closed to eight floors buildings with mat foundation, which are situated on 3.8m deep from natural surface, was realized the retaining structures (concrete wall) with dimension lengths 12m and depth 12.5m (each of them). The concrete walls were constructed for new buildings for two underground floors (Fig.2). During the processes of excavation (when was arrived 3m down a mat foundation of existing building) the concrete wall was revolved and it had damage to caused in the existing mat foundation dangerous settlement. The settlements are not stabilized during the time; therefore they arrived up to 8 cm near to excavation and 1cm at other side of building. During all the time of excavation it was pumped water from the hole. After 5-7 days by settlements, the inclination of existing mat foundation arrived tag $\theta = 0.0035$ very dangerous value because of the allowable limit is tag $\theta_{\text{limit}} = 0.0040$.

- 1, 2 eight stories buildings
- 3- Two stories buildings
- 4, 5 concrete walls H=12.5m

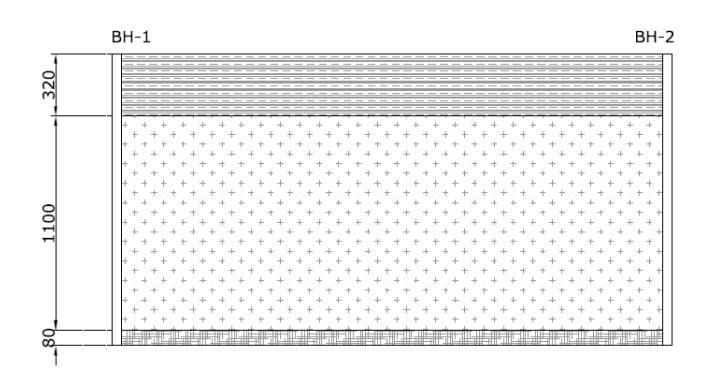
Fig. 3. Lithological profile of investigated site

Initially we have realized some new bore holes to clarified the geological situation and to determinate the exactly the geotechnical properties of soils. From bore holes results the geological profiles consist from three layers (Fig. 3) and underground water table is 1-1.3m deep of natural surface.

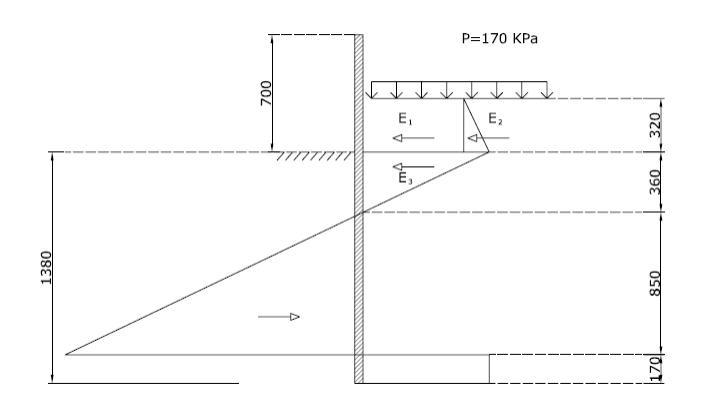
Fig. 5. Sheet pile walls and earth pressure diagrams (E1=308; E2 = 55; E3 = 205).

After our calculation to consider the concrete wall as sheet pile wall (cantilever pile) and to report (refer) a new geological profile and new soils properties (Fig. 5) results that: The necessary depth fixation concrete wall was 5.5m.

In consequence the concrete wall is unstable.

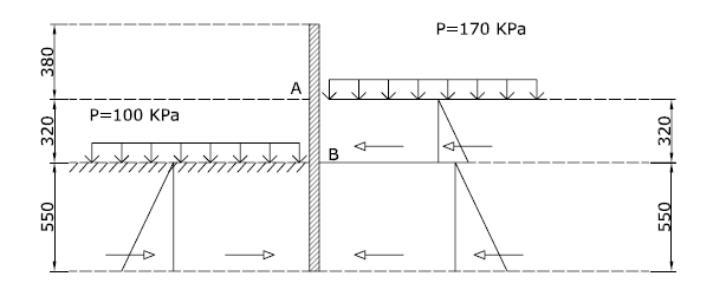
Fig.6. Verification of sheet pile walls after putting 4m concrete on the bottom of hole ($\Sigma Er = 1132 \text{ KN/m}$; $\Sigma El = 1830 \text{ KN/m}$).

First of all immediately we take engineering measures to put of 4m concrete on the bottom of excavation hole. By our calculations results that after application of 100 kPa pressure (4m X 25 KN/m³) the concrete wall make sure temporally to be fixed in 5.5m depth under the bottom of excavation (Fig.6).

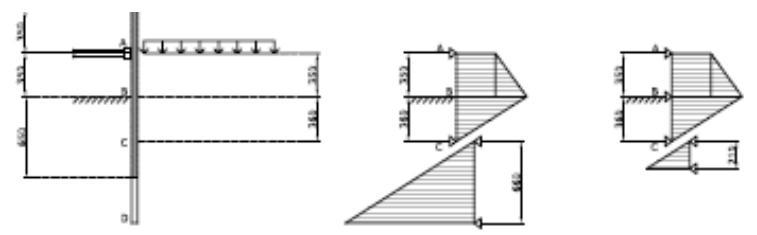
For the second concrete wall (4), where it is not coming the excavation we have executed (accomplished) a reconstruction. We have conceived this retaining structure as anchored sheet pile wall or with support. On the first phase we can to excavate until 3.5m depth from natural surface and we can to put the first support. Then we can continue excavation until 7.0m depth. The real fixed depth of concrete wall was 6.5m. From our calculations this depth is insufficient for the stability

of retaining structure. The necessary length of concrete wall will be 13.7m (Fig. 8).

Fig. 8. The scheme of second sheet pile wall with one and two support.

So, it is necessary to put the second support (Fig. 8b) to insured a resistible retaining structure. The second support shall to put in the bottom of the hole. On second phase, when we can realized the mat foundation of new building, which transmits in the basements 130 kPa pressure we can to take off the supports and in conditions the necessary fixed depth of retaining structure will be 3.5m (Fig. 9).

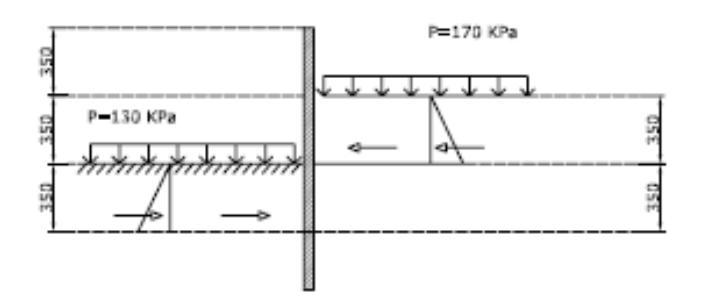
Fig. 9. The schema for calculation of second phases.
