(2013) - Seventh International Conference on Case Histories in Geotechnical Engineering

Accumulation of Rainfall in the Permeable Fill Behind a Soil Nail Wall

ACCUMULATION OF RAINFALL IN THE PERMEABLE FILL BEHIND A SOIL NAIL WALL

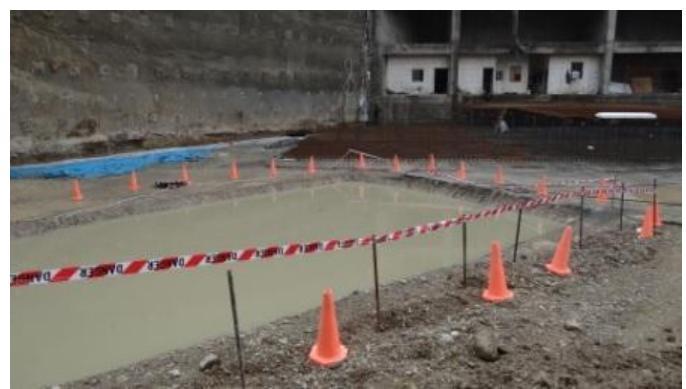
When the wet season began in the region and the amount of precipitation increased measures had to be taken to remove the water accumulation inside the pit. Fig. 25 shows the pond in the site where the water was pumped out after accumulation.

Fig. 25. Accumulation of precipitation water in an excavated pond

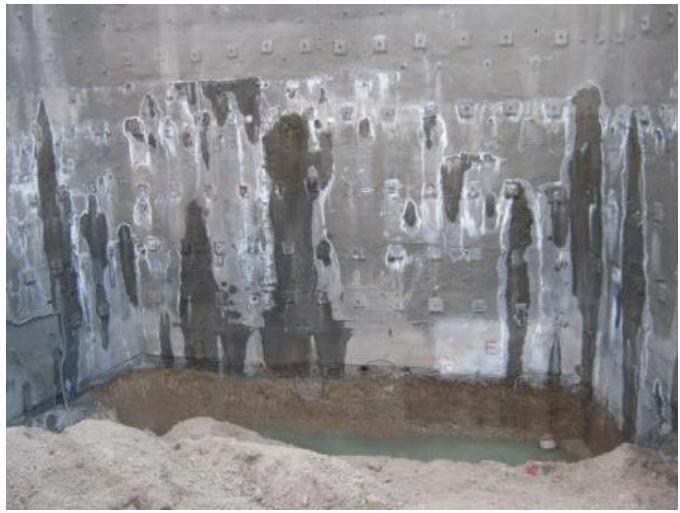
Moreover, the initial concern that there might be localized intrusion of ground water into the excavation pit proved to be correct and water marks began to form on the surface of the shotcrete on some of the soil nailed walls.

At this point the drains incorporated just above the bottom row of soil nails did not seem to function as expected. It appears that the lower permeability of the intact cemented soil and existence of pockets of permeable materials conducts the water towards the shotcrete facing without allowing water pressure dissipation through the lower drains. Fig. 26 shows water marks formed on the surface of the E4 soil nail wall.

Fig. 26. Water marks on the surface of the E4 soil nail wall

The quicker relief of water trapped behind the shotcrete facing was accomplished by scratching the surface of the shotcrete at the location of the large water marks for drains to be installed. Fig. 27 and Fig. 28 show the parts of the shotcrete that were scratched and the finished temporary surface with the drains installed.

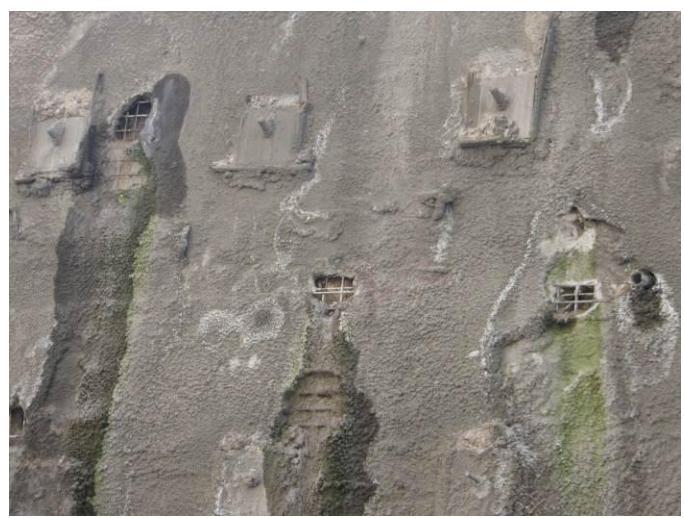
Fig. 27. Shotcrete scratched at the location of the water marks

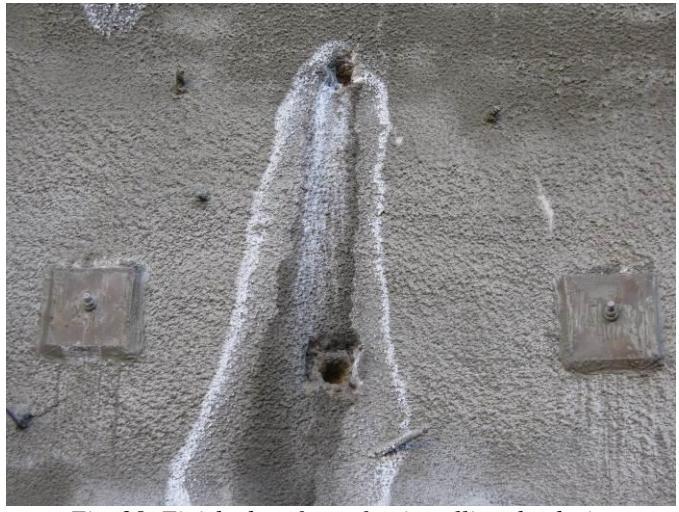
Fig. 28. Finished surface after installing the drains

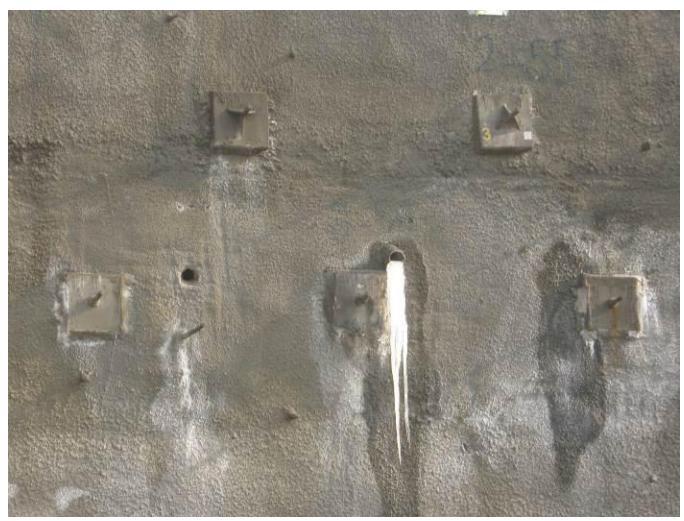
Fig. 29. Frozen water at the tip of a drain pipe installed on the soil nail wall (the drain was installed at this location after the water marks appeared on the shotcrete facing)

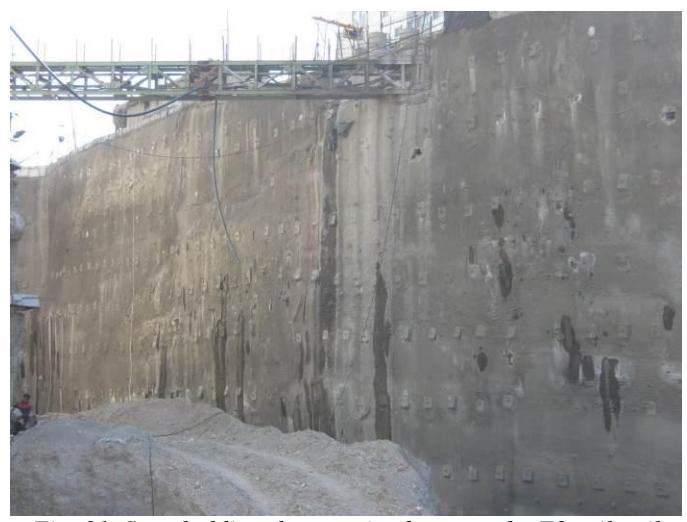
Fig. 31. Strut holding the gas pipe between the E3 soil nail wall and the TOOBA tower

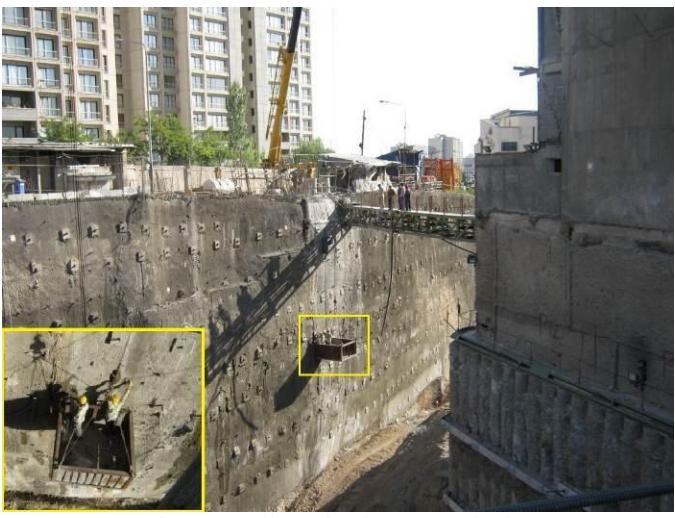
Fig. 34. Workers installing the drains on the locations were water marks have appeared on the surface of the shotcrete

All the cracks on the surface of the road were closed with proper combination of tarmac to avoid further intrusion of water into the tension crack. The scratching of the shotcrete at the location of watermarks alone allowed that some of the accumulated water behind the wall to dissipate quickly. However, 6 meter long handmade drains which consisted of a grooved PVC pipe wrapped inside a geotextile cover were installed to help dissipate the rest of the water possibly trapped inside permeable deposits behind the wall. Fig. 34 shows the strut from a different angle while workers are installing the drains on the locations were water marks have appeared on the surface of the shotcrete.

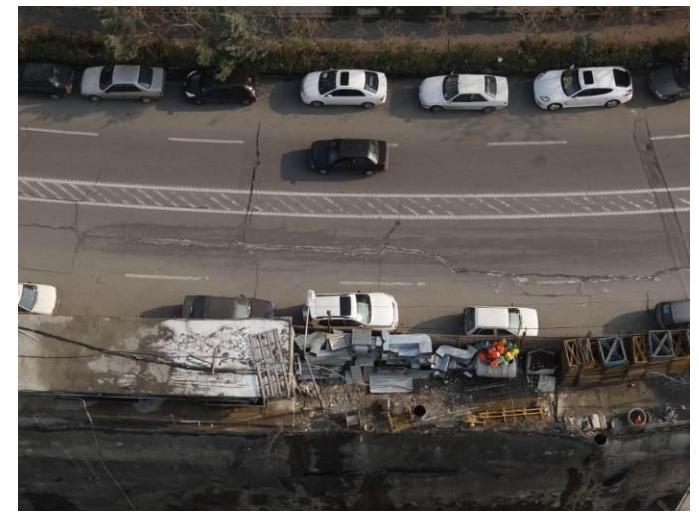
In August 29, 2011 following a three-day rainfall a tension crack suddenly opened on the surface of the road at the eastern side of the excavation site, just behind the E3 soil nail wall. The maximum width of the crack at the surface of the tarmac was 3 cm. The speculation was that the actual crack width beneath the tarmac could be wider. Later reports show that the width of the crack increased to 7 cm during the next day. Tension cracks could happen in passive earth retaining structures such as soil nail walls; but, an opening to the width

of 3 cm very close to the top of the wall over the period of one night after 3 days of continuous raining was interpreted as a signal that a shallow moving block has formed.

Fig. 35. View of the crack at the surface of the tarmac captured from the roof top of the TOOBA tower
