(2013) - Seventh International Conference on Case Histories in Geotechnical Engineering

# Lessons from Revisiting Three Cases of Slope Failure

# LESSONS FROM REVISITING THREE CASES OF SLOPE FAILURE

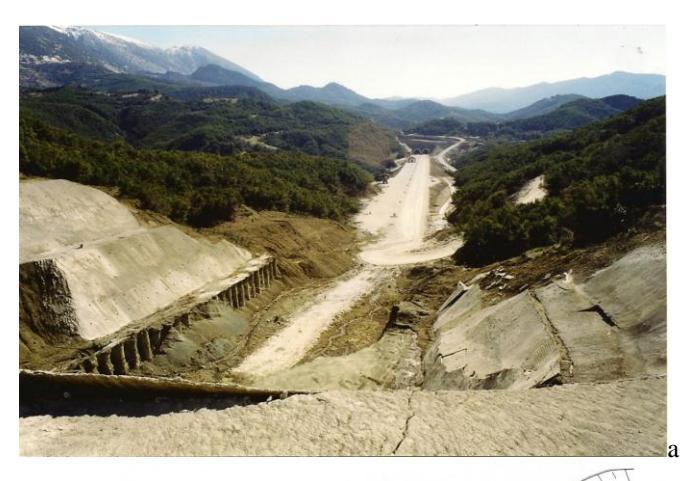
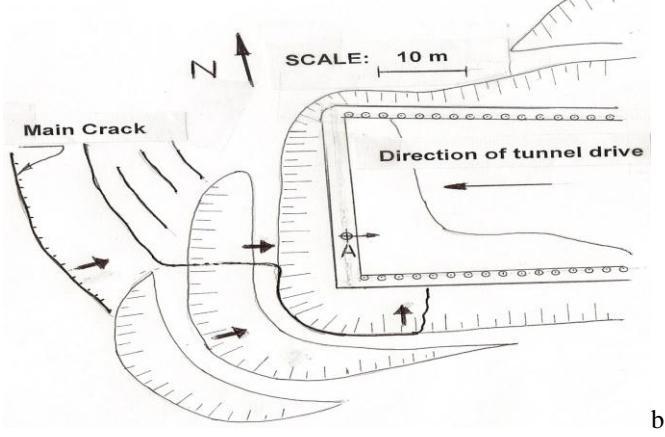
Fig.1a: General view of portal area looking towards the east (photograph taken from the point A). Fig.1b: Plan of the portal area (sketch).

- Slope was probably restricted to the upper mantle of colluvium and weathered flysh.
- It is possible that a failure surface or surfaces pre-existed as a result of previous landslide activity.
- Due to low permeability of the overall rockmass and the general topography of the surrounding area, high groundwater levels could be anticipated in the slope. This low permeability also means that additional recharge due to heavy rain will drain slowly, thereby contributing to excess water pressures in through the rockmass.

Such high pressures, induced by the heavy rainfall in December 1997, triggered the movement that resulted in

the damage.

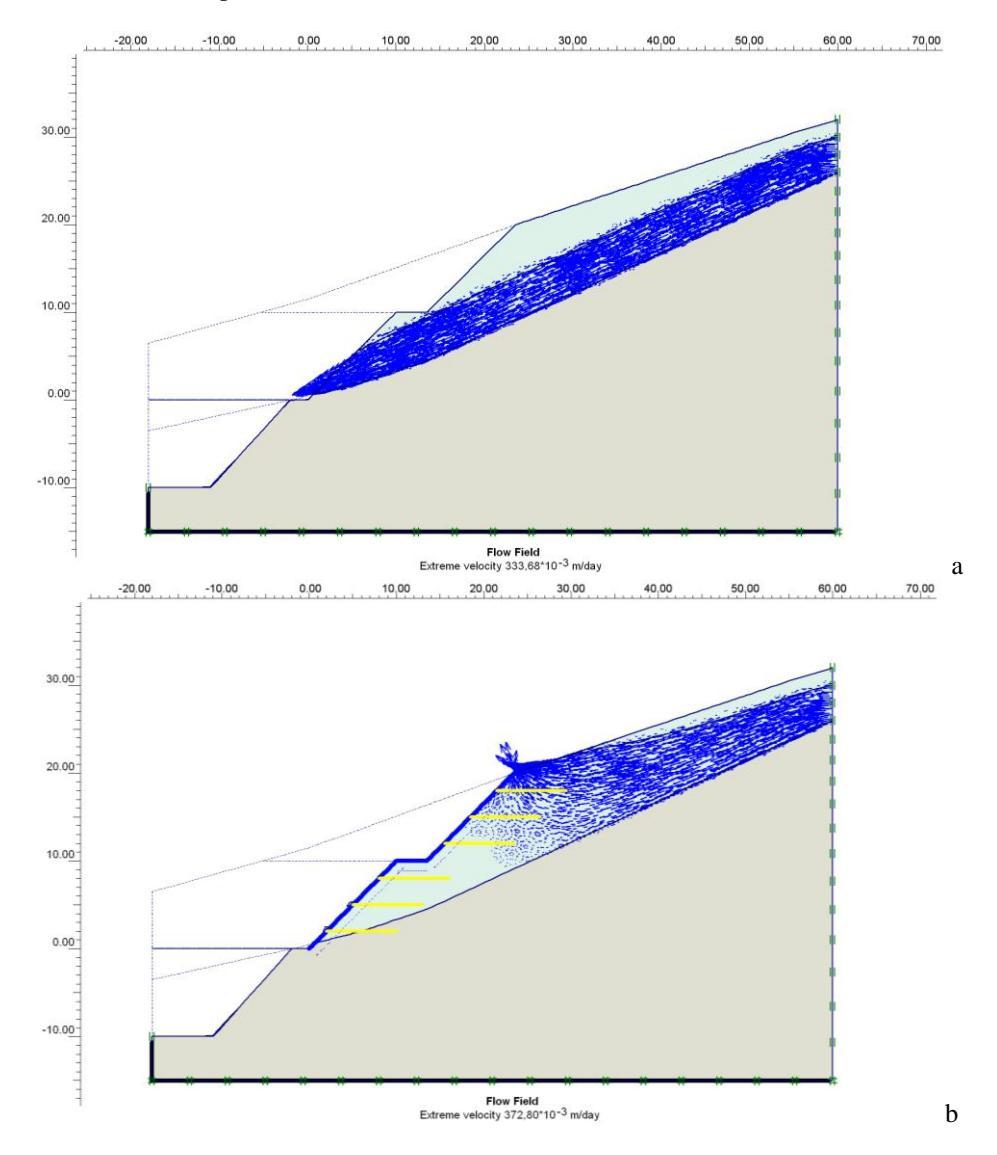
*Fig. 2a: Flow net in case of free slope face. Fig. 2b: Flow net for anchored shotcrete on the slope face.*

It is obvious that the rise of the water level in the upper zone during rainfall was due to the negligible permeability of the underlain flysh, but also due to the restriction of the dissipation of excess pore pressures by the shotcrete. Of course, if all the drainage holes were operating well, no differentiation of the flow would exist, as presented in Fig. 2a and 2b.

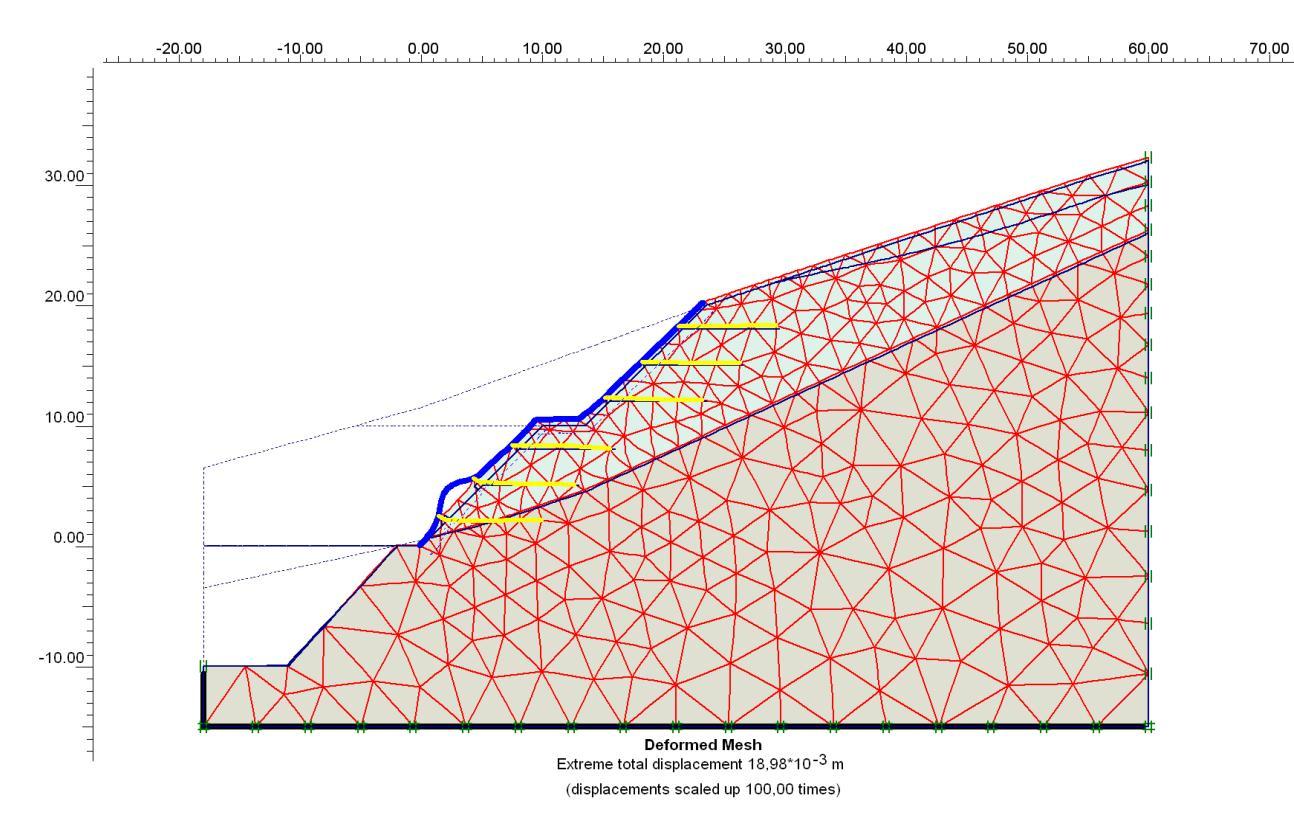
corresponding points are included in the range of variation of the combinations c' and tan $\phi$ ' and near the upper curve (GSI=17). In Fig. 4 the deformed finite element mesh is presented for a representative analysis. From the picture of the deformation of the anchored shotcrete its extensive damages could be justified. Finally, in Fig. 5 the plastic zones, and the shape of failure are presented, which seem compatible with the in situ observations.

Fig.4: Deformed mesh and displacements of the anchored shotcrete.

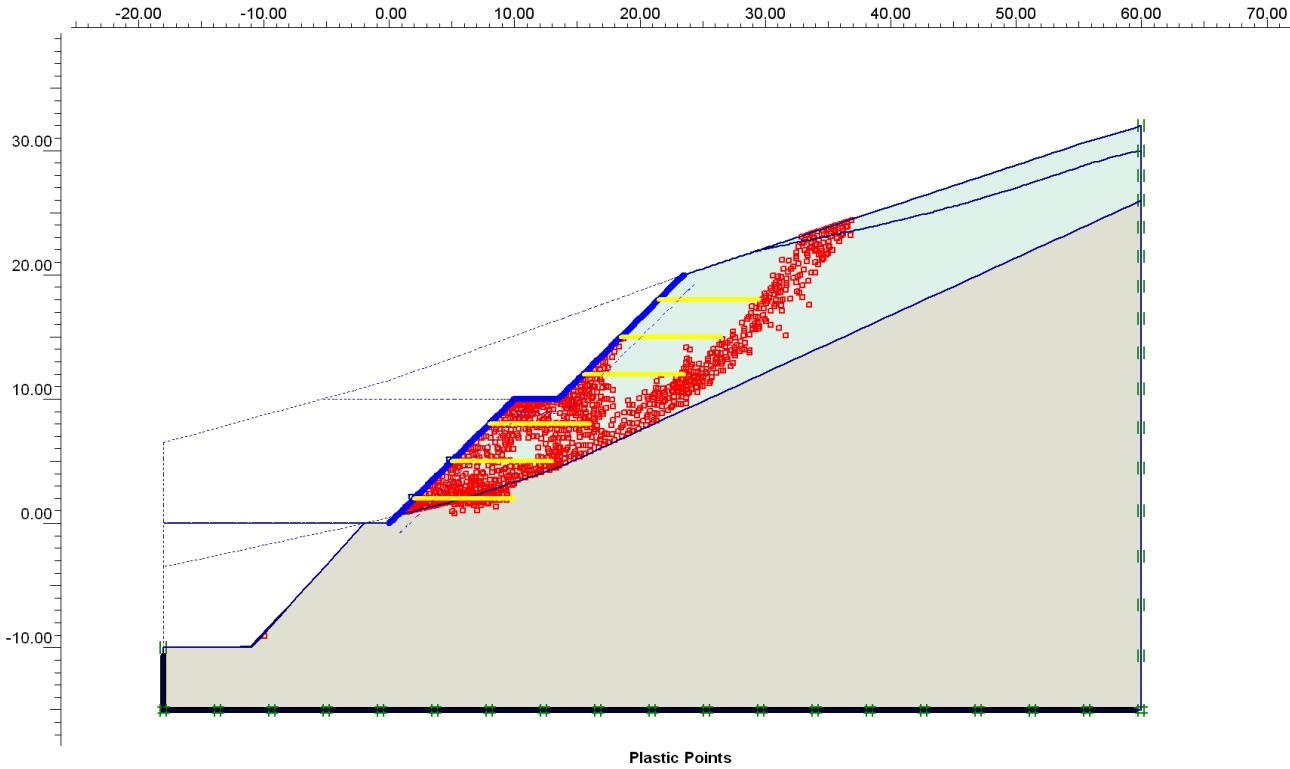
Fig.5: Mode of failure from a representative back analysis.

In conclusion, a suitable interpretation of the strength parameters, recognition of the inhibited water flow regime and numerical analysis offer a satisfactory explanation of the failure.

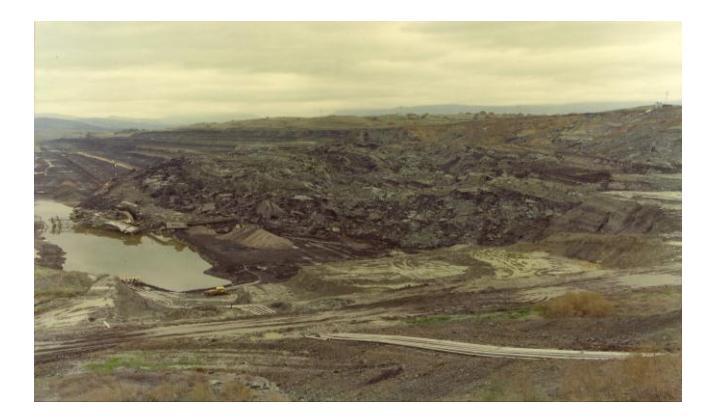
The slope had total height about 90 m, the failure occurred at a length of 400m, and the volume of the soil involved was about  $2 \cdot 10^6$  m<sup>3</sup> (Fig.6).

Fig.6: General view of the slope failure.

• The main factor is the creation of temporary water level, because of the intense rainfalls, which had preceded of the

slope failure. It is also important that the main group of joints followed the dip direction of the slope in the area of failure, so that these discontinuities opened up, because of the excavations, facilitating the inflow of the water.

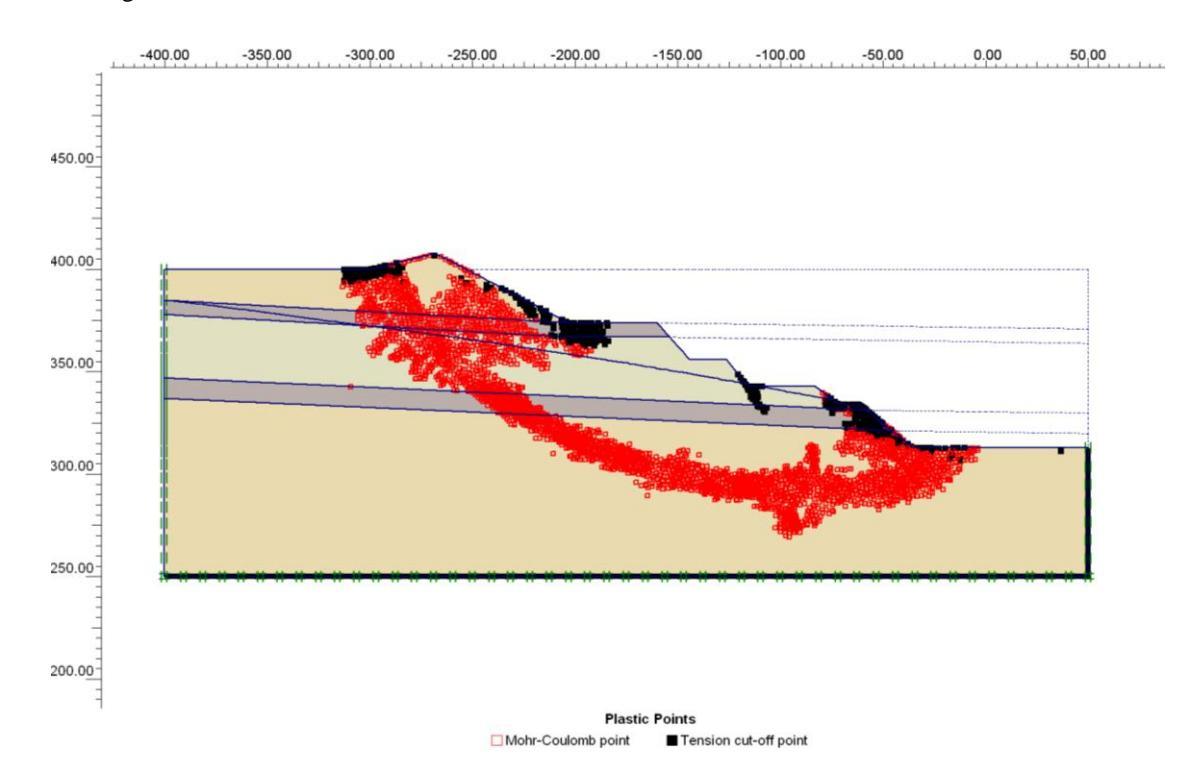
Fig.8: Plastic zones and failure mechanism.

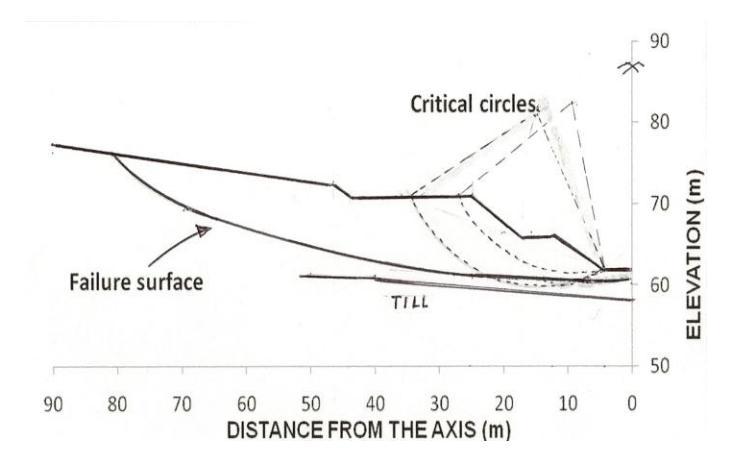
Fig.9:Cross-section of the failed slope (Sketch from a figure after Kankare, 1969).

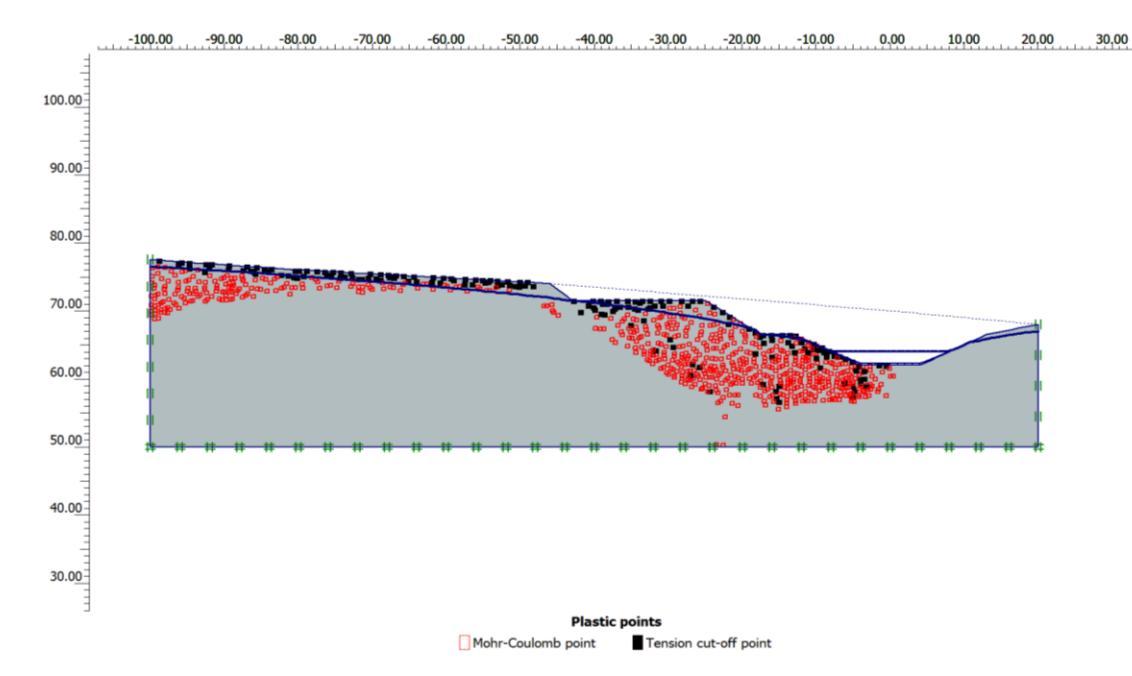
Fig.10: Plastic zones of the cross – section 52+70 during the failure. Analysis with effective stresses for homogenous clay.

(ii) During the limit equilibrium the tension cracks at the crest are shown off, like it happens in practice. The failure seems to have variable curvature and extends more than in Kankare analyses, which were carried out with acceptance of circular surfaces.

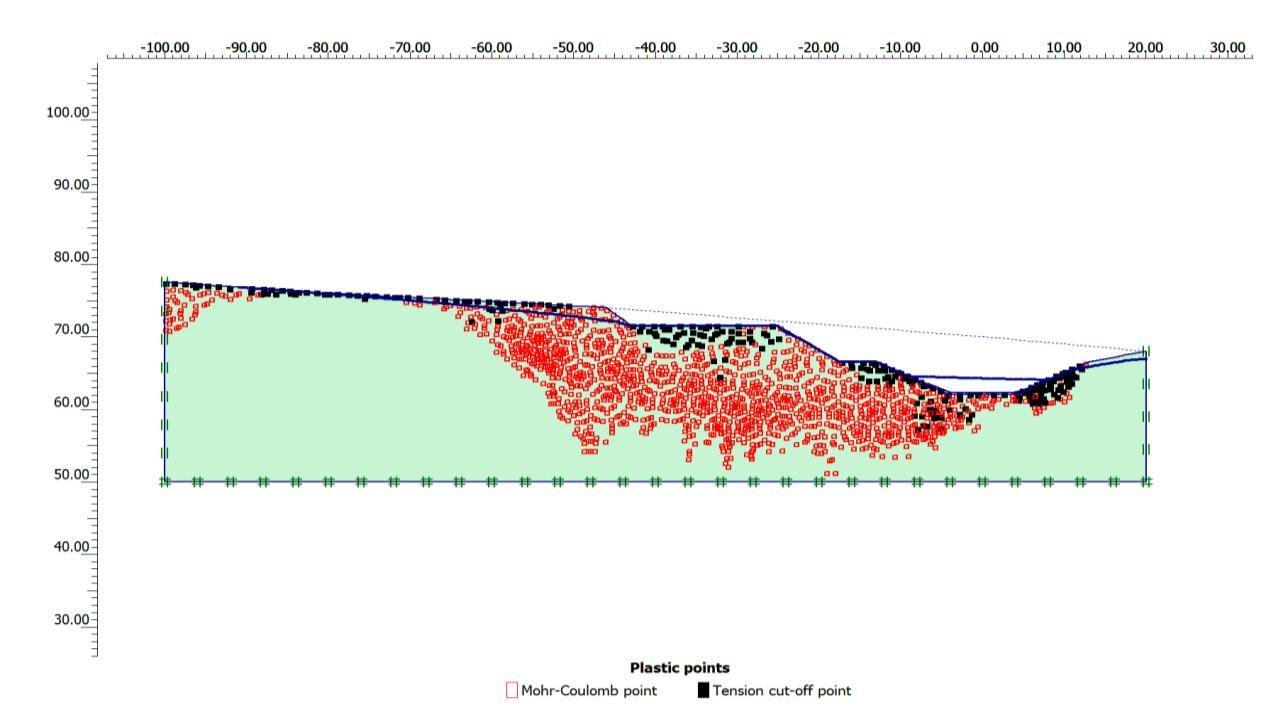
- <u>The inhomogneity of the soil</u>: We refer to the inhomogeneity in the upper zone, where the slope failure broke out and non to the presence of a lower zone till-silty sand doesn't seem to have any impact to the fact. The inhomogeneity is clear, because of the variation of shear strength versus the depth. Intuitively, we expect different failure surface in the soil with increasing strength versus depth, taking into account that the surface upwards zones have smaller strength than this at lower levels. Therefore, the development of shallow failure surface, which extends upwards, in comparison with the surface which corresponds to homogeneous soil, is possible. However, the rate of increase of shear strength in connection with the depth couldn't be directly and accurately developed, in order to be simulated the inhomogeneity of clay zone in terms of effective stresses. Yet, this procedure was attempted with constant angle of internal friction and linearly increasing cohesion c' with compatible way with the geotechnical data. The arised safety factor, from the analysis, which had indicative character with the acceptance of inhomogeneous soil, was MSF=1,135. The plastic zones are presented in Fig.11 and it is confirmed that the failure mechanism extends upwards enough and approaches a lot the really developed mechanism.

Fig.11: Plastic zones of the cross – section 52+70 during the failure. Analysis with effective for inhomogeneous clay.

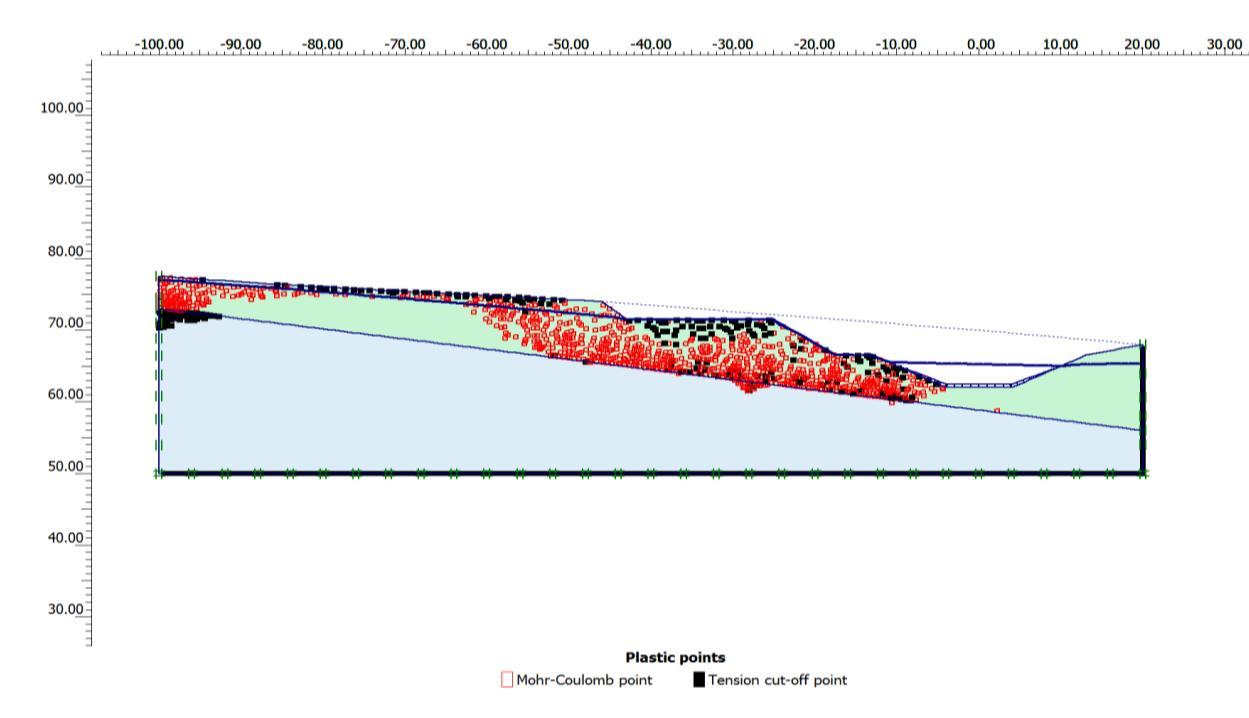
soil in 50%. It is clear that this solution gives with good approximation the real failure mechanism, which deviates a lot from a circular failure surface.

Fig.12: Plastic zones for inhomogeneous and anisotropic clay.
