Forensic Geotechnical Distress Evaluation of Damaged Buildings in Alluvial-Loessic Soils; A Case History

FORENSIC GEOTECHNICAL DISTRESS EVALUATION OF DAMAGED BUILDINGS IN ALLUVIAL-LOESSIC SOILS; A CASE HISTORY

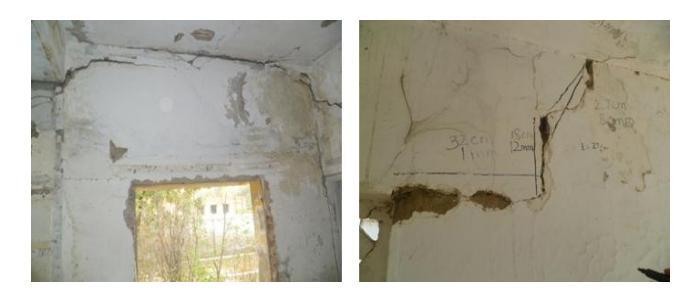
- Distresses are most prominent in walls in the nearest vicinity of kitchen, bathrooms and sewerage tanks shown in Figures 2 through 4
- Distresses are relatively much lesser in walls with only the bathrooms, Figure 5
- Walls in the immediate vicinity of kitchen, bathroom and sewerage tanks are also tilting either inward or outward
- Distresses are almost non existing in the internal walls located in the centre of the buildings
- Most of the cracks are diagonal; initiating from floor and window sills to the corners in the roof
- Width of cracks varies from 10 mm to 50 mm
- Tilt of walls varies from 12 mm to 40 mm

Fig. 2. Cracked walls along kitchen, bathroom and Sewerage tanks

<u>Underpinning of Existing Foundations</u> Cracked walls which are not tilted, are recommended to be rehabilitated using underpinning technique. A field trial would be necessary to optimize the underpinning option.

<u>Retrofitting of Damaged Parts of Buildings</u> Cracks should be repaired while tilted walls should be removed and reconstructed.

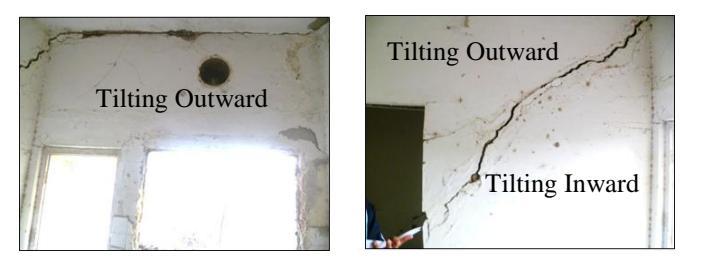
Fig. 3. Walls showing inward and outward tilts

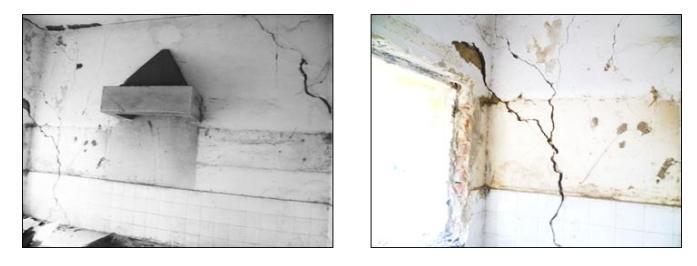
Fig. 4. Walls of the kitchen suffered the severest distresses

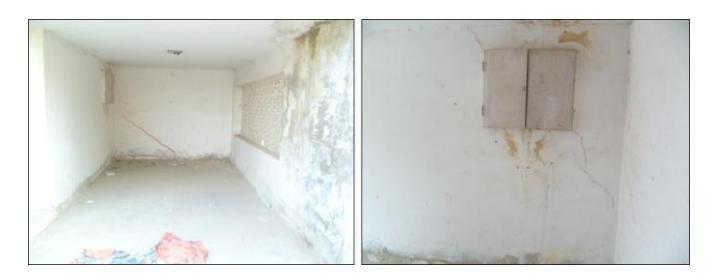
Fig. 5. Garage walls suffered the least distresses

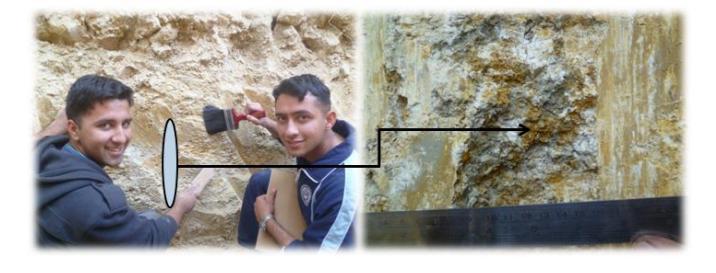
Geologically, the upper soil of research site is alluvial-loessic while deeper layers are a product of spontaneous weathering of underlain layers of limestone of "*Lucky Formation*". Occasionally, shale intercalating with limestone layers have also been reported at some location. The limestone layer is encountered at varying depths starting at shallow depth of 3m. Geologically the soils are classified as "*Marley Clays*". At one of the building site, three soil layers above the bed rock were encountered. The problematic "CH" layer as shown in Figure 7 while it's close up is shown in Figure 8.

Fig. 8. Closer view of problematic layer; CH with calcite

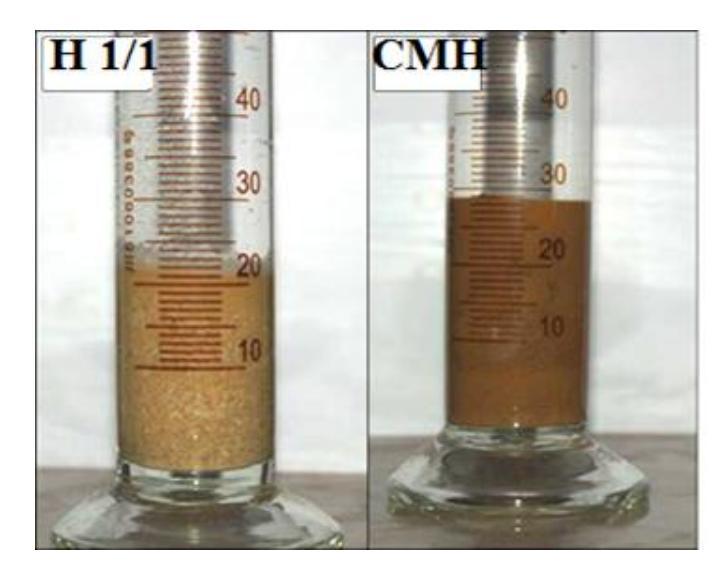
To study the swell potential of soil samples and to study the findings of consolidation test, free swell test was performed. The tests indicated higher free swell in the range of 115% to 185%, Figure 11.

Fig. 11. Free Swell Test at two different soil samples

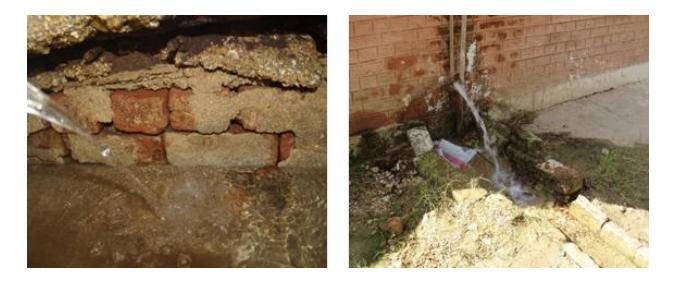
- The upper soil layers are loose agglomerate of finegrained soils and gravels at and underlying soil layer up to bed rock is high plastic clay.
- Chemical analysis indicates the clay type to be "Montmorollonite belonging to Smectite Group". Such clays under wet conditions produce substantial swelling pressures.
- The upper layer has high permeability while underlying CH layer has much lower permeability.
- All damaged buildings had leaky water supply and sewerage pipes. Some damaged houses also had storage ponds in the backyards. All damaged houses also had undergone extensive landscape watering.
- The seeping water quickly makes its way to the underlying clay layer, Figure 17 and 18.

Fig. 17. Leaky sewerage and water supply lines, the water seeps into CH layer

- Water storage ponds within the house and 10 m beyond must be banned.
- Underground pipes must of non-corrosive material and joints must of highest quality. Overflowing water tanks and water taps must be prevented. Half yearly inspection of pipes and drainage may be planned at the garrison level.

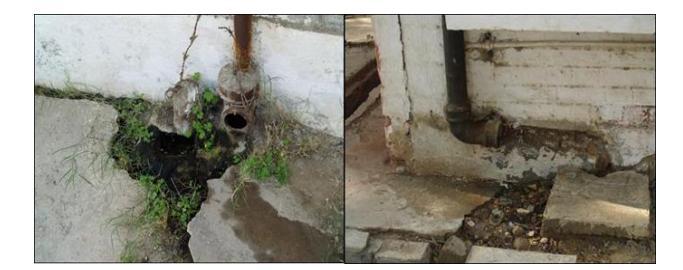
Fig. 17. Broken plinth protection walls, the water seeps into CH layer
