# Lessons Learned from Liquefaction and Lifeline Performance During San Francisco Earthquakes

T. D. O'Rourke Cornell University, Ithaca, New York

# Lessons Learned from Liquefaction and Lifeline Performance During San Francisco Earthquakes Paper No. SOA12

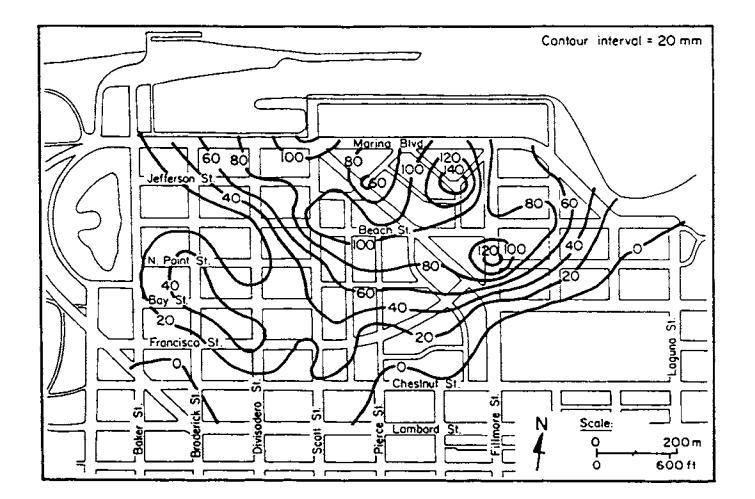
Figure 5. Contours of Corrected Settlement in mm in the Marina District

The damage mapped in Figures 6 and 7 and its close relation to the pattern of settlement mapped in Figure 5 indicate a strong link between pipeline damage and differential settlement that is corroborated further by correlations plotted in Figure 8.

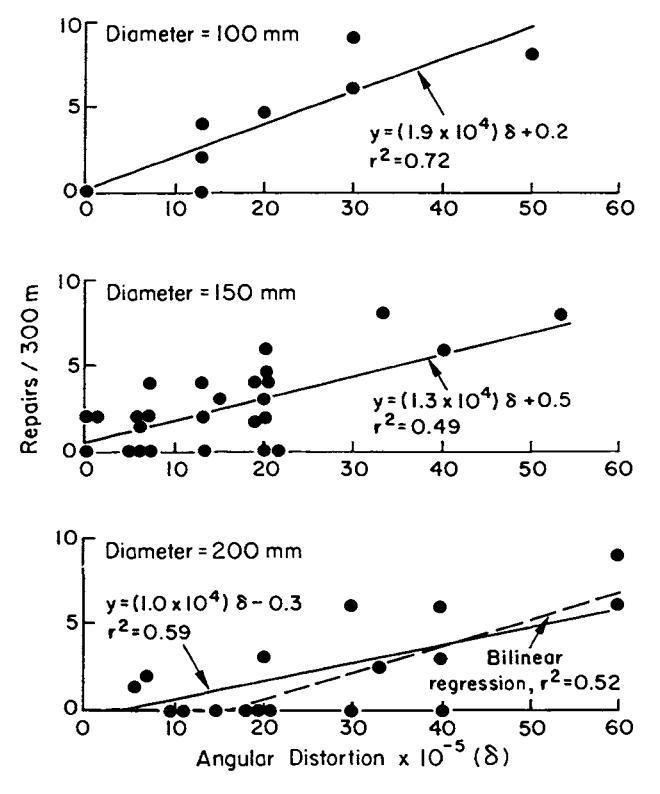
Only a weak correlation was found between repair rate and the magnitude of settlement. Relatively good correlations were found between repair rate and angular distortion. Regressions were developed for each diameter of main, and the resulting relations between MWSS repair rate and the angular distortion are plotted in Figure 8. An equation and coefficient of determination,  $r^2$ , are given for each regression curve in Figure 8. The slopes of these plots increase in inverse proportion to the nominal pipe diameter. For 200 mm diameter mains, a bilinear plot (dashed curve, Fig. 8) also conforms with the data.

Figure 8. Linear Regressions of MWSS Repair Rate Versus Angular Distortion for Water Mains 100, 150, and 200 mm in Diameter

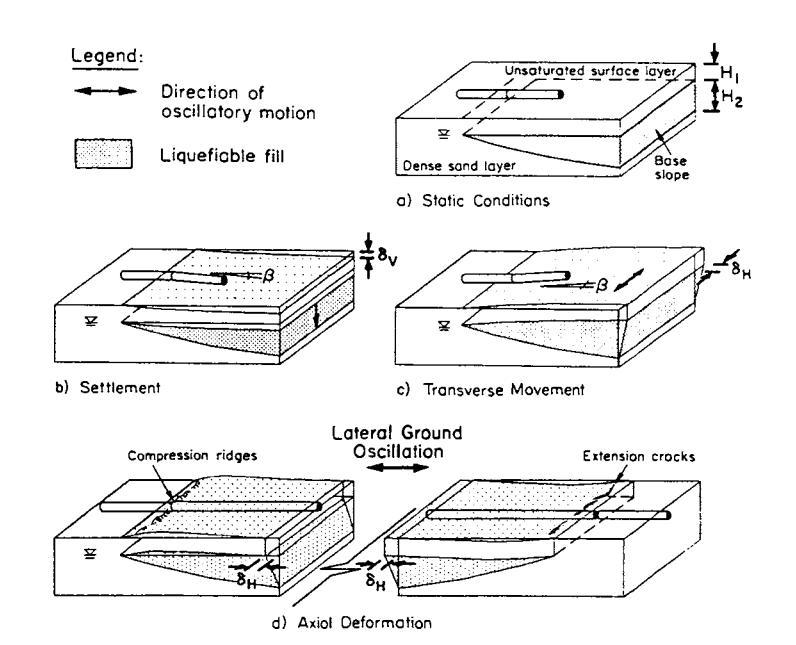
Figure 9. Schematic Comparison (a) of Pipeline Deformations Above a Liquefied Deposit (b) Due to Settlement, and (c, d) Due to Transverse and Parallel Ground Oscillation

formation imposed on buried pipelines. Figure 9 illustrates how buried pipelines are affected by ground deformation arising from settlement caused by post-liquefaction consolidation (Figure 9b) and by lateral shear strains (Figure 9c and d). As an approximation, surficaused by (Figure 9b) cial soil and pipeline lateral movements are equal to the product of the average lateral shear strain and the thickness of soil subjected to liquefaction. The magnitude of lateral displacement, therefore, will vary in direct proportion to the thickness of the liquefiable fill. As illustrated in Figure 9, variations in lateral displacement are largest where variations in submerged fill thickness are largest, which frequently occurs along the margins of the fill.

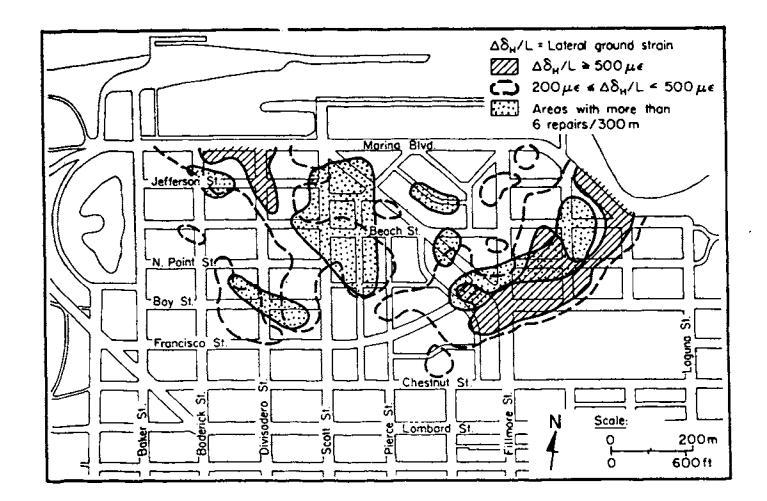
Of particular significance is that lateral ground strains varying from 200 to 900  $\mu\epsilon$  are predicted over a significant portion of the submerged fill. These levels of lateral strain, unlike the bending strains calculated from differential settlement, are fully compatible with levels sufficient to cause damage in cast iron pipelines. Moreover, the lateral ground strains are similar in magnitude to the angular distortion calculated from the postliquefaction settlement contours. This similarity arises because average vertical strains caused by post-liquefaction consolidation are approximately 2% on average (O'Rourke, et al., 1992), which is approximately equal to the best estimate of transient lateral shear strain for the Marina. The use of lateral ground strain caused by oscillatory motion of the liquefied fill provides, therefore, an alternative source of pipeline deformation which not only is compatible with the failure threshold of cast iron pipelines, but also is able to explain why pipeline damage is so closely correlated with differential settlement.

There is good agreement between the areas of maximum lateral ground strain in Figure 10 and those with the highest concentration of pipeline damage. In particular, there is close agreement along the southeastern and western margins of the fill.

Figure 10. Maximum Lateral Ground Strains Resulting from Ground Oscillation with 1.25 to 2.0% Shear Strain, and Regions with Pipe Damage Exceeding 6 repairs/300 m

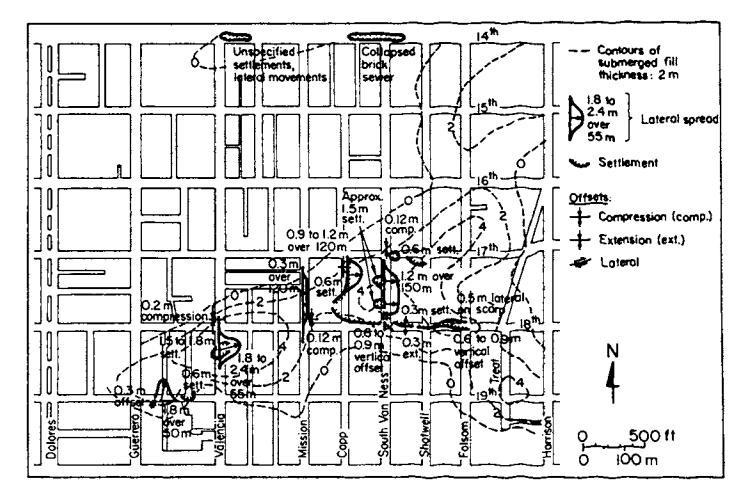
Figure 15 is a map of ground deformations and liquefaction features observed after the 1906 earthquake in the Mission District. The deformation patterns were previously mapped by O'Rourke and Lane(1989), and have been superimposed over contours of submerged fill thickness. Hatchured lines indicate settlement, with the hatchures pointing toward the area of settlement.

This symbol may indicate either gradual subsidence or an abrupt scarp. Sub-parallel lines indicate lateral spreads, the magnitude of which is shown by the separation between lines. Paired arrows indicate the location of abrupt compressional, extensional, or lateral offsets of pavement or streetcar tracks. Lack of historic data in a given area may indicate that relatively minor damage occurred in that area compared to areas that were documented.

A striking feature of Figure 15 is the occurrence of lateral spread in areas with roughly 2 m or more of submerged fill. A major lateral spread is centered on Valencia St. with over 6 m of submerged fill. The ground under Valencia St. spread east and slightly northward down the center of the former ravine, with maximum lateral displacements of 1.8 m to 2.4 m and settlement of 1.5 m. A second area of lateral spread occurred between Capp St. and South Van Ness Ave, where maximum lateral movement of 1.2 m occurred. The thickness of submerged fill is greater than 2 m in this area, and increases towards the east. Maximum lateral movement and settlement of 0.3 m occurred over a width of 120 m across Mission Street between these two sites. Given the relatively small movement on Mission St., it is possible that lateral spread in Upper Mission Creek may not have been a single continuous feature, but may have consisted of two or more discontinuous features occurring in locations where submerged fill is thickest.

Figure 15. Ground Displacement and Liquefaction Features after the 1906 Earthquake in the Mission District

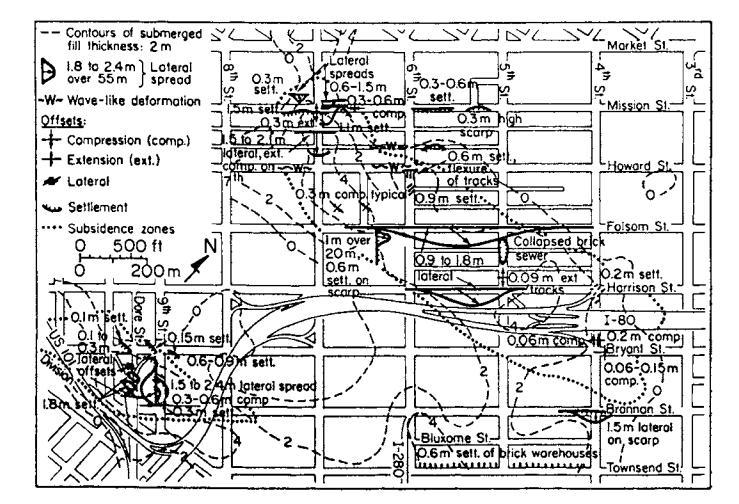
Figure 21 is a map of ground deformations and liquefaction features observed after the 1906 earthquake in the South of Market. The deformation patterns were mapped previously by O'Rourke and Lane (1989), and are superimposed over contours of submerged fill thickness. Similar symbols are used to describe liquefaction ground deformations. A heavy dotted line shows the outline of the major zones of subsidence as reported by Schussler (1906). Schussler indicates that lateral spread, offsets, and wavelike deformation were common throughout the area. Lawson, et al. (1908) reported settlements of amounts varying from a few millimeters to 900 mm or more throughout the former Sullivan Marsh.

Lateral displacement of 1.5 to 2.4 m was observed roughly parallel to 7th St. between Mission and Howard Sts. (Reynolds, 1906). The northern extent of ground failure was near the U.S Post Office at 7th and Mission, and was well documented by contemporary photographs. Maximum eastward displacement of 1.5 m and settlement of 1.5 m were noted at that corner. Submerged fill is as thick as 6 m, and a street gradient of 2.3 percent are present under this block. Lateral displacement of streets 0.9 to 1.8 m eastward was typical further east in Sullivan Marsh.

Figure 21. Ground Displacement and Liquefaction Features after the 1906 Earthquake in the South of Market

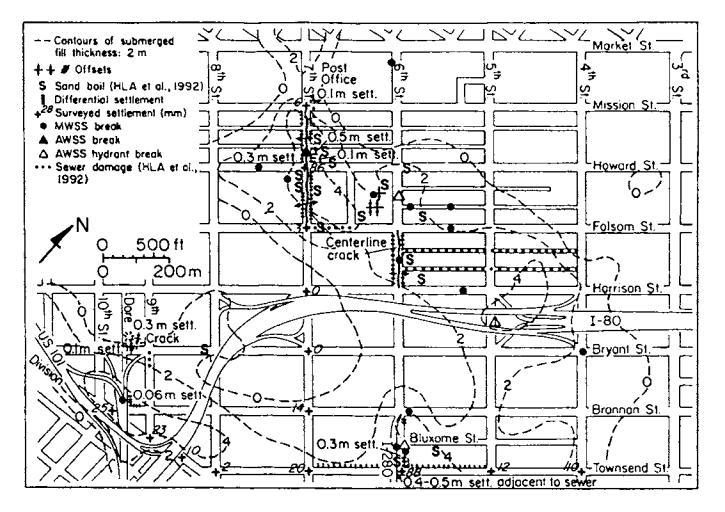
Figure 23. Ground Displacements, Liquefaction Features, and Pipeline Repairs after the 1989 Earthquake in the South of Market
