International Conference on Case Histories in Geotechnical Engineering

Geotechnical Problems in the 2011 Tohoku Pacific Earthquakes

GEOTECHNICAL PROBLEMS IN THE 2011 TOHOKU PACIFIC EARTHQUAKES

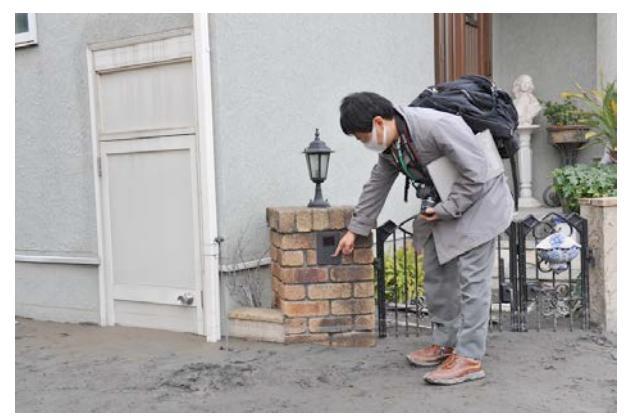
Photo 1. Boiled sand and large settlement of house (Tokimatsu et al., 2011)

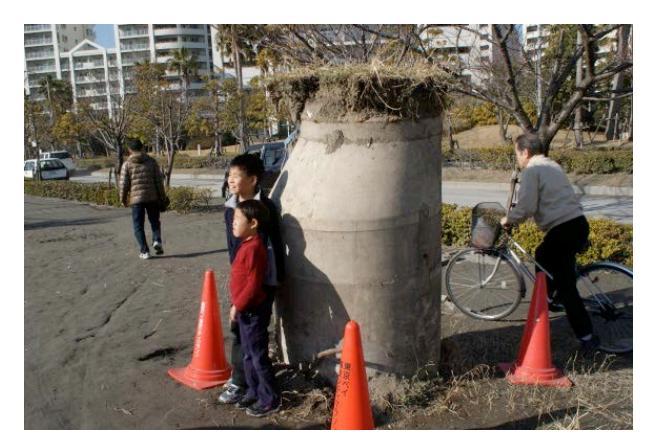
Photo 2. Uplifted manhole (Tokimatsu et al., 2011)

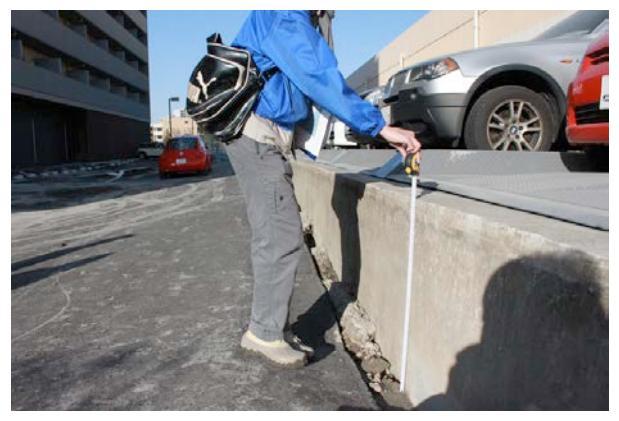
Photo 3. Lifted parking lot (Tokimatsu et al., 2011)

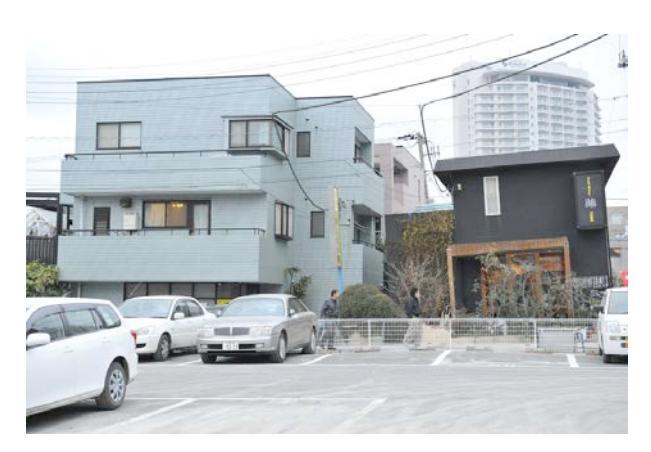
Photo 4. Largely tilted building (Tokimatsu et al., 2011)

A close inspection of the damage to houses suggests that, when two buildings stand closely together, they often tilt toward each other, as in Photo 4 and Fig. 14. This is supposed to occur because the ground settlement between the two structures is greater due to their combined weight loads. When buildings face a street, they tend to tilt backward as shown in Photo 5 and Fig. 14, probably because they tended to incline toward the closer buildings located behind them.

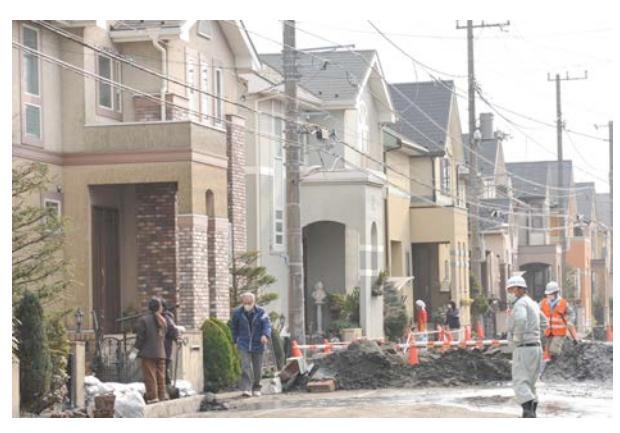
Photo 5. Tilting houses (Tokimatsu et al., 2011)

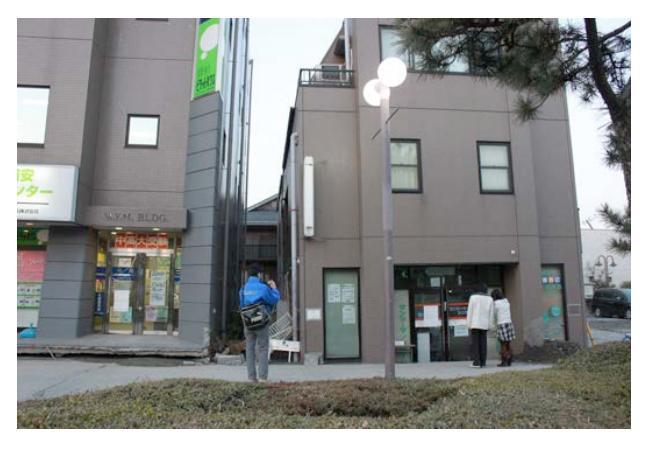
Photo 6. Pile-supported building and settled building (Tokimatsu et al., 2011)

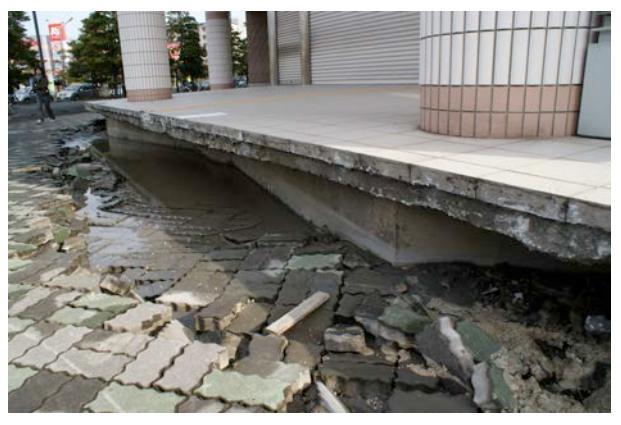
Photo 7. Pile-supporting building suffering large settlement (Tokimatsu & Katsumata, 2012)

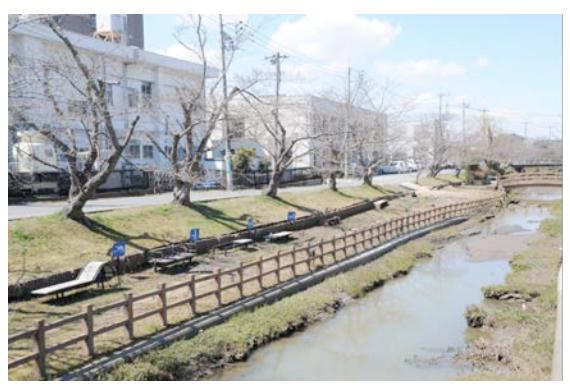
1) Due to liquefaction-induced lateral spreading, the stream became narrow and the riverbed lifted (Photo 8). The ground behind the embankment also settled greatly and shifted horizontally, causing damage to a bridge across the stream.

Photo 8. Lateral ground spreading towards the river (Tokimatsu et al., 2011)

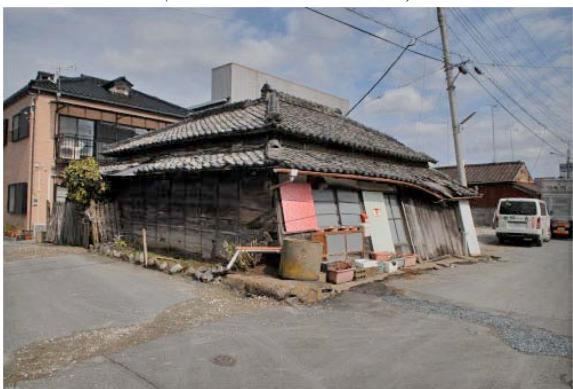
2) Houses and other structures near the embankment had their foundations tilted, as if pushed toward the stream, and some collapsed (Photo 9). Most of the collapsed houses were generally old with low foundation rigidity. A gap of up to 50 cm emerged between pile supported buildings and the ground surrounding them.

Photo 9. House damages by lateral spreading (Tokimatsu et al., 2011)

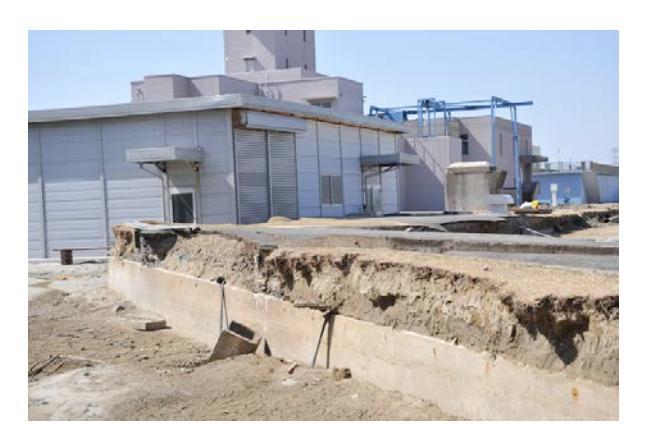
At the Wanigawa purification plant, liquefaction induced ground settlement of up to about 50 cm and uplift of a public utility duct by up to 50 cm (Photo 10). This resulted in a gap of up to 40 cm in the vertical direction between pile supported building and the duct, which severed some of the wiring inside the duct. Horizontal gaps of up to 15 cm also emerged at many joints of the duct, leading large quantities of sand to flow into the duct, which added to the scale of ground settlement. Liquefied ground also caused lateral spreading toward a regulation reservoir at the center of the site, exacerbating ground settlement and raising the water level in the reservoir, inundating roads in the plant.

Photo 10. Uplift of buried conduit (Tokimatsu et al., 2011)

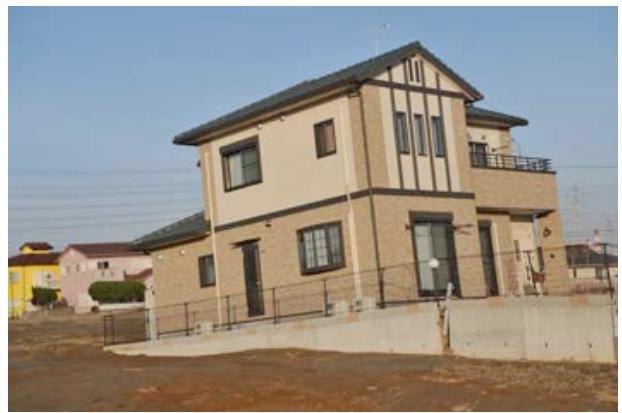
In the Fukashiba and Horiwari areas, liquefaction induced large quantities of sand boiling, causing settlement and tilt of spread foundation buildings (Photo 11), settlement of ground adjacent to buildings supported by a pile foundation, uplift of buried structures and bumps and dents in roads and sidewalks. Boiled sand in Fukashiba measured up to 50 cm thick in some places. When several structures stand close together, they tended to tilt toward the center, where settlement is larger in scale (Photo 12). Several houses located at the end of filled land tilted in the direction of lower ground (outside the land) as the earthfill collapsed due to liquefaction (Photo 11). The northern part of the Horiwari area saw serious damage-an underground drain was uplifted and houses standing along a street settled by up to 50 cm vis-à-vis the road surface or adjacent houses, but the southern part suffered only minor damage. Puddles of water had formed in all of these liquefaction areas, indicating that groundwater level was extremely shallow.

Photo 11. Tilted house on the edge of fill (Tokimatsu et al, 2011)

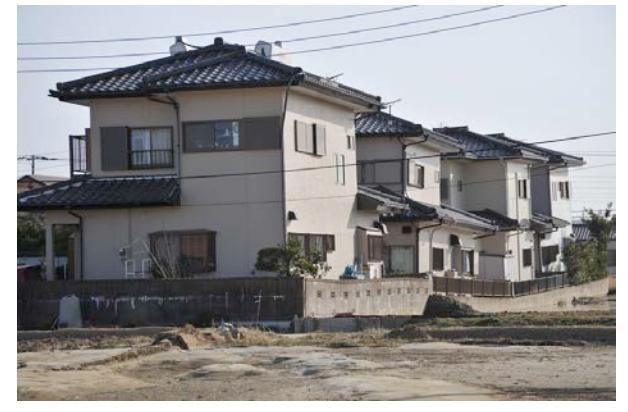
Photo 12. Larger settlement occurring in the middle (Tokimatsu et al., 2011)

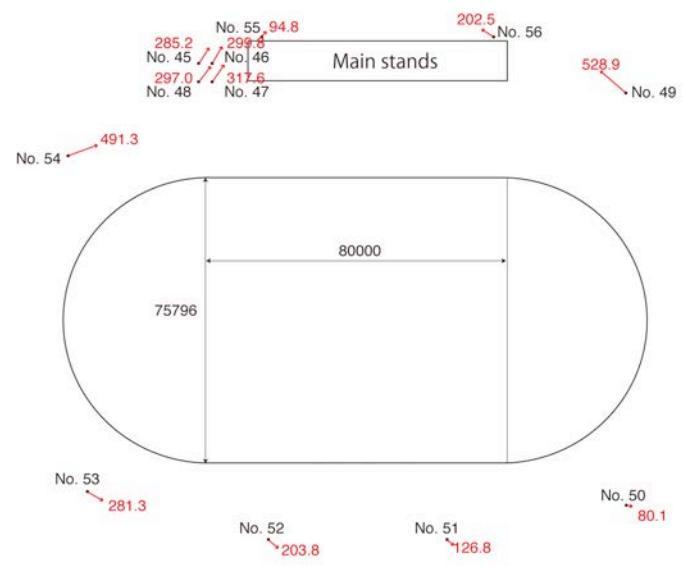
Fig. 19. Vector displacements of pile heads of City Stadium (Urayasu, 2012)

soils in Maihama, was under construction and all the piles except for those of the main stand were extensively damaged. Figure 19 shows the horizontal vector displacements of pile head with respect to the main stand. The 2x2 group piles (Nos. 45-48) supporting the small building moved to northeast by 30 cm, while several single piles (Nos. 49-56) supporting an illuminator moved by 8-53 cm. The pile is about 48m long, having diameters of 0.6 m and consisting of a steel pipe-concrete composite pile at depths shallower than about 10 m and pre-stressed high strength concrete piles below.

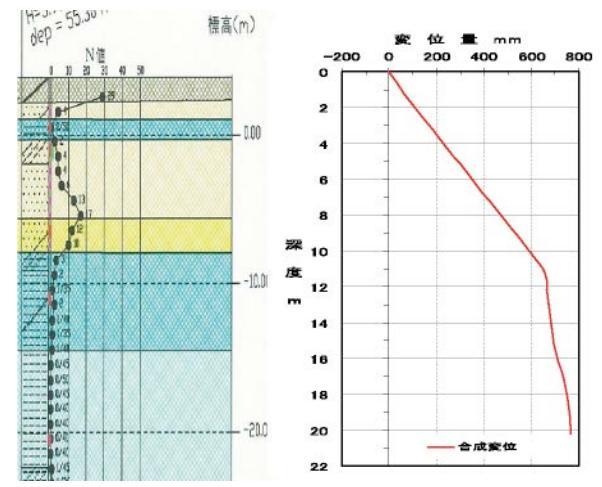
Fig. 20. Soil profile and distribution of pile deformation with depth (Tokimatsu et al., 2012)

Figure 20 shows the horizontal displacement profile with depth of Pile No. 49, detected from field survey using a borehole camera and an inclinometer. The pile has failed and bent at a depth of about 10 m, causing an inclined angle of about 1/15 within the surface sandy layer having a thickness of about 10 m. This confirms that the pile failed near the boundary between sand and clayey layers and immediately below the joint of pre-stressed high concrete pile and steel pipe-concrete pile.

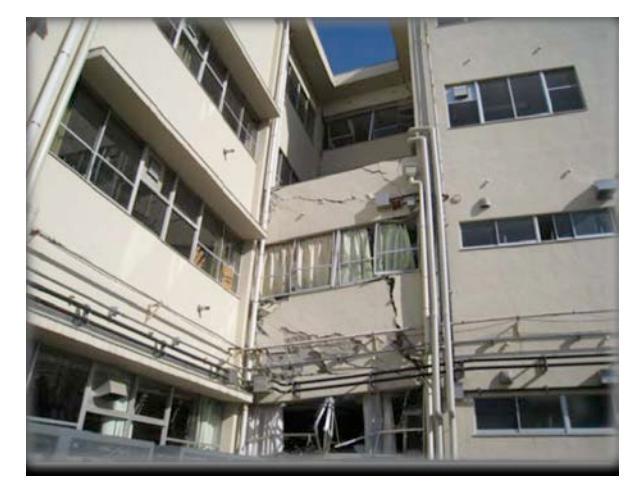
An east part of a 4-story elementary school building in Omiya, Saitama Prefecture, the plan of which is shown in Fig. 21, settled by about 500 mm against the remaining west part, inducing extensive shear failures of the grade beams as well as those of the superstructure near the interface (Photo 13). The building was constructed in 1977-1978 and founded reinforced concrete piles with a length of 36 m and a diameter of 450 mm. The near surface soils around the building doe not consist of liquefiable sandy soils but humic soils, the thickness of which increases towards the north.

Photo 13. Shear failures on beams (Tokimatsu et al., 2012)

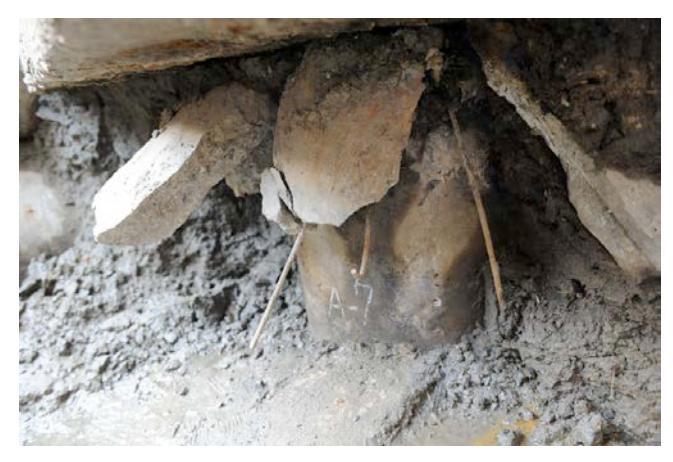
An excavation survey confirmed that the piles on the northern part failed near the pile heads (Photo 14), with those on the

southern part undamaged. The uneven performance of pile foundation within a building could have caused the uneven vertical displacement, and thereby inducing the shear failure of beams. The excavation survey also showed that the ground on the north settled more and induced a longer projection of piles on the north side of the building. This suggests that the difference in soil condition below the building might have induced the uneven failure of pile foundations within the building.

Photo 14. Damage to pile head

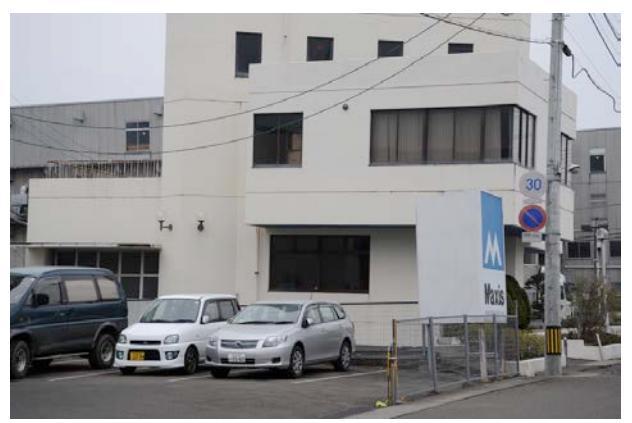
In the western part of Oroshimachi-Higashi area (Fig. 22), soil liquefaction induced sand boiling, settlement of ground adjacent to structures supported by a pile foundation, uplift of buried structures, and bumps and dents in roads and sidewalks. Settlement of ground surrounding pile-supported buildings measured about 10 to 20 cm. At least two buildings apparently supported by a pile foundation tilted remarkably

Photo 15. Tilt of pile-supported building (Oroshimachi) (Tokimatsu et al., 2011)

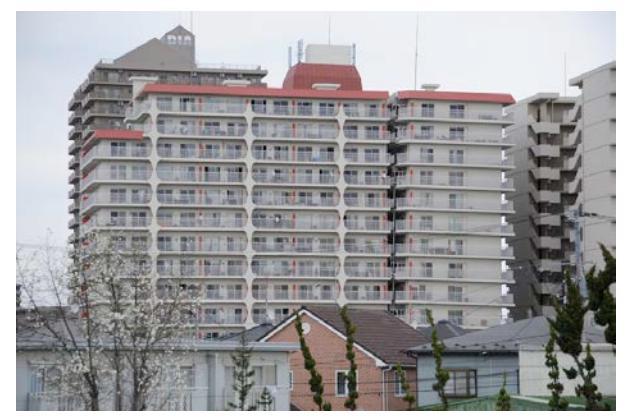
(Photo 15). A similar pattern of building damage associated with pile failure involving soil liquefaction was observed in the Fukumuro area. A 14-story, steel-reinforced condominium complex, consisting of two buildings connected in an L-form with expansion joints, had pile damage (Photo16). It was completed in 1976. Along the bottom of the letter L (on the south side) runs a national highway. It has been reported that the complex's nonstructural walls suffered shear fractures in the 1978 Miyagiken-oki Earthquake. In the March quake, the southern building tilted by about 1 degree southward as its foundation on the south side settled. There were large cracks in nonstructural walls of various parts of the building, but no significant damage was observed in the major structural components. The ground settlements around the neighboring buildings were about 10 cm.

Photo 16. Tilt of pile-supported 14-story building (Fukumuro) (Tokimatsu et al., 2011)

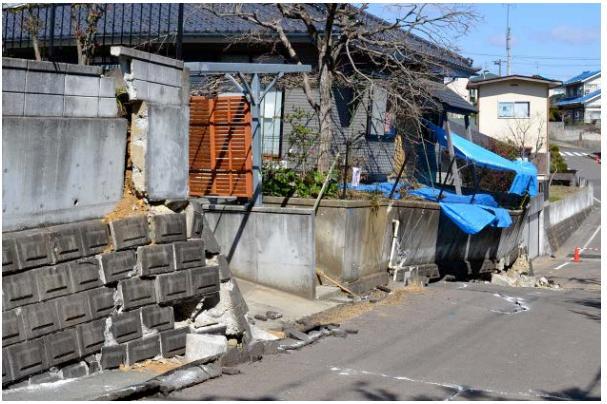
Photo 17. Damage to retaining wall (Tokimatsu et al., 2011)

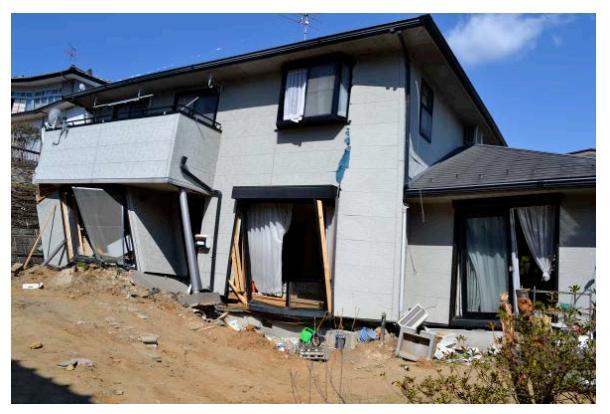
A house that straddles the landslide area and a cut slope was broken around the boundary (P5). Severe damage to houses concentrated at the foot of the landslide area, shown with a shade in Fig. 23 (Photo 18). Damage was greater at the end of the landslide block because ground deformation became greater in both horizontal and vertical directions.

Photo 18. Damage to wooden house (Tokimatsu et al., 2011)

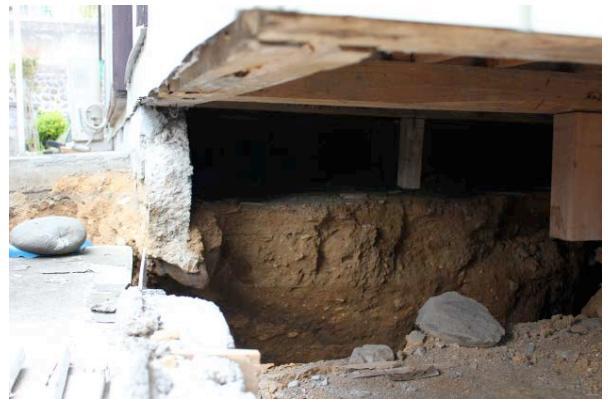
Closer to a valley at P2, the retaining wall shifted about 1 meter to the valley side, causing ground to sink and leaving a void below the foundation, as in Photo 19. At the lower part of the slope, a residential land plot was destroyed as if pushed out, as in Photo 20 (At P3 in Fig. 24). Figure 24 shows the points of tension and compression found from these examples, which indicates that the landslide area was a shaded part in the figure. Comparing it with an old topographical map (around 1964) finds that the area roughly coincides with an earth cliff in the old landscape. The landslide occurred in the residential land developed by widening earthfill along the cliff. Residents

Photo 19. Void below foundation (Tokimatsu et al., 2011)

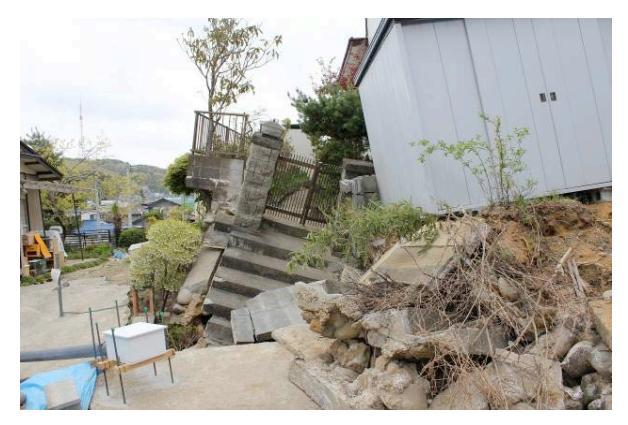
Photo 20. Failure of reclaimed fill (Tokimatsu et al., 2011)

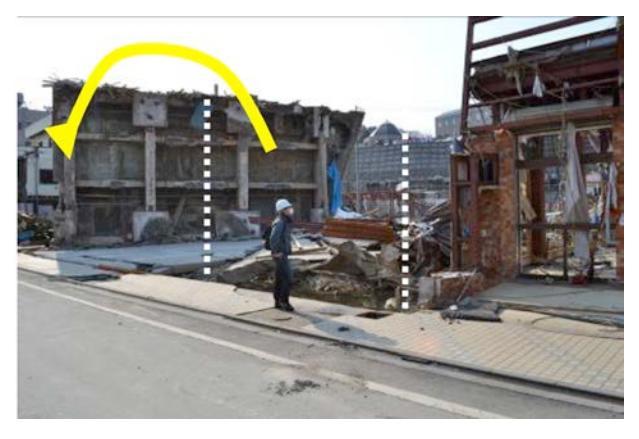
Photo 22. Toppled building A (Tokimatsu et al., 2011)

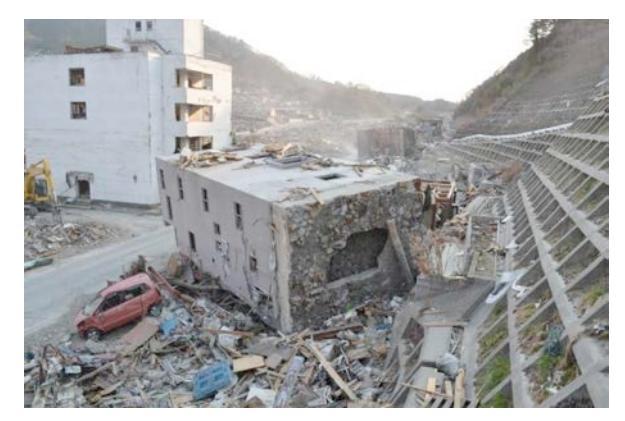
At point B, a four-story, reinforced concrete building with a pile foundation lay on its side (Photo 23). The building used to stand at point B0, from which it was swept toward the mountainside by about 70 meters. A PC pile with a diameter of 300mm was hanging from the pile cap. The pile's head barely remained connected with the cap by reinforcing steel, but the rest of the pile suffered comparatively minor damage. Most of the other piles were found at point B0, either fractured at their heads or head joints, or pulled from the ground with damage at or near their heads. The state of destruction of these piles showed that bending and tensile forces had applied. At a neighboring five-story, reinforced concrete building (at P2), adjacent ground apparently settled, indicating soil liquefaction. It is possible that, when soil liquefaction had lowered the shear strength of the ground, horizontal and buoyant forces of the tsunami applied to the building, pulling the piles out of the ground or causing complete failures at the pile heads. At point D, a two-story, reinforced concrete building with a pile

Photo 23. RC building B carried 70 m away and toppled (Tokimatsu et al., 2011)
