A CASE HISTORY: SEISMIC ANALYSIS OF THE RETAINING WALL OF THE «SACRO CONVENTO» IN ASSISI (ITALY)

The aim of the present work is to analyse the seismic behaviour of the retaining wall of the square in front of the Basilica di San Francesco at Assisi that during a long seismic crisis occurred in September 1997 suffered some damage. Static, pseudo-static and dynamic analyses have been carried out on four significant sections of the wall. The data for the analysis derive from the geometric survey of the structures, the survey of the state of the damage, the measurement of the rotation movements of the wall, the collection of stratigraphic and geotechnical data, as well as the accelerometric recordings of the seismic events using instruments that had been in operation on the structures of the «Sacro Convento» since 1995.

THE SO-CALLED «SOSTRUZIONE» WALL OF THE «SACRO CONVENTO» OF ASSISI

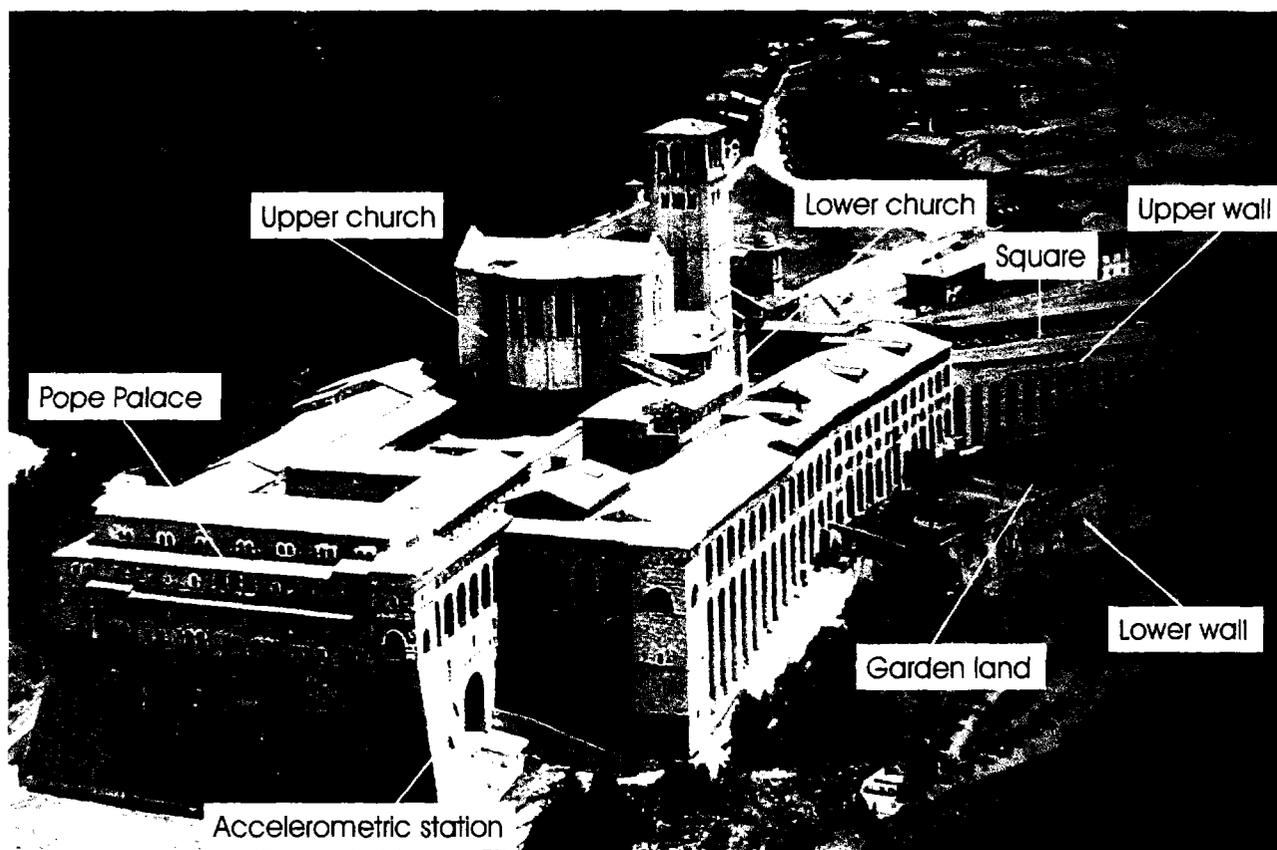
Photo 1. General view of the monumental complex of the «Sacro Convento» in Assisi.

The monumental complex of the Basilica of San Francesco at Assisi rises at the top of a hill known as Paradise Hill, the morphology of which has been profoundly modified compared to its natural state (Photo 1 and Figure 1).

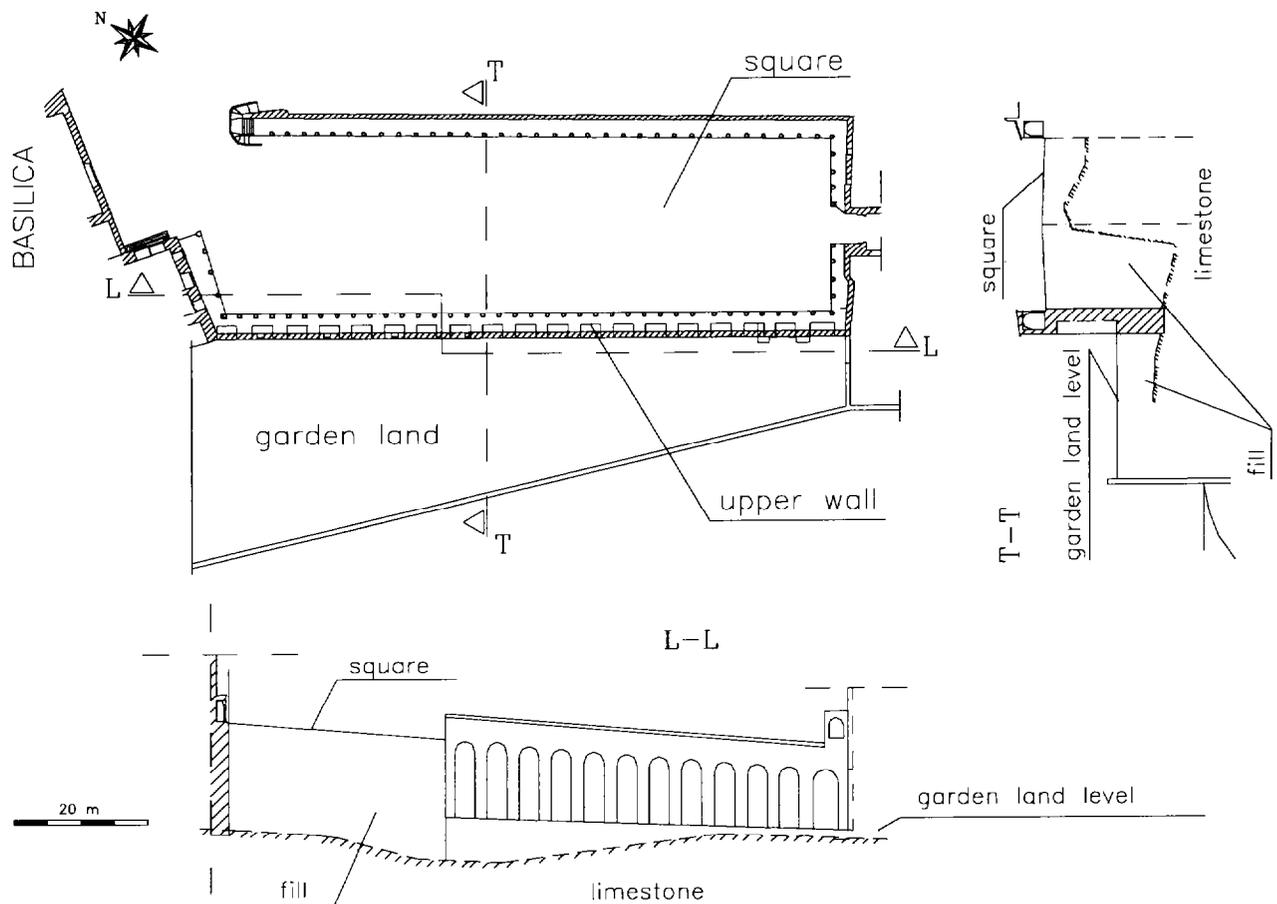
The wall, made of stone masonry, has constant thickness from the foundation level to ground level of the garden land, while in the upper part it has a ribbed, box-shaped structure, with pylons and arches that repeat themselves every about 4.8 m (Figure 1). On the top of the wall, at the height of the square of the lower church, there is a loggia decorated with cross vaults, closed from the valley side by a 0.7-m-thick wall and delimited by a colonnade on the side overlooking the square. The loggia continues also beyond the «sostruzione» wall, delimiting the square of the lower church on three sides.

Figure 1. Plan at the square level; transversal and longitudinal sections.

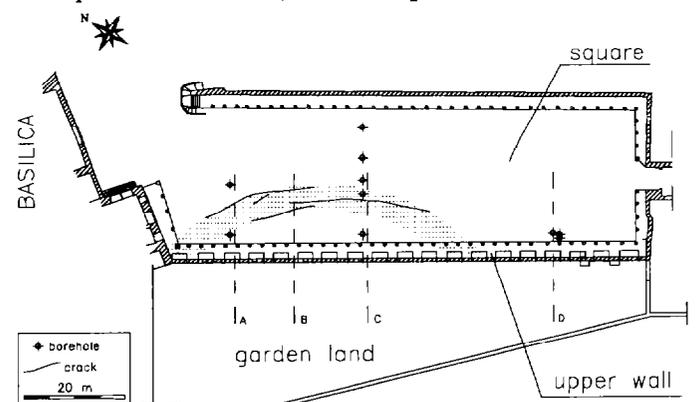
As a result of the September-October 1997 earthquake, four large cracks (Figure 2) were manifested in the pavement of the large square behind the «sostruzione» wall. The cracks, with a length of between 3 and 26 metres, formed a system that planimetrically delimited a flat arch in the end zone of the wall, where its height is greatest. The arch has a rise of 11 metres and a chord of about 60 metres.

Verticality measurements (out of plumb) of the downstream face of the wall pointed out the rotation of the wall towards the outside, with maximum values in the section corresponding to the top of the arch detected by the system of cracks in the pavement of the square. In short, a three-dimensional active earth pressure wedge, delimited by an arch in the horizontal level of the square, was well defined. The extremities of the arch corresponded on the one side with the terminal corner - and therefore constrained - zone of the wall and, on the other, with a zone in which the height of the wall is considera-

bly less. In correspondence with the four sections A, B, C, and D, indicated in the plan of Figure 2, the out of plumb from the level of the square to the level of the garden land, or for the height of wall above ground, was 14, 22, 20, and 3 cm, respectively. By supposing a rigid rotation movement of the wall around the outside edge of its foundation, the corresponding rotation angles are 0.65° , 1.06° , 1.03° , and 0.19° . As the value of the out of plumb of the wall before the 1997 earthquake is not known, it was not possible to learn the rota-

Figure 2. Plan at the square level with the position of the main cracks, the stratigraphic boreholes and the four analysed sections.

sections: A, B, C, D, indicated in the plan of Figure 2 and schematically represented in Figure 3.

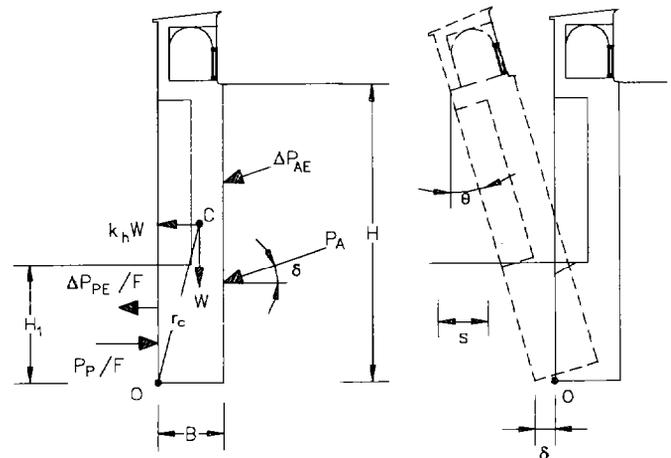
Section A is that of the maximum net height, $H-H_1$, but is also the one that most greatly feels the three-dimensional effects because it is the one closest to the constrained extremity of the wall. The greatest overall height, H , corresponds to section B. Section C is in correspondence with the apex of the arch delineated by the system of lesions in the pavement of the square. Section D is of a lesser free height, but also of a lesser embedment depth, and it is outside the zone in which evident lesions appeared.

For the four sections, the weight W , the position of the centre of mass C , and the barycentric moments of inertia J_x , J_y , and J_C were determined by taking into account the three-dimensional geometry of the wall (with arches and ribbings on the external face and the loggia at the top) and the different materials of which it consists (stone masonry, brick masonry, marble).

Section	A	B	C	D
B (m)	4	4	4	4
H (m)	16.9	18	17.2	11.2
H_1 (m)	4.6	6.1	6.1	2.1

Figure 3. Scheme, symbols and dimensions of the four analysed sections.

With reference to the symbols in Figure 3, the motion equations to be integrated numerically are equation (1) for rotation movement and equation (2) for translation movement.

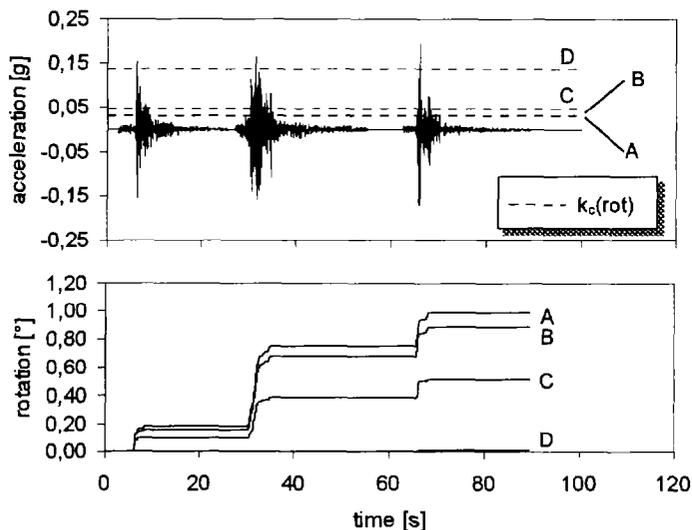
The results of the calculation are summarised in Table 2. In Figure 4, the time histories of the WE component of the three recorded motions used in the analyses and the cumulated rotations for the four sections of the wall are represented. The measured and calculated values of the permanent out of plumb movements of the wall are represented in Figure 5. In the abscissa is indicated the distance of the section from the constrained extremity of the wall.

Figure 4. WE component of the three main shocks of 1997 seismic sequence recorded at the Assisi-Stallone accelerometric station and cumulated rotation of the upper wall in the four analysed sections.

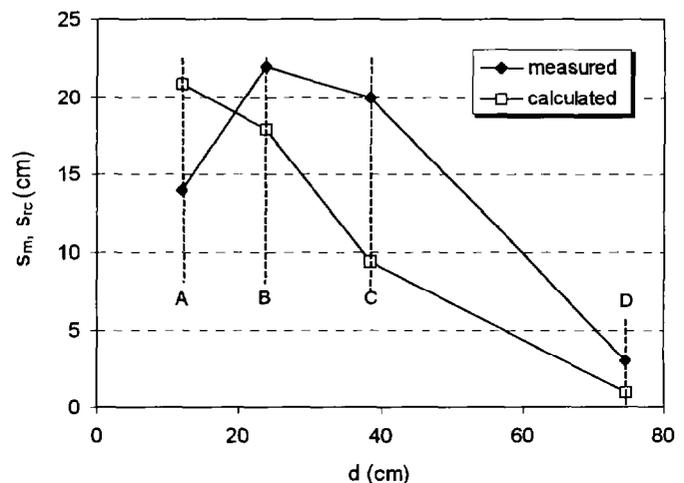
Figure 5. Measured and calculated movements of the wall in the four analysed sections.

tion A, close to the constrained extremity of the wall, and to an underestimate of the actions and movements of section D, of the lowest height (Figure 5). In addition, reasonable but simplified design hypotheses were made with regard to the geometry of the wall, (which in its underground part is only partially known), the geotechnical properties of the filling soil (which was assumed to be homogeneous), the partial mobilisation of the passive earth pressure, the elevation of the static and dynamic earth pressures, the kinematic mechanisms of the wall. Lastly, the seismic input was assumed to be uniform along the height of the wall and coincident with the accelerometric records of the Assisi Stallone station, disregarding amplification phenomena. Despite all this, the results were good. In fact:

- for sections C and D, far away from the constrained extremity, the measured movements were from two to three times greater than the calculated movements. This was justified by the fact that the measurements referred to the initial non-deformed configuration, and included the movements accumulated from the period during which the wall was built (1509) up to today: during this period, at least three strong earthquakes have occurred, in addition to the one in 1997. For section A, the closest to the constrained extremity of the wall, the movements measured were inferior to the calculated ones; for section B, they were just a little larger.
