Errors in Design Leading to Pile Failures During Seismic Liquefaction

ERRORS IN DESIGN LEADING TO PILE FAILURES DURING SEISMIC LIQUEFACTION

ABSTRACT

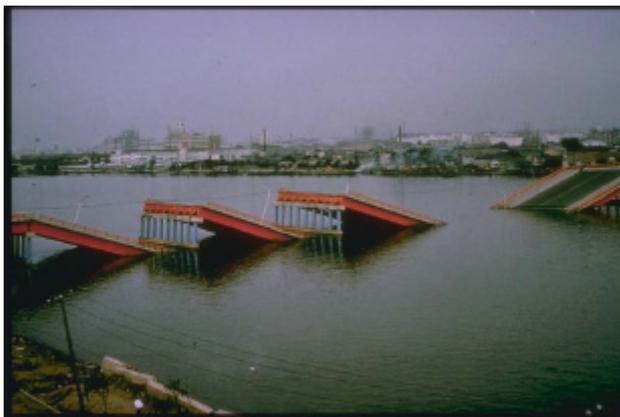
Figure 5: Failure of Showa Bridge; (a): Photograph of the failure after NISEE; (b): Schematic of the falling of the decks after Takata et al (1965)

due to lateral spreading the piers should have deformed identically in the direction of the slope. Furthermore, the piers close to the riverbanks did not fail, whereas the lateral spread is seen to be most severe at these places.

1. This hypothesis of pile failure assumes that the pile remains in stable equilibrium (i.e. vibrates back and forth and does not move unidirectionally as in case of instability) during the period of liquefaction and before the onset of lateral spreading. In other words, the hypothesis ignores the structural nature of pile.
2. The effect of axial load as soil liquefies is ignored in this hypothesis.
3. Some observations of pile failure cannot be explained by the current hypothesis.
4. It is suggested by Bhattacharya (2003), that the pile foundation of Showa Bridge, which is considered safe based on the current JRA (1996) code, actually failed by buckling during the 1964 Niigata earthquake.

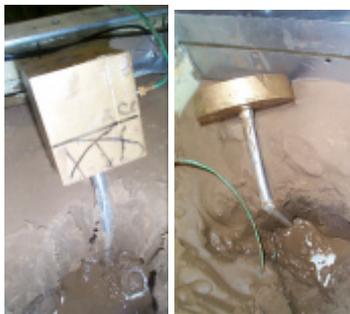
Figure 8: Some failed piles in the centrifuge tests. The tests were carried out in level grounds to avoid lateral spreading.

As can be seen from Table 2, axial loads applied to the piles ranged from 22% to 148% of Euler's elastic critical load (P_{cr}) treating piles as long columns neglecting any support from the soil. It immediately becomes obvious from the table that the piles having P/P_{cr} ratio greater than 0.75 failed (see Figure 8). The loads in the piles marked 7 8 and 10 were purely axial. The pile heads were restrained in the direction of shaking (no inertia effects) and the piles buckled transversely to the direction of shaking. It must also be remembered that the piles were carrying the same load (load at which it failed) at 50-g and were stable before the earthquake. The stress in the pile section is well within the elastic range of the material (less than 30% of the yield strength) but it failed as the earthquake was fired. This confirms that the support offered by the soil was eliminated by earthquake liquefaction and that the pile started to buckle in the direction of least elastic bending stiffness.

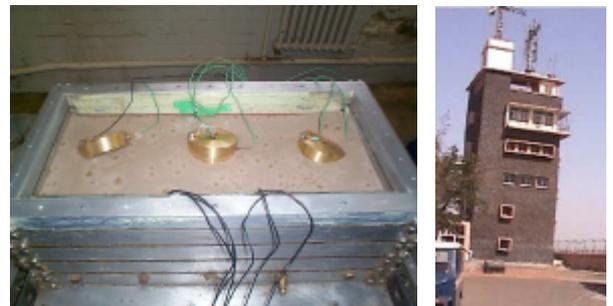
Figure 9: Replication of the failure; (a): Failed piles in the centrifuge test carried out in level ground; (b): Collapsed piled Kandla Tower after 2001 Bhuj earthquake in laterally spreading soil, after Madabhushi et al (2001).

Figure 9 shows the surface observations of the piles after test SB-02. It may be noted that the head of the piles rotated. This is quite similar to the visual observations of the collapsed piled building in laterally spreading soil after the 2001 Bhuj earthquake.
