Geotechnical and Strong Motion Aspects of Recent Indian Earthquakes

Jai Krishna, Professor Emeritus
University of Roorkee, India

SYNOPSIS: India had many strong earthquakes in the past. The paper describes some strong motion and geotechnical aspects of Indian earthquakes.

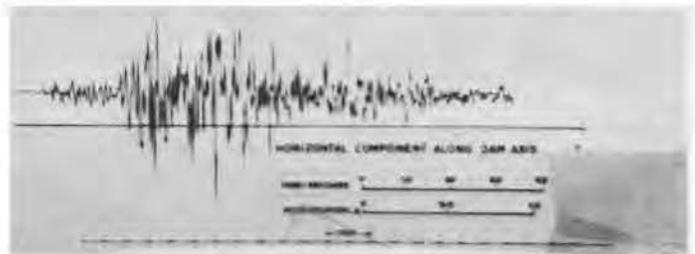
First of all, let us examine what the strong motion has been like during Indian earthquakes. Since there were no strong motion instruments installed in India before 1963, the strongest ground motion that was actually recorded here was the accelerogram for Koyna Earthquake of December 11, 1967 (Magnitude 6.7), which recorded a peak acceleration of 0.63g (Fig.2).

Figure 2. Accelerogram Recorded at Block 1-A of Koyna Dam on December 11, 1967 at 04-21 IST

Bihar and Assam earthquakes are two of the biggest shocks in History but even San Fernando shock, moderate by usual standards, recorded an acceleration bigger than 'g'. It will thus be seen that it is not the size of an earthquake that determines the peak value. A very large value can be recorded in a moderate size of an earthquake since acceleration is the rate of change of velocity of motion and if the change is large over a short period of time (fraction of a second), its value can be quite large. For Koyna, the peak of 0.63g lasted only about 1/15th of a second and in Pacoima record 1/10th of a second. The contribution of this one peak of the Koyna earthquake to the stresses in Koyna Dam has been calculated to be negligible in the total stress at that instant. That shows Koyna Dam would have cracked even if this particular peak was half its recorded size.

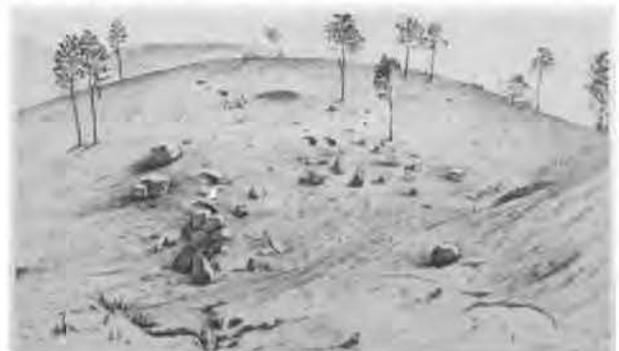
This was the highest acceleration recorded upto that time anywhere. Indications were, however, given by Oldham (1) when describing Assam Earthquake of June 12, 1897 (Magnitude 8.6) that stone boulders deposited on the hill slopes were thrown up in the air which means that the acceleration was more than 'g' (Fig.3).

Figure 3. Displaced Boulders Near Kanchi Khasi Hills

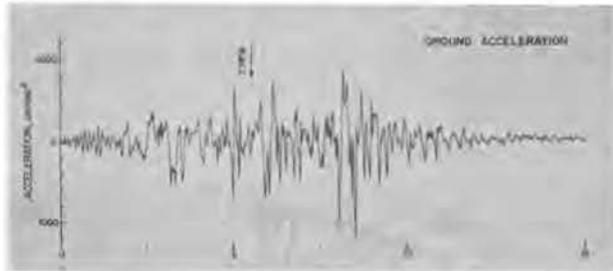
This story was not always believed till the accelerogram on the Pacoima Dam during San Fernando earthquake of February 9, 1971 (Magnitude 6.6) (2) showed a peak greater than 'g' (Fig.4). Some evidence is available that during Bihar earthquake of January 15, 1934 (3) (Magnitude 8.4) some houses in the epicentral region were observed to have been lifted upwards by thuds under the ground surface and then dropped suddenly and collapsed. Obviously ground acceleration has exceeded 'g' at times.

Figure 4. Pacoima Dam, California - San Fernando Earthquake of February 9, 1971

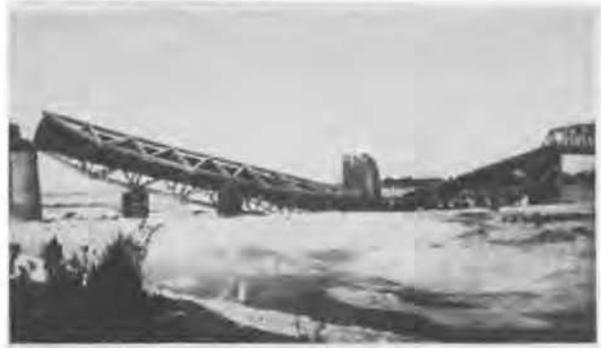
These significant observations have led to correlate damage to a structure more to velocity and consequently to total energy transmitted over a period of time than to peak acceleration. There are, however, certain instances where an instantaneous pulse can twist or overturn as shown by the overturning of the girders shown in Fig. 5 during Bihar earthquake of January 15, 1934 (Magnitude 8.4). Although no one has observed the mechanism of actual overturning of these 350 ft. span girders yet it is quite likely that duration of the impulse which led to the overturning was not the determining factor but it was its magnitude. Alternatively, it may be the successive build up of amplitudes of vibration, which may have caused it, but since the girders did not have much energy absorbing capacity in that direction, the overturning must be more or less an instantaneous action.

Figure 5. Overturning of Girders of a Railway Bridge During Bihar Earthquake of January 15, 1934.

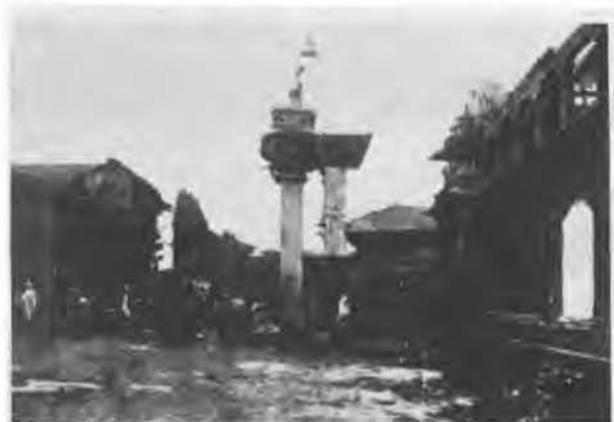
In the midst of vast destruction caused by the Bihar 1934 earthquake, there were interesting structures that were not damaged whereas everything around them collapsed. Stone columns carrying idols (Fig. 6) stood unaffected since their foundation was deep, joints were tight-fitting sockets and generally the workmanship was good. There were many other structures of this kind which escaped damage. Experience has shown that good workmanship, good quality of materials and good anchorage of foundations lead to considerable safety much beyond what normal analysis would predict. Obviously it has a good deal to do with the special features of an earthquake ground motion, which changes in direction, magnitude and duration several times a second besides the shortcomings of analysis to estimate the actual strength of materials at the time of an earthquake and the inherent capacity of a structure to share the distress with the less stressed of its portions before final collapse.

Figure 6. Stone Columns Carrying Idols Unaffected During Bihar Earthquake of January 15, 1934.
