The Leaning Tower of Pisa Revisited

J. B. Burland

THE LEANING TOWER OF PISA REVISITED

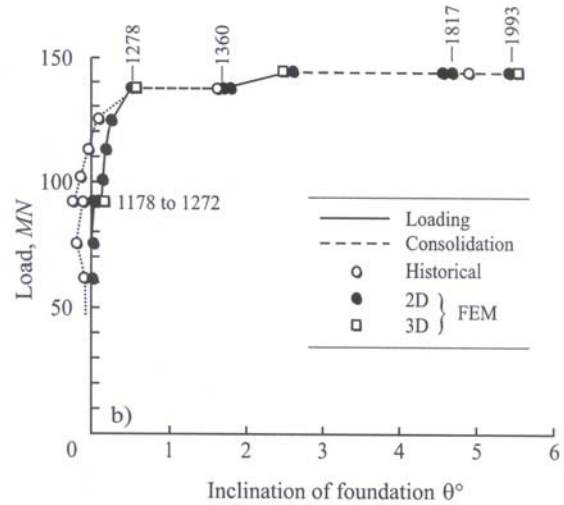
In Fig. 7 the results of the analysis are plotted on a graph of load against inclination and compared with the deduced

history from Fig. 4. It is important to appreciate that the only point that has been pre-determined on this plot is the final inclination of about 5.5° . The agreement between the simulated and historical behaviour is remarkable and gives considerable confidence in the reliability of the computer model. A striking difference is that the model does not predict the initial northerly inclination of the tower. This is not felt to be of importance for the intended application of the model. It was found that, during the early stages of loading, the model did show a small inclination to the north. This was due to the fact that consolidation of the thin northern end of the tapered layer of compressible soil took place more rapidly than the thicker southern end. It should be possible to devise a soil profile in Horizon A that more accurately simulates the early history of inclination of the tower but this was outside the scope of the project.

Fig. 7. Comparison between deduced and computed history of inclination of the Tower
