# The Leaning Tower of Pisa Revisited

J. B. Burland

## THE LEANING TOWER OF PISA REVISITED

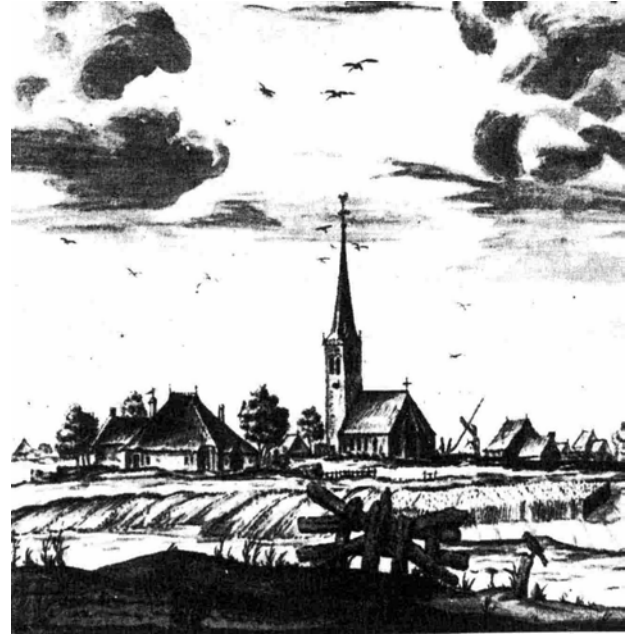
Fig. 12. View of the church at Nijland (Drawing in Indian ink, circa 1750)

Barends (2002) gives a full contemporary account of the stabilisation of a leaning church tower at Nijland by means of soil extraction. Fig. 12 shows a drawing of the 52m high church spire which in 1866 was out-of-plumb by nearly 1.6m and increasing at a rate of about 20mm per year. The foundations rest on stiff clay. After detaching the tower from the adjacent church, the lean was corrected by digging down inside and outside the foundations and then drilling horizontal holes in the underlying clay from the inside outwards. The drill holes were about 25mm in diameter and were subsequently repeatedly reamed out to about 36mm in diameter. The holes were concentrated in the regions where the most settlement was required. The following is a quotation by the superintendent architect:
