International Conference on Case Histories in Geotechnical Engineering (2008) - Sixth International Conference on Case Histories in Geotechnical Engineering

## A Case Study of Characteristics of Damages Caused by Typhoon EWINIAR 2006 in South Korea

## **A CASE STUDY OF CHARACTERISTICS OF DAMAGES CAUSED BY TYPHOON EWINIAR 2006 IN SOUTH KOREA**

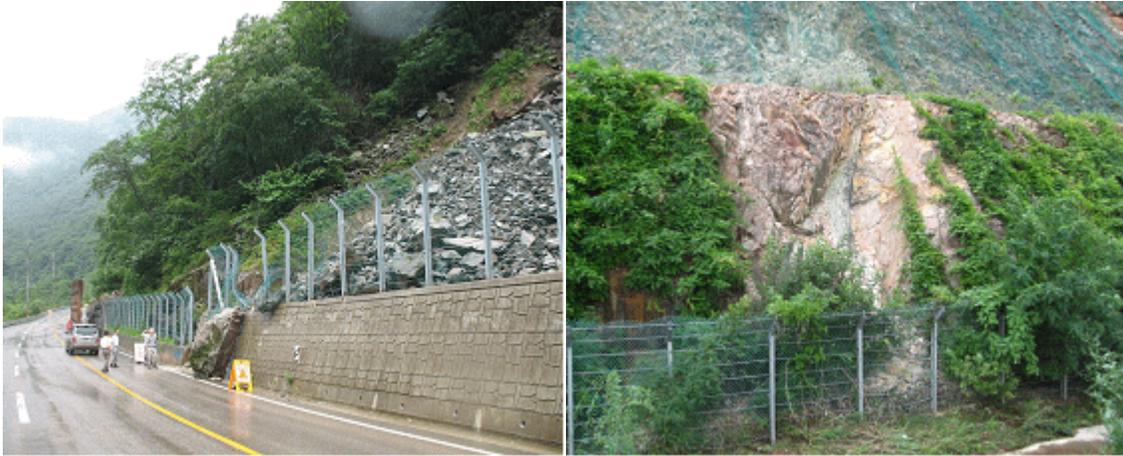
**Fig 4. The Damage Example due to Stone falling**

In the damaged area, rocks partially fell down from the cut slope due to weathering of the face of the rock or the

penetration of water into the joint face. However, there was no serious damage to the roads primarily because the slopes were equipped with facilities to block the falling rocks. Figure 4 shows the pictures of stone falling and the blocks to prevent damage or blockage of the roads.

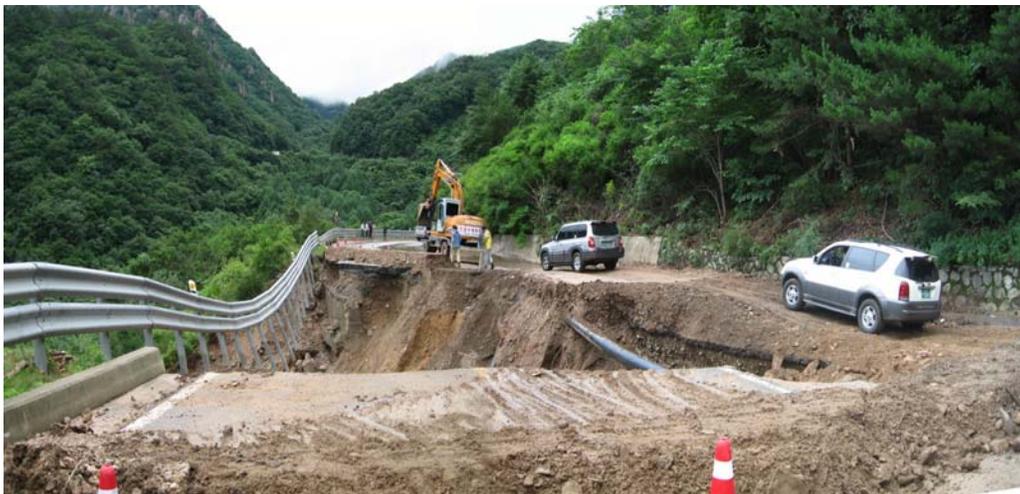
**Fig 9. The damage example by banking section**

At places where fill slopes were constructed on bedrock, the water from valleys and roads penetrated the fill layer and flew

on the face of the rock and washed off soil which resulted in the collapse due to the loss of the soil from the fill layer. Reinforcing stone walls and retaining walls constructed on these fill slopes collapsed due to the loss of the soil layer. Figure 9 shows the picture of failure of fill slope.

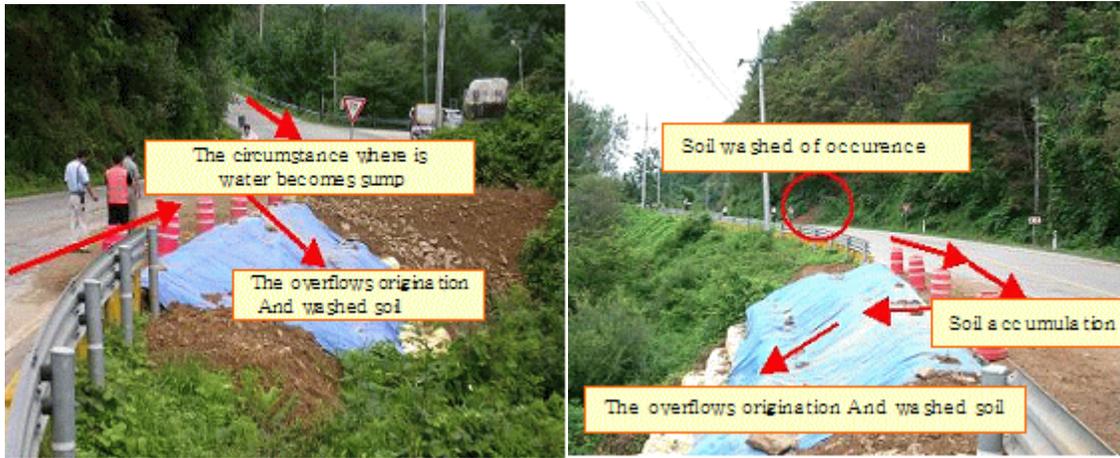
**Fig 10. The damage example due to washing of fill material**

Another type of damage that occurred on the fill slopes was due to washing out of the fill after the fallen soil from the

adjacent cut slope blocked the flow of the water. Figure 10 shows the pictures of fill slope failures due to washing of fill materials.

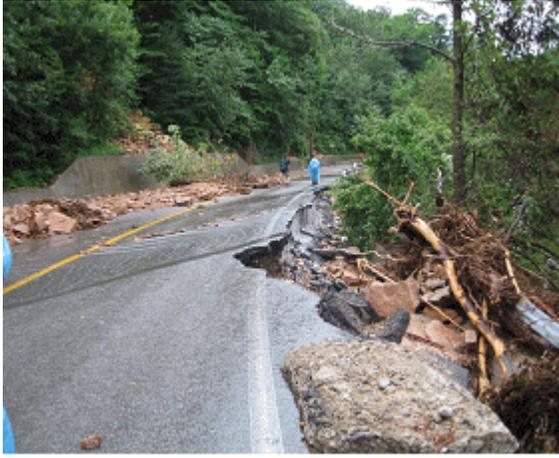
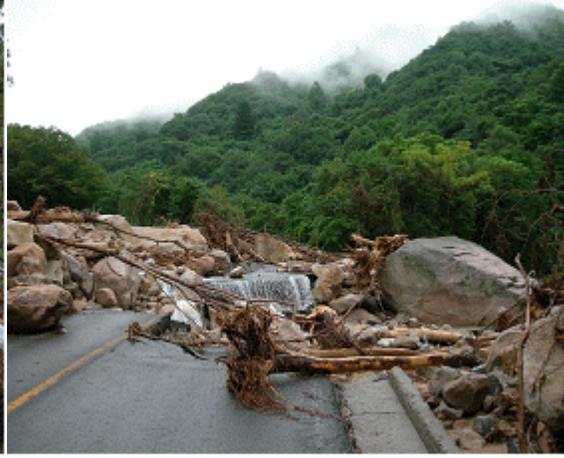
part paralyzed the function of the crosswise drain pipe at the lower part of the road, and the concentrated rainfall overflow and eroded the filling part of the road. Figures 15 and 16 show the schematics of damages to roads due to falling of rocks and soil. Figures 17 and 18 show pictures of road failures due to falling of boulders.

**Fig 17. Loss of road by the boulder flow**

**Fig 18. Loss of road example**

- (1) Most of the collapses of the slopes were minor washout of soil. So there were no serious casualties, but the massive loss of rocks and soil that occurred in the valley parts caused the washout of many roads.
- (2) To prevent the repetition of similar damages, it is recommended to develop and improve the breeds of plants that fit the characteristics of domestic atmosphere and apply them to the actual sites.
- (3) It is recommended to set up structures like control dam that can decrease the movement energy of rocks and soil in the places where valleys are formed.
