# Investigation on the Liquefaction of a Clayey-Sandy Soil During Changureh Earthquake

## INVESTIGATION ON THE LIQUEFACTION OF A CLAYEY-SANDY SOIL DURING CHANGUREH EARTHQUAKE

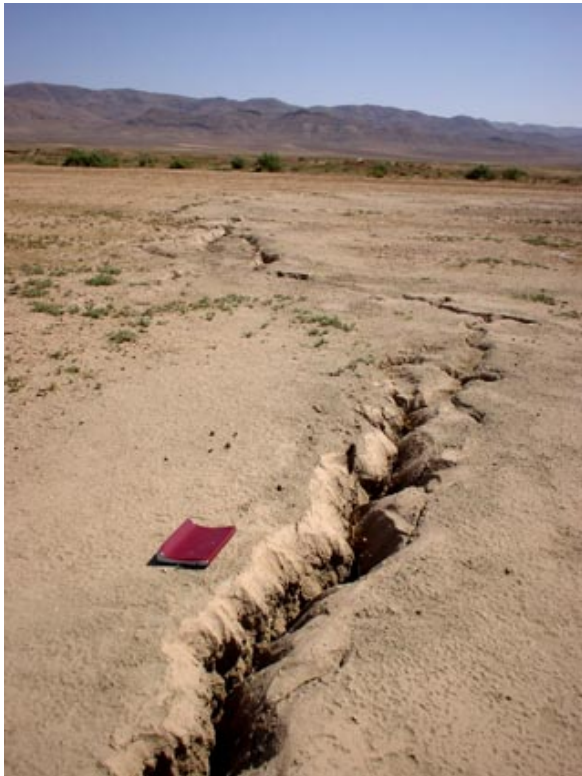
Hesar, about 5km north of Abdarreh, lies in the middle of a valley of about 15km wide extending in NW-SE direction. Liquefaction took place in a flat area of a little grassy land about 2 km northwest of Hesar (Fig.2a). Figure 2b shows the traces of liquefied sand. The bunch of cracks appearing across the area seems to be winding along a small river trace, which is dried up in hot weather. Soils along the crack at Point A are

Figure 2. (a) Liquefied area at point A , (b) Crack mat at the liquefied area, Hesar

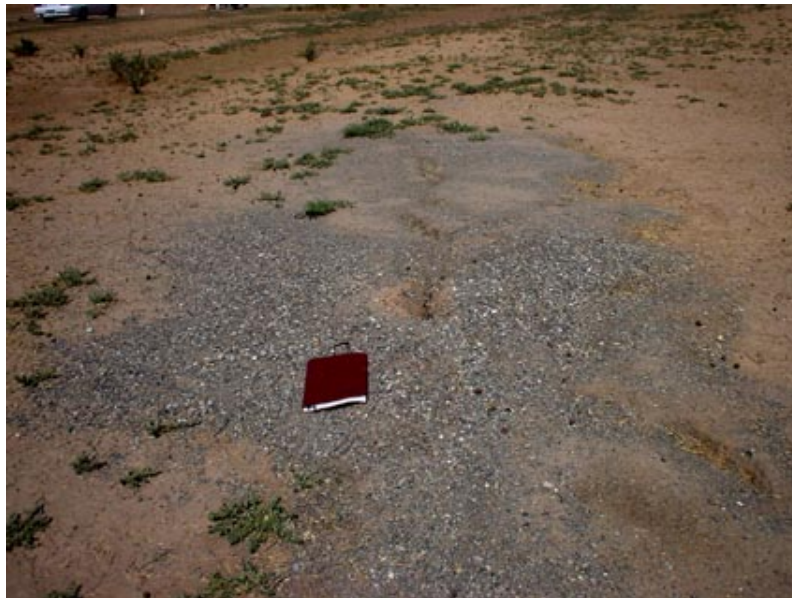
covered 5-10 cm thick with fine sand (about 0.5 mm in diameter, Fig.2a), while gravels were found at Point B (Fig.3). The flat mass of gravel stopped there was cut upright (Fig. 4) to discuss its possible sedimentation process. The bottom part was full of middle size grains of about 3-5 mm diameter, which was then covered thick with finer sand. And lastly, a number of bigger grains (5-15 mm) were found all over the sand mass. This fact suggests that the liquefied matter was forcibly spouted twice (Konagai and Ghalandarzadeh, 2003)

Figure 3. Liquefied gravel at point B

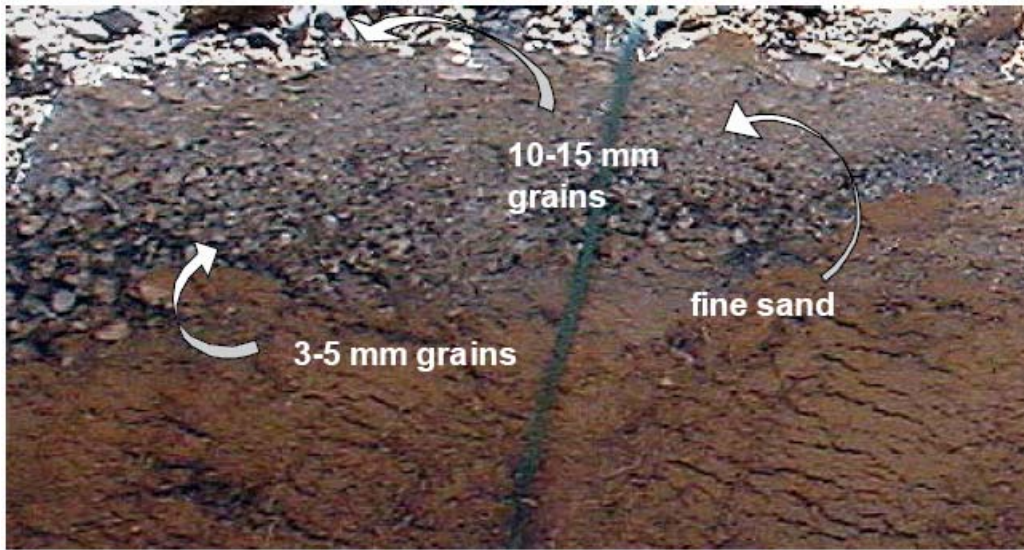
Figure 4. Cross section of flat mass of liquefied matters at point B

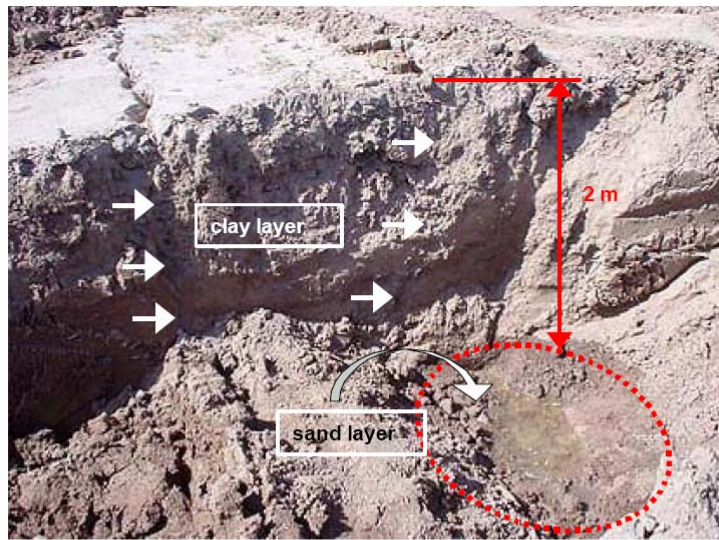
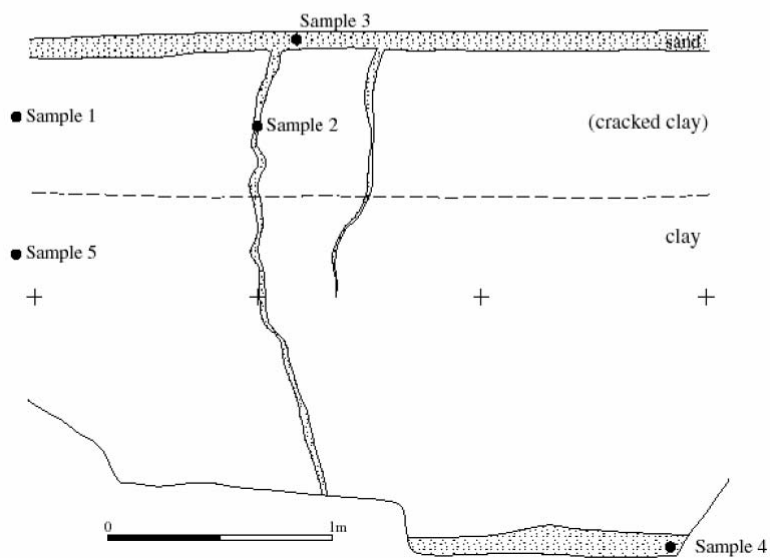
A trench was excavated at Point C, where the surface soil was covered thick with fine sand (0.5 mm in diameter). Several cracks were found almost upright on a stiff clay wall of the trench through which liquefied sands forced their ways up

(Fig.5). There were several cracks appearing upright on the clay wall of the trench, through which liquefied sands forced their ways up. The clay layer was 2m thick lying over the completely wet sand layer.

Figure 5. Liquefied sand channels through clay layer at point C

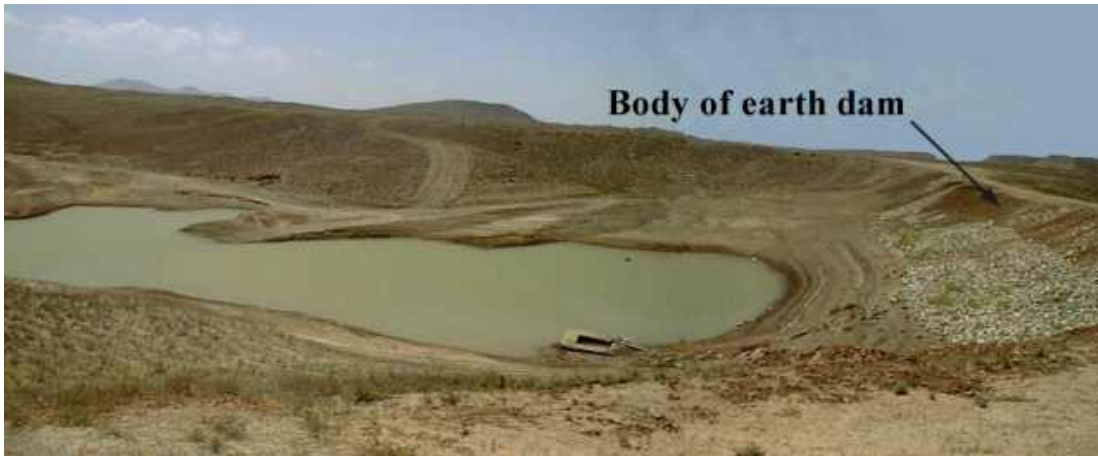
A small size earth dam, located at northwest of Abdarreh village experienced the strong ground motion caused by Changureh earthquake (Fig. 6). The height of dam is approximately 10 meter. The body of this dam consists of clayey soil with no core section constructed inside. The upstream side is covered by rock fill material. Approximate cross section and layout of the dam is shown in Figure 7.

As can be seen in figure 6 the dam reservoir was not full at the time of earthquake. Therefore, the body of dam was not

saturated. In contrast, the ground at upstream and downstream sides seems to be wet and probably saturated due to the certain level of water in the reservoir. This condition can well explain the damage pattern of the mentioned dam and adjacent ground. The instabilities appeared in the form of some longitudinal cracks indicating failures of upstream and downstream slopes of the dam. Some minor cracks which cross the body at both end of the dam were also appeared. Figure 7 shows the distribution of these cracks. Figures 7 to 13 show the cracks at both sides of dam and at its two ends.

Figure 6. General view of the small earth dam located northwest of Abdarreh village

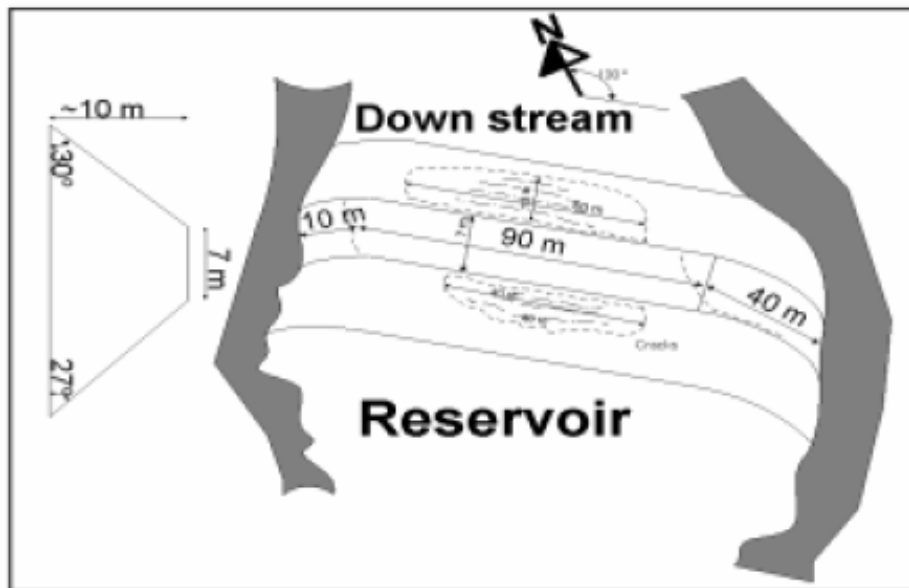
Figure 7. Layout of the earth dam and the crack distribution on its body

By measuring and summation of the width of all longitudinal cracks the total permanent displacement of both upstream and downstream slopes were estimated to be 56 cm and 87 cm, respectively. These values represent the deformation of the displaced ground, whereas the horizontal permanent displacements were 10 cm and 30 cm for upstream and downstream slopes as shown in figure 8. The size of dislocated zone at downstream side is almost 60 m in length and 10 m in width

(Fig.7). To estimate the maximum acceleration at the position of the dam a simple analysis based on Seed-Makdisi method is conducted. By measurement of internal friction angle of almost  $30^\circ$  and cohesion of  $\sim 25$  KPa, using remolded soil samples obtained from the body of dam and selecting an average shear wave velocity of 400 m/sec, the maximum acceleration is approximated to be 0.16g at the ground level and 0.58g at the crest of dam which looks to be reasonable.

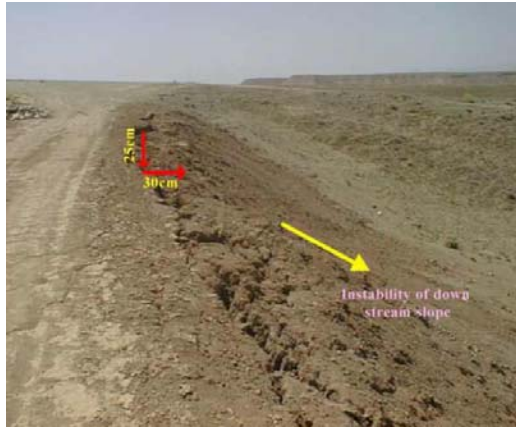
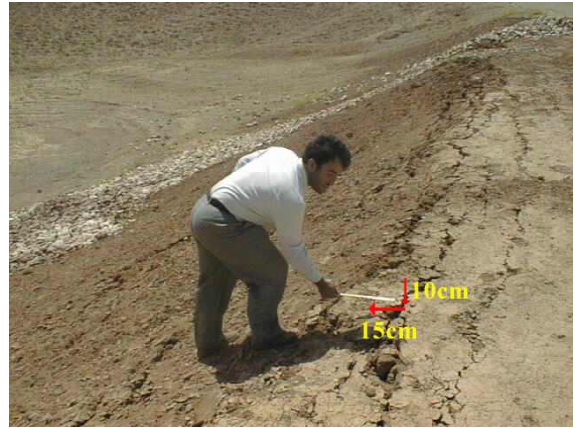
Figure 8. Instabilities at (a) upstream slope (b)down stream slope

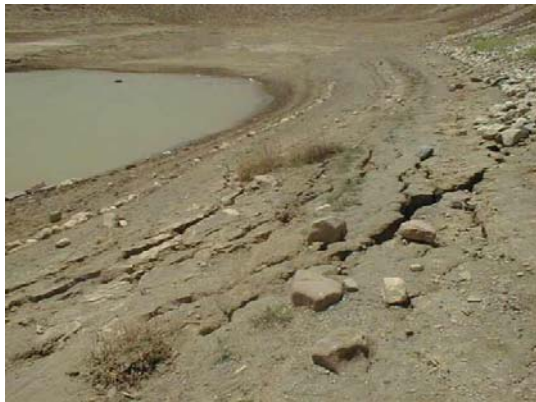
Figure 9. Instabilities at upstream slope from a closer view

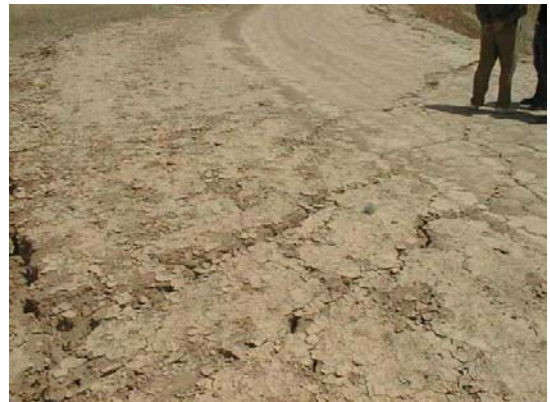
Figure 10. Cracks crossing the body of dam at its left abutment

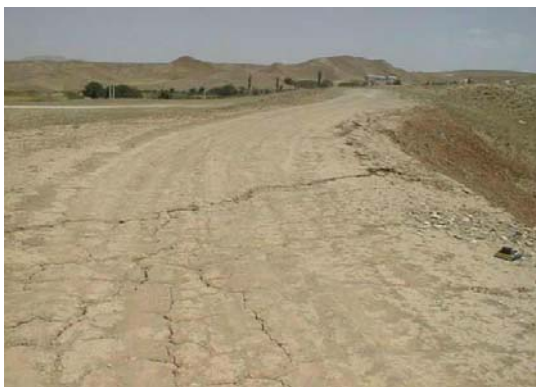
Figure 11. Cracks crossing the body of dam at its left abutment

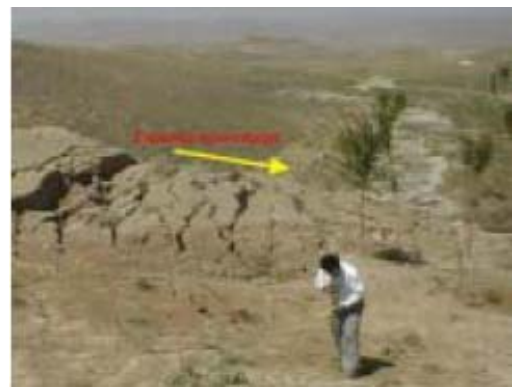
Two other types of failures are observed at two different points in the riverbank of both upstream and downstream sides. The large deformation caused by earthquake at the left bank of river in the downstream part is shown in Figure 12. A kind of slumping is occurred probably due to softening of the soil caused by reduction of effective stress. The evidence for

Figure 12. Slumping of the left bank of river at upstream side

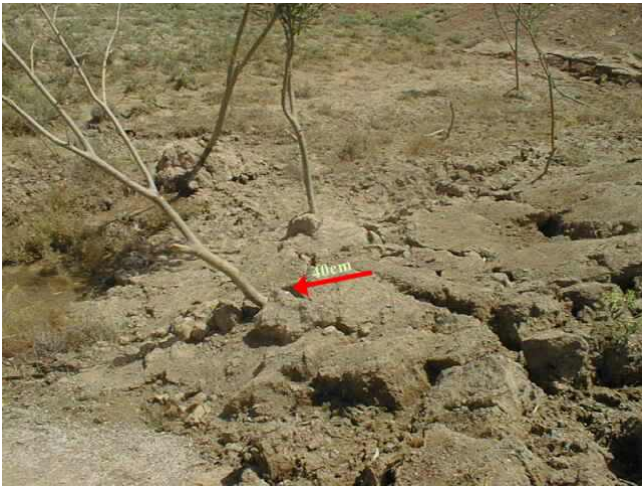
lateral movement is the clear displacement of trees, which were located at the feet of the bank as is shown in Figure 13. Figure 14 illustrates another failure, somehow similar to that explained above, at the left river bank in upstream side. As it can be seen in that the soil was wet and probably saturated. The cause for the lateral deformation could be the softening of soil due to reduction of effective stress.

Figure 13. Movement of trees indicate lateral displacement of trees

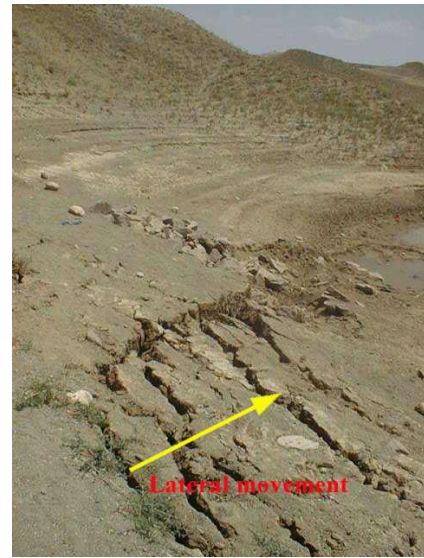
Figure 14. Lateral movement of left bank at upstream

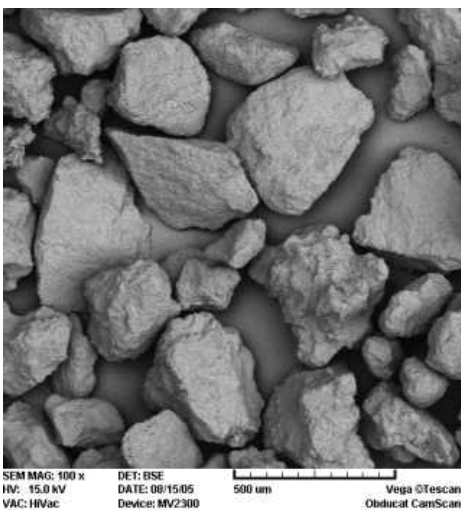
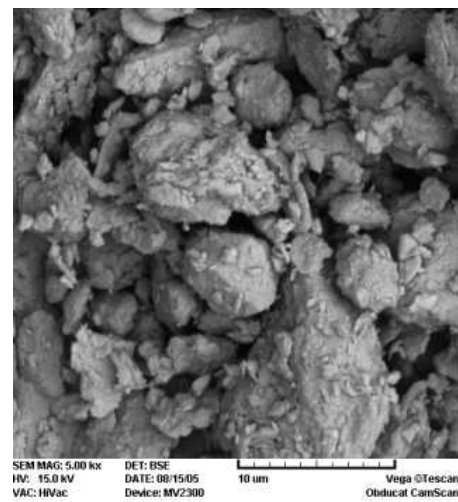
Figure 15. SEM image of (a) clean sand (b) fines of Changureh soil

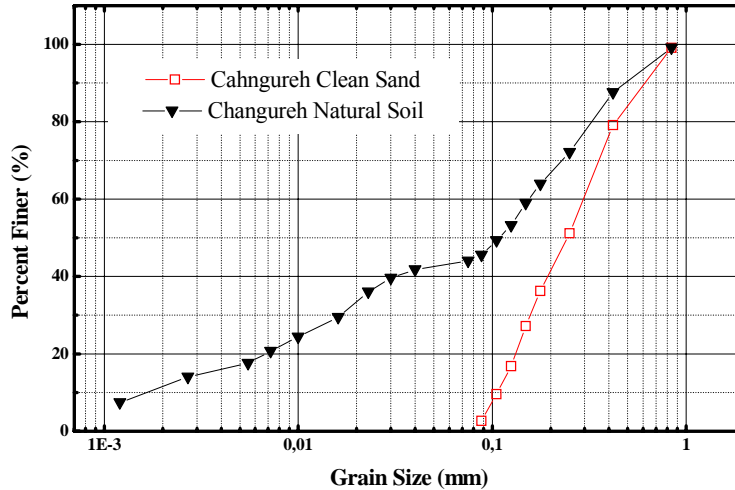
Laboratory tests on samples from the liquefied clayey sand included gradation, index test and undrained cyclic triaxial tests in compression-extension mode. An amount of soil (sample 4 in figure 5) was sent to the laboratory for further investigations. The preliminary tests showed that the soil has a fine content ( $<0.075$  mm) fraction of 44% mixed with subangular sand grains. Index tests revealed that the fines have a liquid limit of 38 and a plasticity index of 18. Figures 15a and 15b show the SEM image of clean sand and fines, respectively. Figure 16 presents the grain size distribution curve of clean sand and natural soil.

Figure 16. Grain size distribution of clean sand and natural soil of Changureh

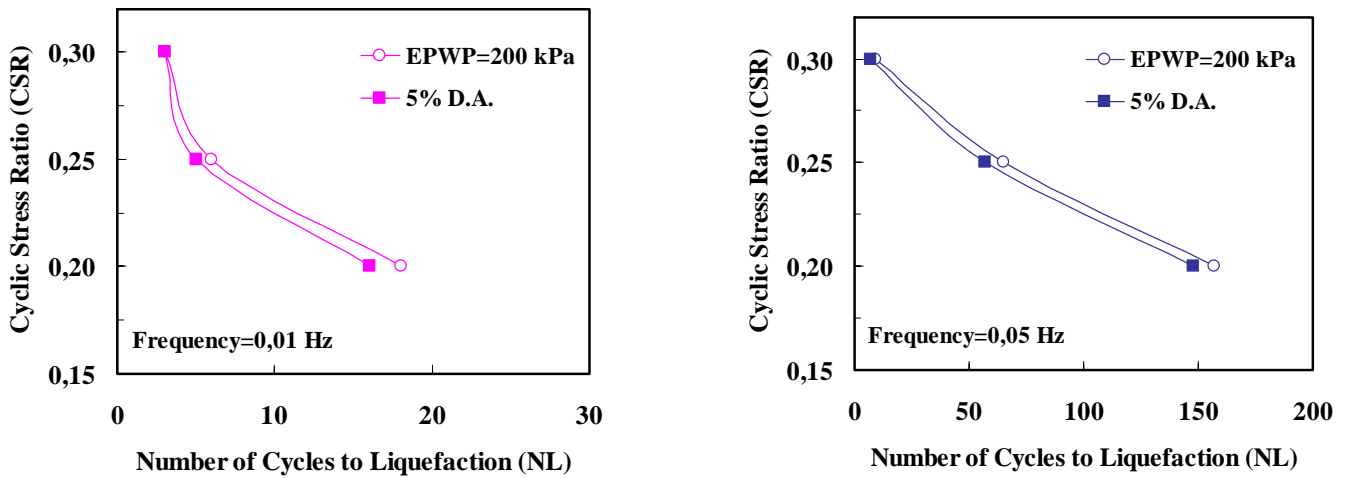
The cyclic stress ratio versus the number of cycles to initial liquefaction ( $u=\sigma_3$ ) and 5% double amplitude axial strain for

both frequencies is plotted in Figure 17. The cyclic stress ratio was defined as  $CSR = \Delta\sigma_d / 2\sigma_{3c}'$ , where  $\Delta\sigma_d$  is the deviatoric load and  $\sigma_{3c}'$  is the isotropic consolidation stress. It is clearly seen that the failure defined by 5% axial strain occurs at relatively smaller cycles than those required to develop a state of initial liquefaction ( $EPWP=200\text{kPa}$ ) for both frequencies. Therefore, it seems that criterion of 5% double-amplitude axial strain is more convenient than initial liquefaction to define liquefaction of soils with high fine contents in cyclic triaxial tests, as reliable pore pressure measurements are difficult in cyclic testing with relatively low permeabilities as stated by El Horsi et al. (1984) and Das et al (1999). Figure 18 presents the SEM image of the specimen. It is clearly seen that most of the sand grains have been fully confined by fine particles; hence, the specimen can be taken as a fine dominated one. It can be concluded that in the fine dominated soils, it is better not to rely on pore pressure measurements, because: 1) The conventional cyclic triaxial test apparatuses measure the water pressure at the top and bottom of the specimen; whereas, it is known that the water pressure cannot equilibrate throughout the sample and measurement system. 2) The specimen becomes more ductile when fine particles have separated sand grains. Therefore, cyclic failure in the form of cyclic deformation can be more likely to occur. The same behavior was observed for sand with high kaolin content (Ghahremani, 2005)

Figure 17. Comparison between number of cycles to initial liquefaction and number of cycles to 5% D.A. for (a) frequency of 0.01 Hz (b) frequency of 0.05 Hz

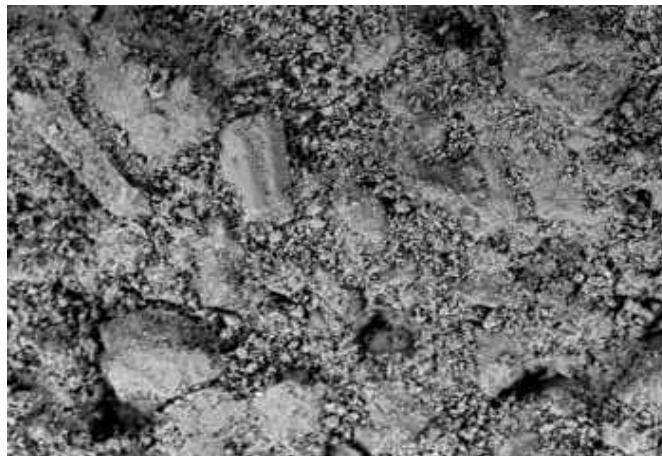
Figure 18. SEM image of natural soil of Changureh

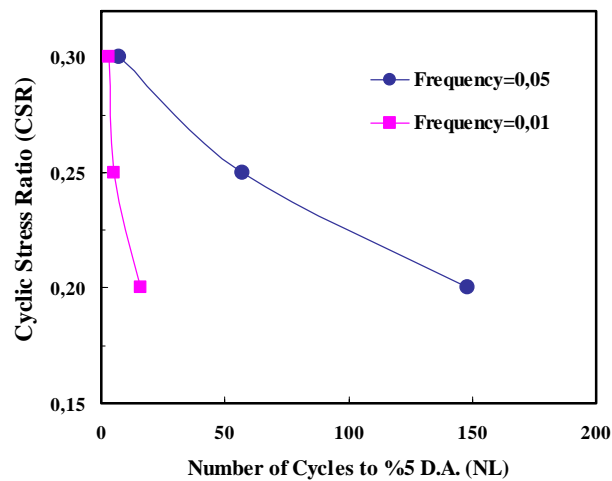
The effect of frequency of loading on the cyclic resistance of mixture is shown in figure 19. It is demonstrated that by decreasing the frequency of loading, resulted cyclic strength is also decreased. This is in line with findings of Zergoun and Zaid (1994) who demonstrated that pore pressure

measurements on clay samples can only reliably be obtained in slow cyclic tests and found that slow cyclic test resulted in lower cyclic strengths that fast ones.

Figure 19. Effect of frequency of loading on cyclic resistance of mixture
