## 6th International Conference on Case Histories in Geotechnical Engineering, Arlington, VA, August 11-16, 2008

### GOOGLE EARTH MAPPING OF DAMAGE FROM THE NIIGATA-KEN-CHUETSU M6.6 EARTHQUAKE OF 16 JULY 2007

#### ABSTRACT

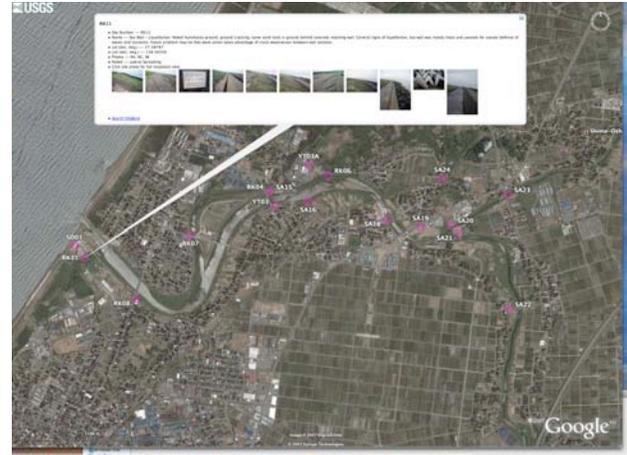
Figure 4. Example of balloon text and imagery box in the Google Earth map. Note spatial relation of liquefaction-related lateral spread sites to their proximity to the Sabaishi River.

In Figure 4, the information balloon can be seen pointing to a site that experienced multiple-landslide damage. The balloon lists the site identifier, a paragraph detailing the observed damage, the geographic coordinates of the site, and a suite of small 100-200 pixel thumbnail images. Each thumbnail is linked to its corresponding full resolution image.

The program is also useful as a research tool for identifying spatial patterns of damage, and directional aspects of structural failures. In the first instance, some of the damage patterns are related to specific vulnerable geologic units. Clicking on 'Lateral Spreads' or 'Liquefaction', two cases of earthquake-induced ground failure that effect young loose deposits of sandy material, brings up spatially clustered damage sites. Lateral spreading is a type of landslide that occurs in liquefied ground: liquefaction is the rapid rise of pore fluid pressure between soil grains and the corresponding loss of strength that can happen in soil during an

earthquake (Figure 4). The majority of these locations appear to be situated on the banks of two main rivers that cross the city of Kashiwazaki. Further, it can be seen the damage appears to be more spatially extensive and severe along the river-bank closer to the epicenter of the earthquake, and occurs primarily near the river mouth at the Sea of Japan. In these areas the riverbank deposits are sandy and the proximity to the fault rupture elevates the loading cycles of strong motion to a critical level that would trigger these damage types. On the other hand, upriver areas appear to be less susceptible to this damage, even in cases when the river is closer to the epicenter. These areas are composed primarily of clay and silt, and as can be seen in the mapped data, are intrinsically far less susceptible to liquefaction and lateral spreading than are sand deposits.

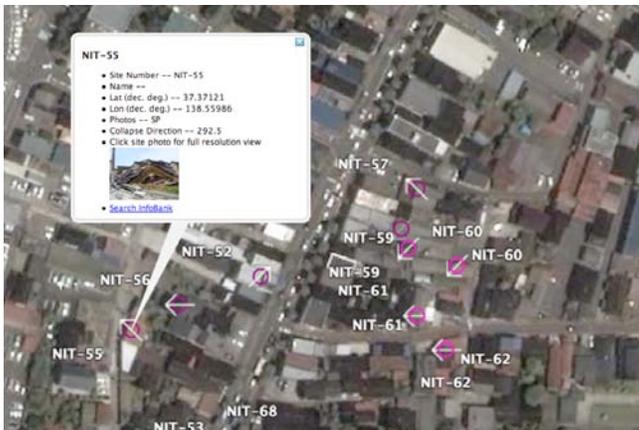
Figure 6. Detail of house collapse at site NIT-55 with collapse vectors indicating direction of fall.

House tilt and collapse data were given special treatment in the Google Earth presentation. Nagoya Institute of Technology cataloged several hundred structures that suffered racking (tilt) or collapse. Along with the details of the failures, the team recorded the compass direction (azimuth) of the failure. We used the direction data to specify the icon used in the map, and thereby plotted arrows of failure in the direction of collapse. As an example, if the reader clicked on the site NIT-55, in the ‘NIT-Niigata Survey’ folder in ‘Places’ a vector pointing west-northwest is shown on the map. This structure, an old style residence collapsed towards the azimuth 292 degrees, probably under the load of strong eastward acceleration pulse. Similar directions of collapse can be seen throughout the neighborhood in Figure 6.

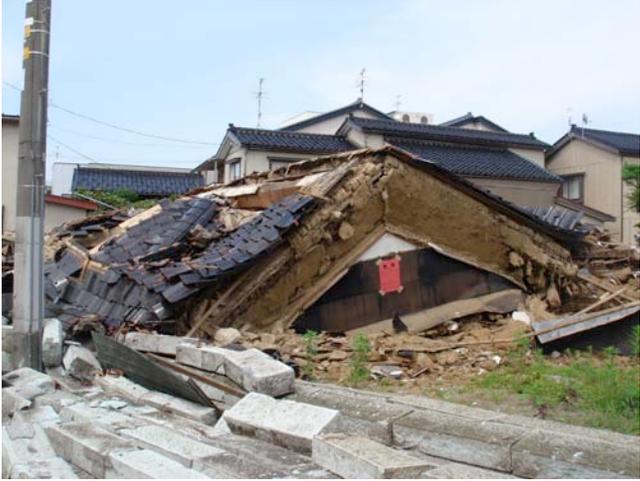
Figure 7. Photograph of house collapse at site NIT-55 that is linked to the thumbnail image in the balloon in Figure 6

An image of the home can be viewed clicking the thumbnail (Figure 7). Google earth is used here to correlate directional patterns of damage with the strong motion data recorded at several sites in the city. This is important if many of the collapses can be associated with one or several specific pulses of motion that
