Investigation on the Causes of Longitudinal Cracks on Prestressed Monoblock Railway Sleepers of Metric Gauge of the Greek Railway Network

National Technical University of Athens, Greece

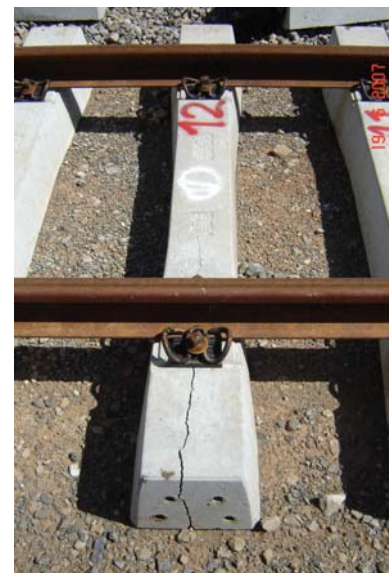
Fig. 4

In Fig. 4, 5, 6 and 7 some cracked sleepers are shown, as found by the supervision team during the rehabilitation works, provisorily fastened, before performing the welding of the rails, according to the CWR procedure. Almost, all cracks went through the whole height of the sleeper. As it can be seen, cracks started from one of the rail seats and have been developed towards the end of the sleeper having in the same time the tendency of developing also in the area of the sleeper between the two railseats. In Fig. 8 one damaged sleeper is shown which was intentionally forced to develop full longitudinal cracks and in Fig. 9 two other sleepers are shown which were separated in two longitudinal parts each, in order to observe the situation of the profile between the sleeper screws and the surrounding concrete.

According to all the above, the Authors believe that the sleepers cracked longitudinally due to the high level of the tightening torque ($\gg 200$ Nm) that was applied to the sleeper screws. It seems that values of the tightening torque higher than about 450 Nm (depending also on the age of the concrete) may provoke sliding of the screws which together with the existing prestress stresses lead to the cracking of the sleepers.

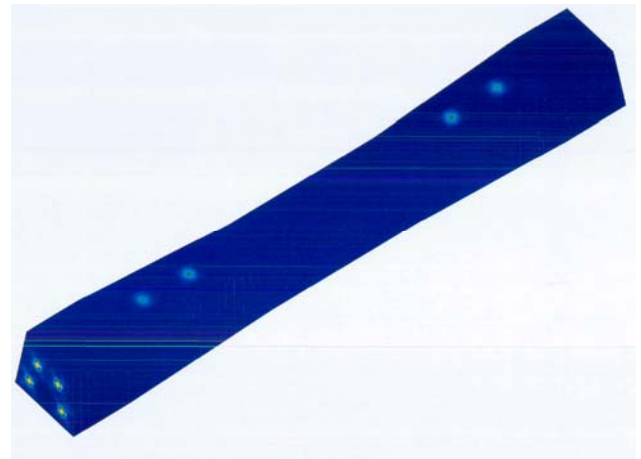
Fig. 15.

A finite element approach has been also performed to get an idea about the multiaxial stress conditions in the concrete area around the sleeper screws, due to the simultaneous action of the prestress force and the screw actions.

- the sleeper has been modelled using volume finite elements representing concrete grade C50/60
- the longitudinal prestress was modelled through truss elements able to recognize the prestress force
- the sleeper screws were also modelled using truss elements with force according to the level of the tightening torque. The forces corresponding to each level of tightening torque were estimated by suitable tests.

In Fig. 15 a representative picture of the stresses around the screw is presented indicatively.
