## **BENEFITS OF CASE BASED INSTRUCTION IN UNDERGRADUATE GEOTECHNICAL EDUCATION**

**D. T. P. Phillips**

University of Limerick,  
Limerick, Ireland.

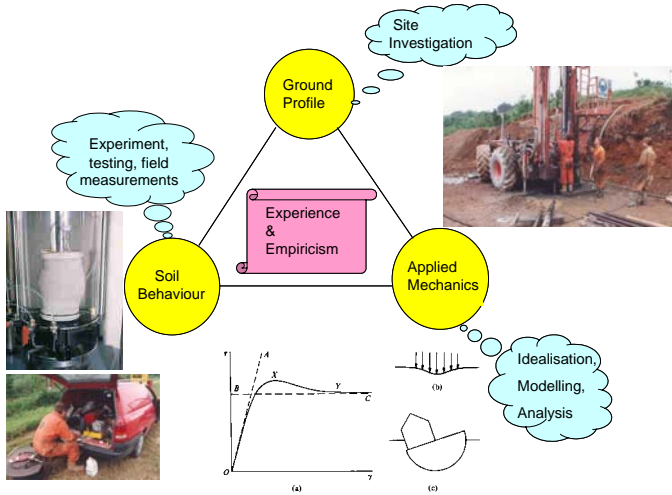
Fig. 1. Modified from Burland's soil mechanics triangle (Burland, 1989)

At the outset, the type and form that the presentation should take is outlined. A sample case history drawn from well-documented geotechnical failures from personal or secondary sources is then presented. The case is presented using Burland's Soil Mechanics Triangle (Fig. 1) as the reference

framework for the geotechnical design process and for demonstrating the interplay that exists between the core areas of the discipline. It also provides an opportunity to introduce the significant role played by empiricism and experience in the practice of geotechnical engineering.

In the second case history the links between ground profile, soil behaviour and applied mechanics as presented in Fig. 1 are emphasised through a bearing capacity failure. The importance of promptly highlighting engineering concerns in writing once they emerge during construction is key learning outcome in this case.

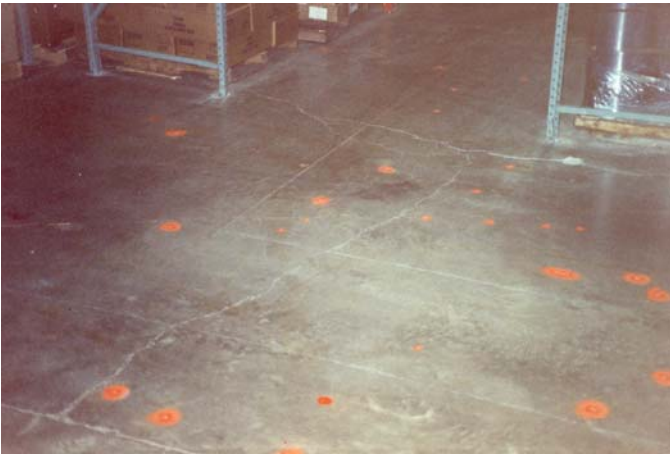
Fig. 4. Warehouse slab exhibiting transverse cracking and popouts (painted orange for identification purposes).

Within two years of completion the slab-on-grade exhibited a number of defects; these included, pop-outs, transverse cracking, extensive surface crazing and tilting in a number of slab bays. The owner complained about excessive wear in the forklift wheels and feared that the deep transverse cracking was getting progressively worse and would eventually lead to fracturing of the guidance wires, an untenable situation in a warehouse operating by computer controlled equipment.

Like most construction failures a myriad of factors were responsible for the rapid deterioration of the concrete slab, these included; poor finishing practices, presence of unsound aggregates, foreign matter in the concrete mix, absence of a subbase beneath the slab<sup>1</sup>, improper placement of reinforcing steel, late cutting of control joints and poor compaction of the subsoils (Fig. 4). While each of these is an interesting study in itself, the case history presented to the students is limited to the investigation and analysis of the poor compaction of the engineered fill and secondly, the implications of these results on the slab's performance.

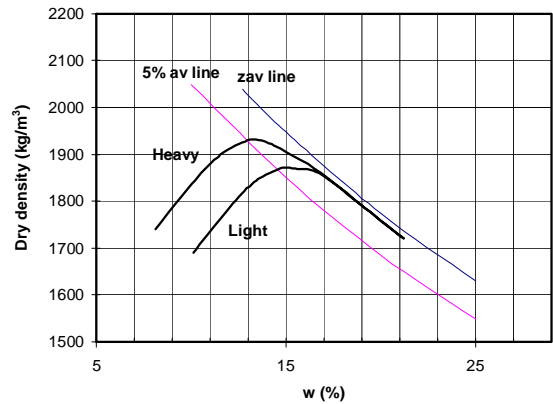
Fig. 6. Effect of compaction energy on moisture-density relationship

The influence of compaction energy is summarised in Fig. 6. The sensitivity of the moisture-density curve to changes in moisture content and the issue of overcompaction are also considered as part of the student’s investigative brief.

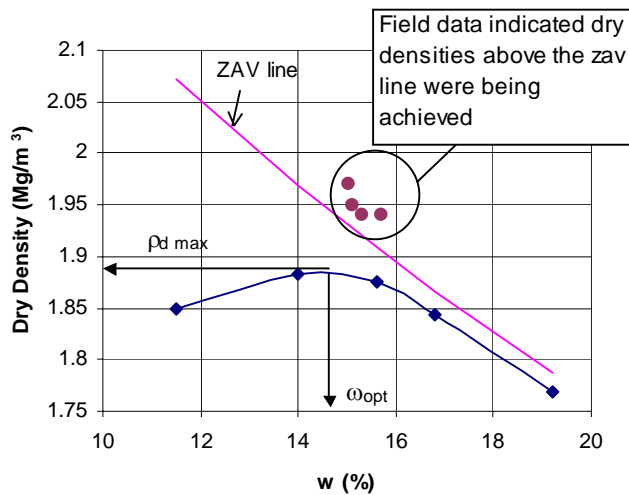
Fig. 7. Reported field densities plotted on moisture-dry density graph.

Once the data provided is analysed and the results plotted on the moisture-density relationship (Fig. 7), the students observe that the field dry densities reported by the technician all have moisture contents greater than the optimum moisture content and plot above the zav line (Fig. 7). Only two conclusions can be drawn from this result:

1. The material represented by the moisture–dry density relationship used to assess the field compaction has changed and the material being compacted needs to be submitted to the laboratory for testing, or the more sinister option
2. The technician was falsifying the results!

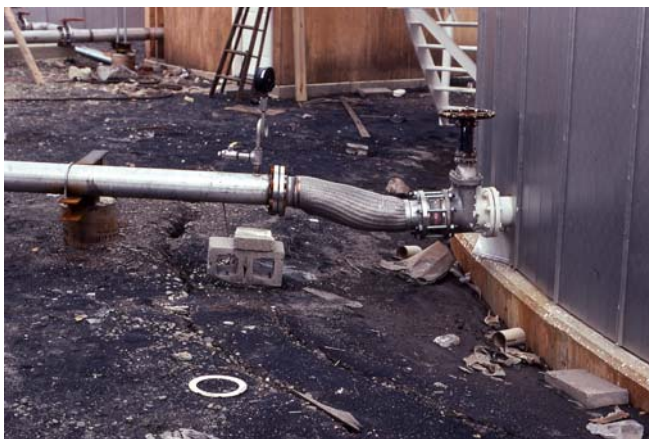
*Fig. 8. Flexible connection indicates movement and ground failure*

During integrity testing of the tanks, the owner noted that one of the tanks started to visibly tilt in a northerly direction as it was filled with water. There followed a panicked call to the geotechnical consultant who advised immediate unloading of the tanks and the execution of a level survey to establish the pattern and magnitude of the ground movement around the tanks. A maximum vertical settlement of 400mm (16 inches) was recorded in a sixteen-hour period – obviously indicating a bearing capacity failure in the underlying soils. Fig. 8 shows the failure in the ground and the downward movement of the flexible connection pipe that once stood at an elevation higher than the crown of the horizontal distribution pipe.

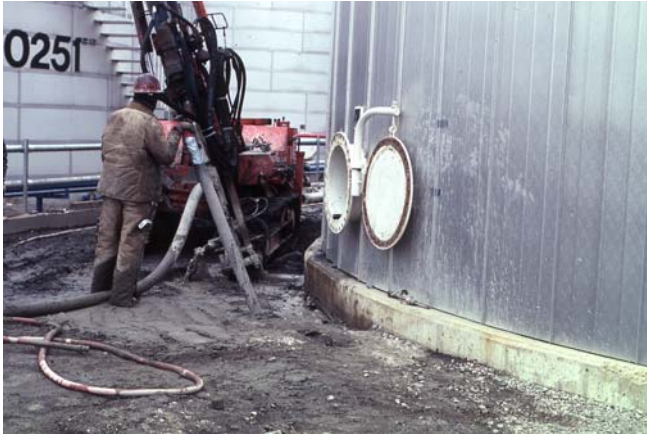
Fig. 11. Remedial grouting programme in progress

the flexible base during grouting. Strategically located vertical and inclined grout holes (Fig. 11) were initially used to inject grout at low pressure beneath the tanks to lift them into the vertical position. The underlying weak soils were then strengthened using deep holes grouted under high pressure as the probe was raised to the surface. The remedial work was a success and the tanks were re-commissioned at a cost approaching \$175,000. This case is further proof of the adage, you pay for a SI whether you have it or not!
