## A Case History of Deep Excavation in Doha

L. Tony Chen

*Hyder Consulting Limited, Hong Kong, China*

The Doha high-rise tower consists of a 4 level basement which required an excavation depth of 16m along the site perimeter. Minimization of impact of excavation-induced ground movements on the adjacent structures and underground utilities was one of the major considerations in the design and construction of the excavation and its temporary retaining system. The temporary retaining system initially consisted of anchored secant pile walls with toe grouting along the entire site perimeter. After excessive movement was detected on one section of the southern wall, inclined steel bracing was installed inside the excavation as a remedial measure to provide additional lateral support to the wall. This paper discusses the geotechnical aspects of the design and construction of the excavation and its retaining system, the analysis approaches employed to evaluate the conditions of the moving wall, and the remedial measures taken to prevent further wall movement.

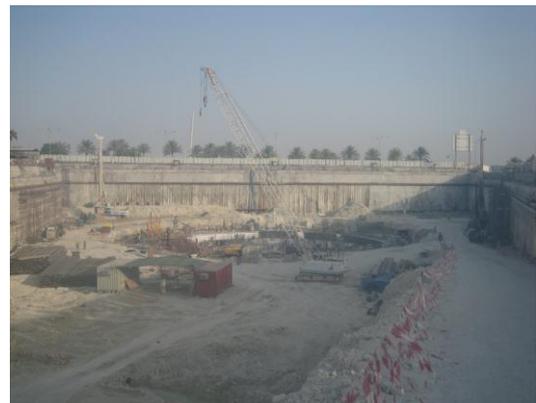
Plate 1. Excavation to Level of -12m

Lateral and vertical ground/wall movements were monitored by inclinometers and settlement markers, respectively. Plate 1 shows the site condition when the excavation reached the level of about -12m.

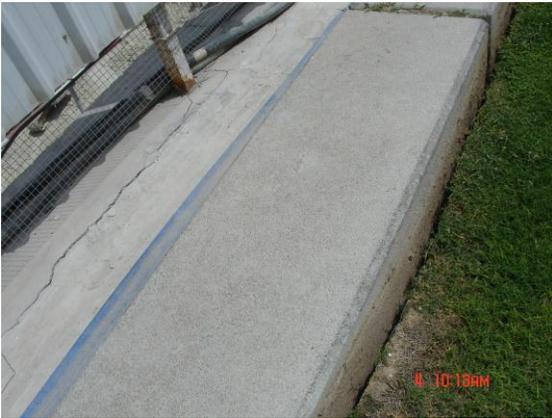
Plate 2. Ground Depression behind Secant Pile Wall

When the excavation reached the level of about -13.5m, excessive lateral wall movement was detected on part of the southern wall. Within a couple of days, the measured wall deflection had reached about 80mm which was significantly greater than the design limit of 25mm. Plate 2 shows the ground depression behind the wall.

A subsequent investigation found that the excessive wall movement had been caused by some loosened ground anchors.

The excavation was immediately stopped and the concerned wall section backfilled to the level of about -10m as an emergency measure to prevent wall collapse.

The loosened ground anchors were subsequently re-stressed to their design load level. Furthermore, it was considered necessary to strengthen the concerned wall section by additional lateral support prior to resumption of excavation works, in order to prevent further wall movement.

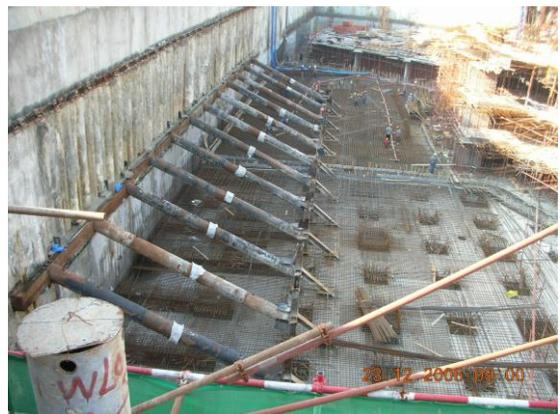
Plate 3. Installed Strutting System

After option evaluation, it was decided to adopt a strutting system consisting of inclined steel tubular pipes having an external diameter of 600mm and a wall thickness of 10mm, installed at an inclination angle of  $30^\circ$  to the horizontal and at a spacing of 4.3m, see Plate 3. The top of these bracing pipes were connected by a steel wailer beam fixed to the wall at the level of -10m. The bottom of the bracing pipes was supported by a foundation consisting of inclined steel sections and the 750mm diameter bored piles which had been installed as tension piles to support the basement.

Although this strutting system had caused inconvenience to the subsequent excavation and construction of the basement slab, it played a critical role in safeguarding the retaining system.

Following installation of the additional strutting system, the excavation was continued successfully to completion.
