Failure Investigation of a Helical Anchor Tie-Down System Supporting an Olympic Size Swimming Pool

Tom Labuda
CTLGroup, Columbia, MD

FAILURE INVESTIGATION OF A HELICAL ANCHOR TIE-DOWN SYSTEM SUPPORTING AN OLYMPIC SIZE SWIMMING POOL

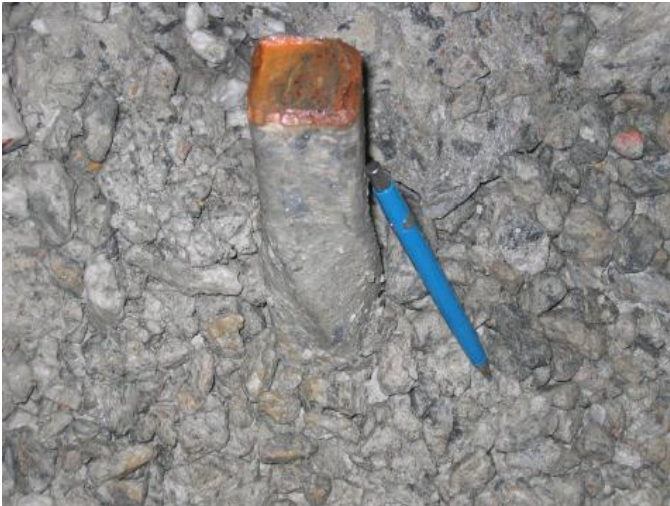
Fig. 3. Twisted Helical Anchor.

Exposed steel rod tops were generally at their design elevations indicating adequate embedment and sufficient uplift capacity. Most of the helical shaft rods exposed during demolition showed inelastic twist deformation of approximately 1/4 turn in the upper eight inches of exposed shaft length. The observed permanent twist deformation very likely occurred during installation at the maximum installation

torque which was sufficient to produce inelastic torsion in the shaft, Fig. 5.
