## **Defect Detection of Concrete Structures through Sounding Data Analytics**

R. Cao<sup>1</sup>, A.K. Agrawal<sup>2</sup>

### **Abstract**

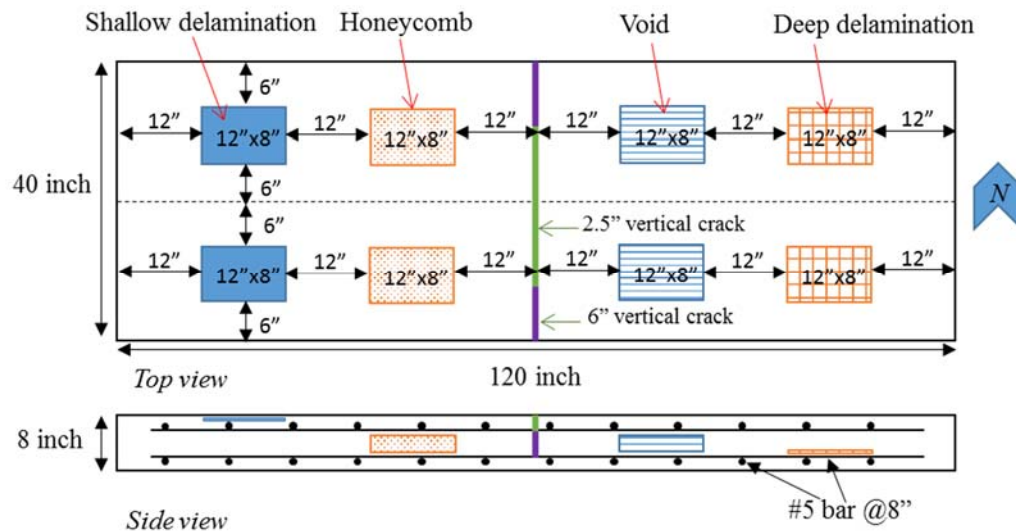
Fig. 1. Design of the concrete slab with engineered defects

In order to collect test data to develop/verify signal processing tools, a concrete slab with known engineered defects at the Turner Fairbanks Highway Research Center of FHWA has been tested. Fig. 1 shows the layout of the slab. The dimension of the slab is 40 inch by 120 inch and it has a thickness of 8 inch. In the slab in Fig. 1, four different artificial defects were designed and embedded in the concrete slab: shallow delamination, honeycomb, void, and deep delamination. The delaminations were simulated by plexiglass sheets, which were placed at depth of 2.5 and 6 inches. The honeycomb was created by loose aggregates and the void defects were built using styrofoam board. Detailed information about the construction of the slab with defects can be found in Lin et al. (2018).
