Tests of Full Scale Brick Veneer Steel Stud Walls to Determine Strength and Rain Penetration Characteristics

RESEARCH REPORT

This study was conducted by the Department of Civil Engineering and Engineering Mechanics of McMaster University for Canada Mortgage and Housing Corporation under Part IX of the National Housing Act. The analysis, interpretations and recommendations are those of the consultant and do not necessarily reflect the views of Canada Mortgage and Housing Corporation or those divisions of the Corporation that assisted in the study and its publication.

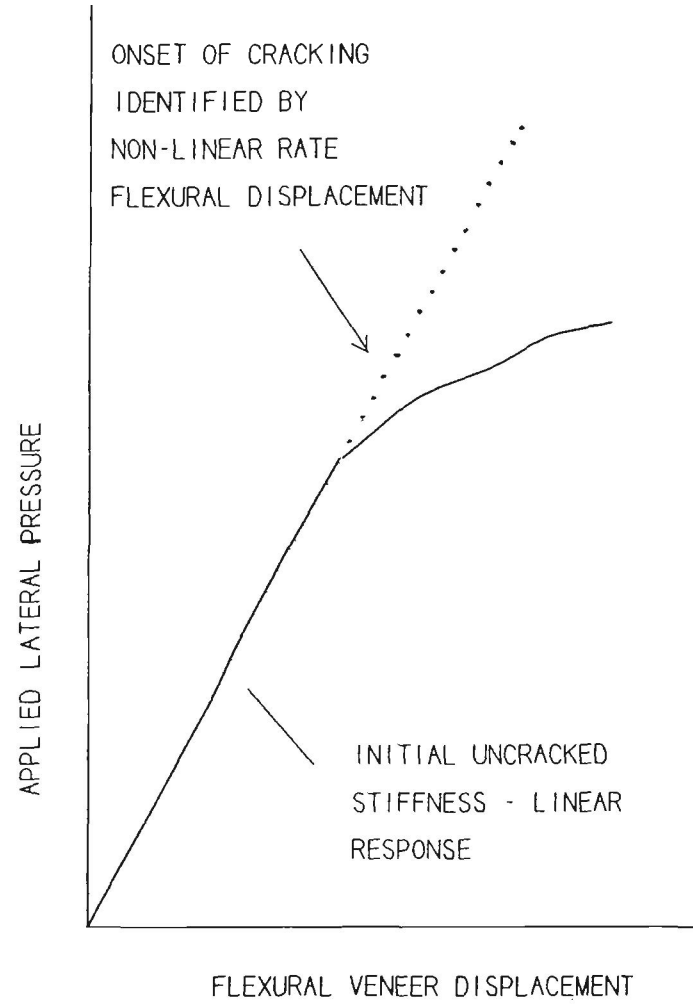
FIGURE 2.20 GRAPHICAL IDENTIFICATION OF ONSET OF VENEER CRACKING

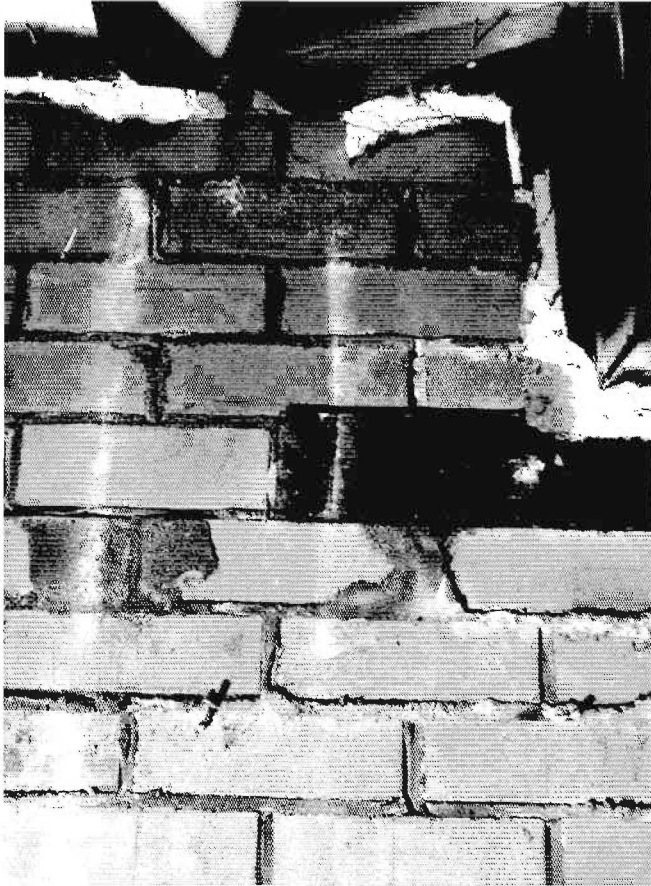
a) Loose Lintel Built Into Veneer Wall

b) Partially Filled Bed Joint and Heavy Furrowing

FIGURE 4.15 SOURCES OF ADDITIONAL LEAKAGE IN WALL4

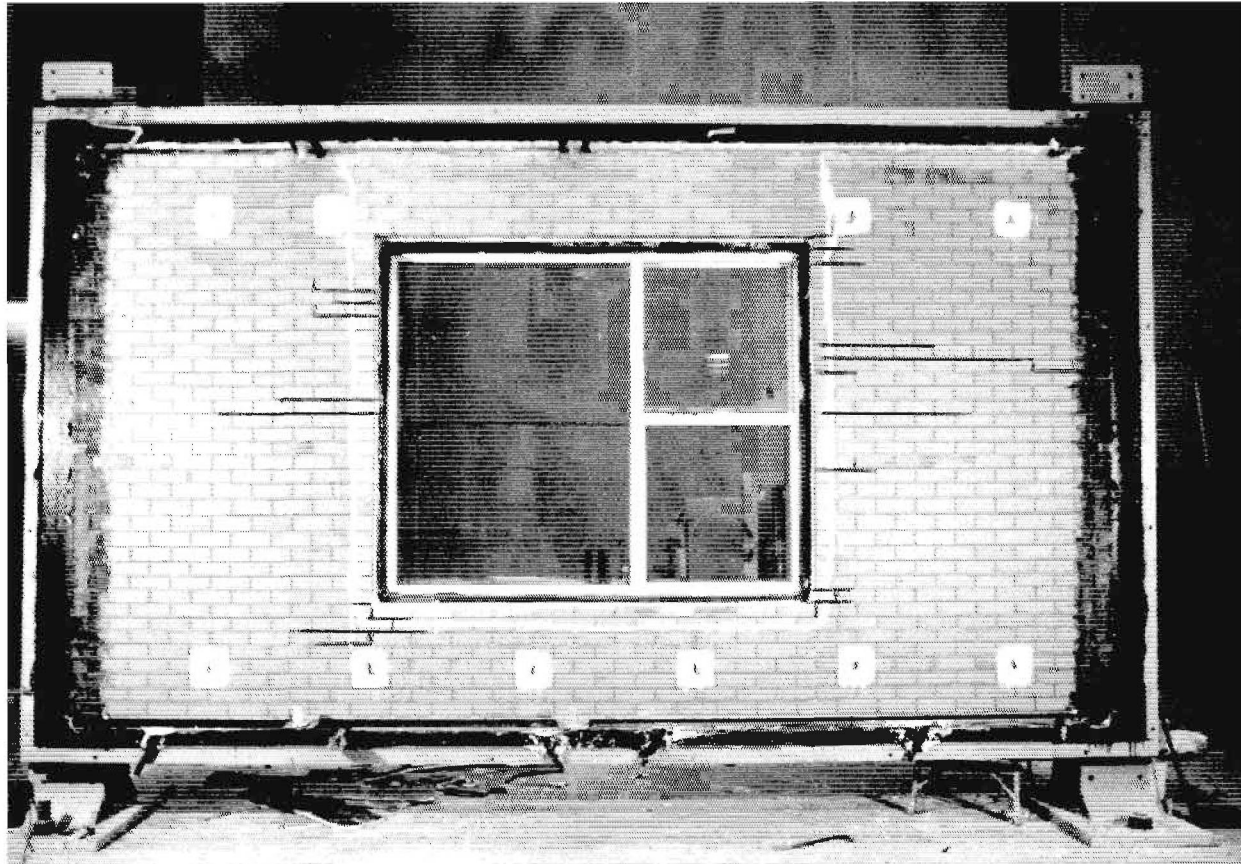
FIGURE 5.25 CRACK PATTERN AT FAILURE – WALL4

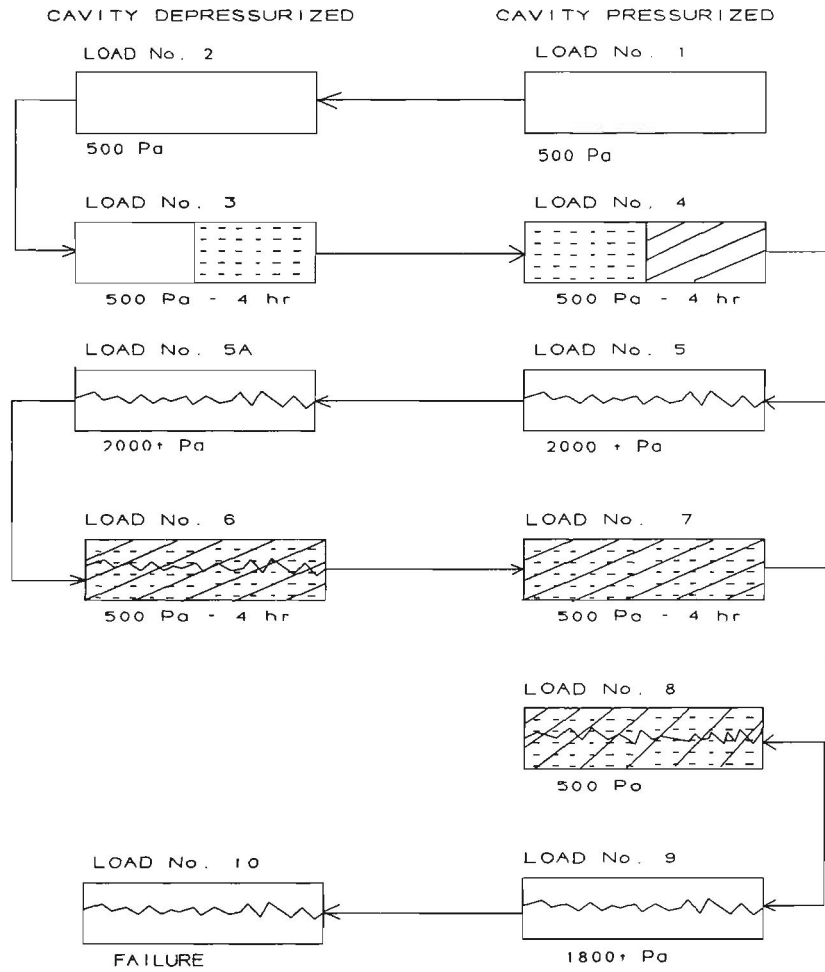
FIGURE A2.1 LOAD SEQUENCE FOR WALL1
