## Geotechnical Factors in Recent Earthquake-Induced Structural Failures in Greece

# GEOTECHNICAL FACTORS IN RECENT EARTHQUAKE-INDUCED STRUCTURAL FAILURES IN GREECE

A review is made of geotechnical factors that played an important role in three recent earthquake-induced failures, two of which were deadly. The first two catastrophes concern two five-storey hotels that collapsed during the "Alkyonides earthquake" of 24 February 1981 ( $M=6.7$ ) and the "Egion earthquake" of 15 June 1995 ( $M=6.2$ ). The third failure is the collapse of a multi-storey factory caused by the "Athens earthquake" of 7 September 1999 ( $M=5.9$ ). In the first two catastrophes, ground subsidence was estimated by two different methods and was found to be of the order of 0.13 to 0.46 m. These estimates are based on tentative assumptions that should be reviewed and possibly revised. Considerable differential settlements must have existed before the earthquake, as there were no basements that would have attenuated vertical loading and so even a moderate additional differential settlement could cause failure. In the third case, the structure was built near the edge of a steep slope of clayey soil. The co-seism

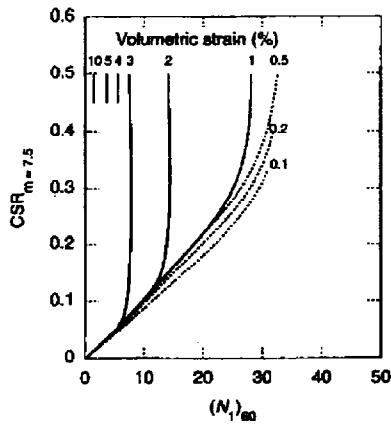
Figure 1 below, shows the chart which is used for the estimation of the volumetric strain (ground subsidence  $\div$  layer thickness) of saturated sands, given the normalised  $N_1(60)$  SPT value and the cyclic stress ratio  $CSR$  for an earthquake of magnitude  $M=7.5$ . The cyclic stress ratio  $CSR$  for an earthquake of magnitude  $M$  is given by the following expression:

Fig. 1 Estimation of earthquake-induced settlements of saturated sands (Tokimatsu and Seed, 1987)

According to Fig. 1, the volumetric strain for  $N_1(60)$  values of 2.5 and 7.5 and 12.5 (average values for the  $N_1(60)$  ranges of 0-5, 6-10 and 11-15) are 7, 3 and 1.5% respectively. As a result, the subsidence of the first layer is  $0.07 \times 2.6 \text{ m} = 0.18 \text{ m}$ , of the second layer is  $0.03 \times 2.0 \text{ m} = 0.06 \text{ m}$ , and of the third  $0.015 \times 4.6 \text{ m} = 0.07 \text{ m}$ . Therefore, the total subsidence is 0.31 m.

According to Fig. 1, the volumetric strain for  $N_i(60)$  values of 2.5, 7.5 and 12.5 (average values of the  $N_i(60)$  ranges of 0-5, 6-10 and 11-15) are 7, 3 and 2% respectively. As a result, the subsidence of the virtual layers is  $0.07 \times 0.80$  m = 0.056 m,  $0.03 \times 0.80$  m = 0.024 m and  $0.02 \times 2.4$  m = 0.048 m totalling 0.13 m. It is reminded that this calculation is based on a "guess".

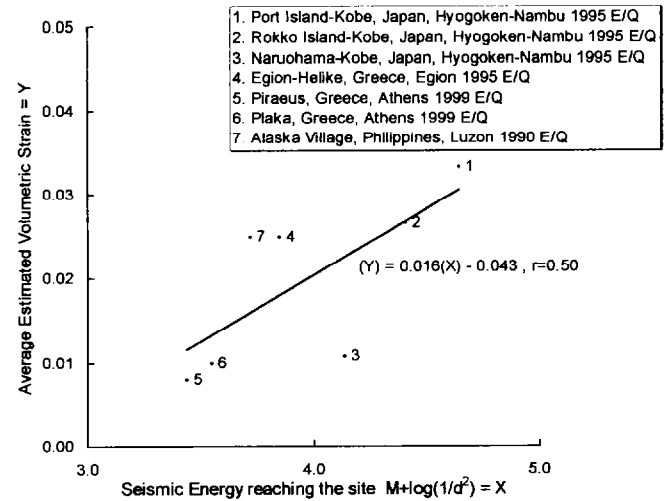
Figure 2 presents the correlation of the average volumetric strain (=representative observed ground subsidence  $\div$  layer thickness) with a measure of the seismic energy reaching a site  $SE=[M+\log(1/d^2)]$ , where  $M$  is the earthquake magnitude and  $d$  is the epicentral distance in km. As  $M=\log(\text{energy})$ ,  $SE=\log[\text{energy}/d^2]$  where the expression in the brackets equals the energy reaching the circumference

Fig. 2 Statistical correlation between ground subsidence and seismic energy, from case histories (Second Annual Report, ENV4-CT97-0392, DG XII, European Commission)

Each of the numbered points shown in Fig. 2 indicates a representative value of observed subsidence at the general location receiving the seismic energy. The locations included in the correlation are known to be underlain by geologically very recent granular deposits or by artificial fills. The coefficient of correlation of 0.5 allows the assumption that:

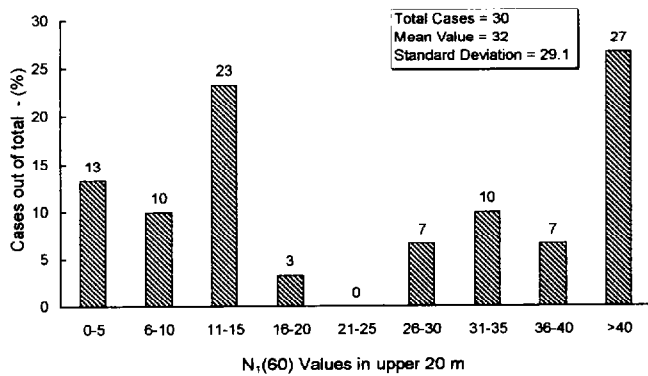
The hotel was constructed around 1969. It was built at a distance of about 75 m from the sea coast and did not have a basement. A subsurface investigation that preceded construction showed medium to dense sands down to the depth of 8 m, underlain by sands and silts of lower density down to the depth of 20 m. The ground water level was approximately 1 m below the ground surface. Figure 2 shows the results of the Standard Penetration Tests:

Fig. 3 Hotel site at "Vrahati". Pre-earthquake subsoil investigation. Water level depth = 1.0 m

Fig. 3, the corresponding percentages of the  $N_1(60)$  values are 13, 10 and 23%, therefore the presumed thicknesses - out of the total of 20 m - that densify are:  $0.13 \times 20 \text{ m} = 2.6 \text{ m}$ ,  $0.10 \times 20 \text{ m} = 2.0 \text{ m}$  and  $0.23 \times 20 \text{ m} = 4.6 \text{ m}$ .

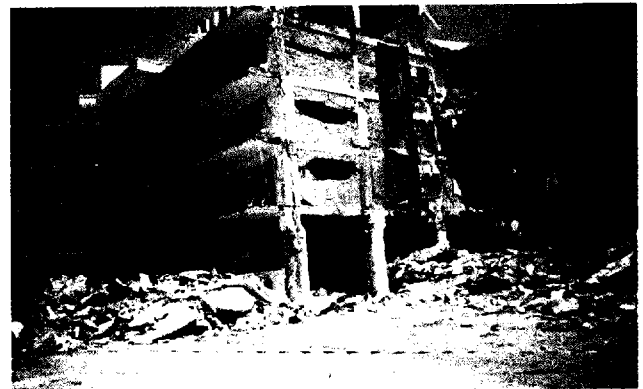
The collapse of a part of this five-storey hotel at the "Valimitika" summer resort in the Peloponnes, which resulted in the death of 15 people, was caused by the "Egion earthquake" of 15 June 1995, with magnitude 6.2 and epicenter near the city of Egion, 130 km west of Athens. The hotel epicentral distance was 15 km approximately.

Fig. 4 Hotel collapse at "Valimitika", 15 June 1995.

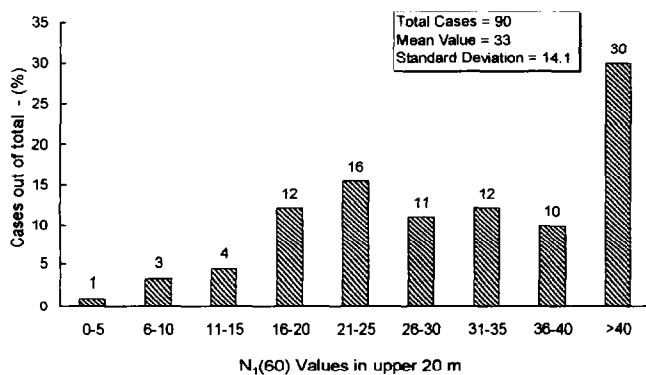
The hotel was built at a distance of about 20 m from the sea coast and was founded on shallow footings without a basement. After the collapse, a geotechnical investigation with 5 borings showed that to a depth of 20 m subsoils consist mainly of sand and silt. The ground water level was about 1.5 m below the ground surface. Figure 7 shows the results of the Standard Penetration Tests normalised as  $N_i(60)$ .

Fig. 7 Hotel site at "Valimitika". Post-earthquake subsoil investigation. Water level depth = 1.5 m

the densification that must have taken place as a result of the earthquake. As it is necessary to make an assumption for the pre-earthquake values, it does not seem unreasonable to accept that the earthquake caused the values of  $N_i(60)$  to increase by 5. True, this assumption is arbitrary and can be easily contested, so for this reason it should be regarded only as a tentative "guess". On this basis the pre-earthquake percentages of cases for the  $N_i(60)$  ranges of 0-5, 6-10, and 11-15, become 4, 4 and 12%.

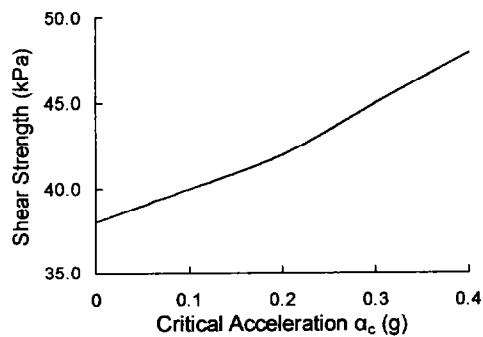
A pseudo-static analysis of the slope was carried out with the slope stability program LARIX-2S, which can estimate the Factor of Safety  $FS$  of a slope by applying the well-known Bishop's method of slices (Bishop, 1955). Figure 11 that follows, presents a graph of the shear strength of the soil in the "Ricomex" slope, versus the critical acceleration  $\alpha_c$ , that is, the horizontal acceleration for which  $FS=1$ .

Fig. 11 "Ricomex" slope - Results of pseudo-static analysis with Bishop's method of slices - it is assumed the angle of internal friction of the soil  $\phi=0$ .
