## **DESTRUCTIVE AND NON-DESTRUCTIVE TESTING OF BRIDGE J857 PHELPS COUNTY, MISSOURI**

### **VOLUME III STRENGTHENING AND TESTING TO FAILURE OF BRIDGE PIERS**

**CIES  
99-08C**

#### **STRENGTHENING AND TESTING TO FAILURE OF BRIDGE PIERS**

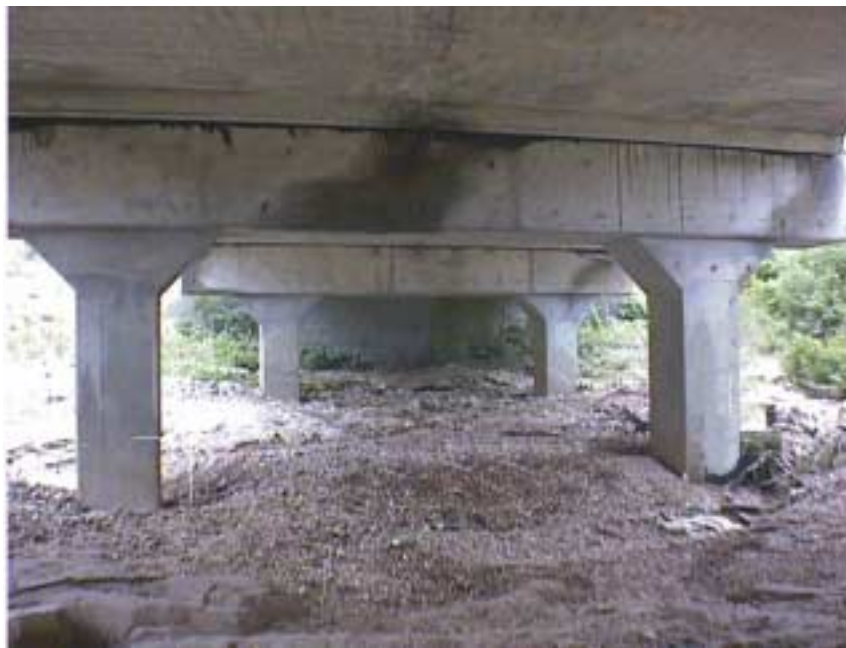
**Figure 2.1.** Photo showing bridge columns.

Bridge decks were supported on two abutments and two bents. Each bent consists of two columns connected at the top by a RC cap beam, as shown in Figure 2.1. The abutments and the bents were all at a 15-degree skew. The columns had a 2 ft  $\times$  2 ft (0.6 m  $\times$  0.6 m) square cross-section and were reinforced with four #6 (19 mm) deformed steel bars located at the corners of the cross section. The haunch of each column was reinforced with four #6 (19 mm) steel bars that extended 3 ft (0.9 m) into the column from the bottom of the haunch. The transverse reinforcement consisted of #2 (6 mm) steel ties spaced at 18 in. (457 mm) on centers. Each column was supported by a 4 ft by 4 ft by 2.5 ft (1.2 m  $\times$  1.2 m  $\times$  0.75 m) RC square spread footing. Figure 2.2 shows typical geometry and reinforcement details of a bridge column as given by the original plans.

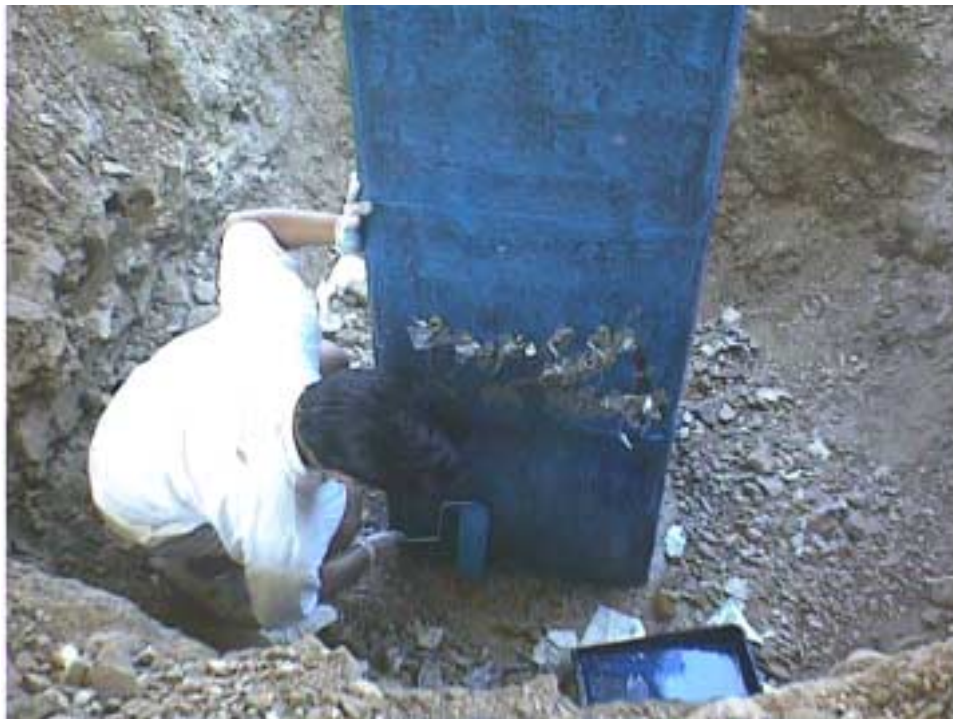
**Figure 2.11.** Applying the bottom lift of the jacket.

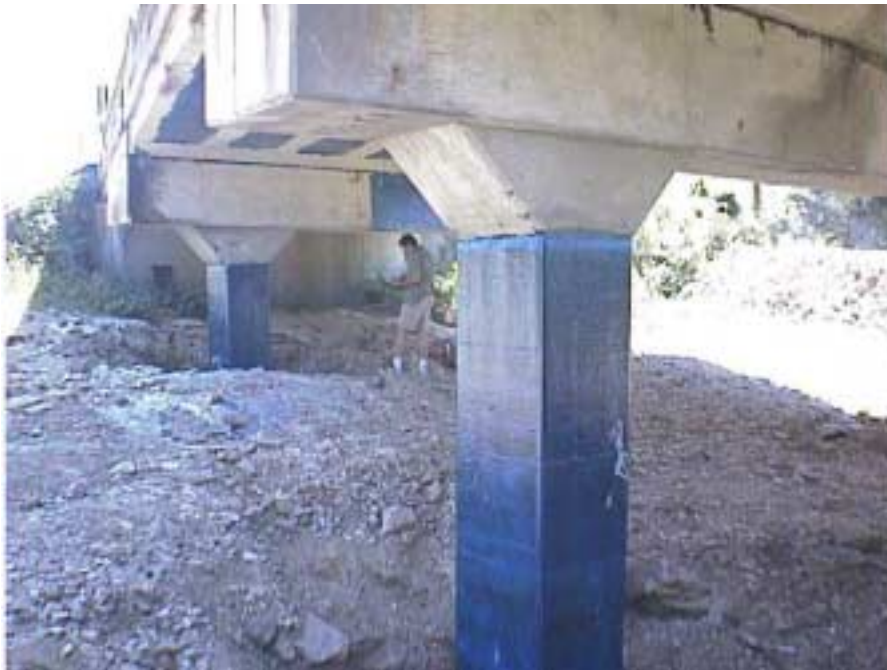
**Figure 2.13.** Photo showing the bridge after strengthening.

Due to variation in column lengths, the number of lifts of CFRP sheets required to cover the entire column was different. The number of lifts for B2P2, B3P2, and B3P2 were 6, 6  $\frac{1}{4}$ , and 4 lifts, respectively, as shown in Figure 2.10. The bottom lift was applied after the rest of the lifts were installed and allowed to cure, as shown in Figure 2.11. This was done to prevent damaging the strain gages wires. The bottom lift was applied after the wires were extended such that they exit between the first and the second lifts from the bottom of the column, as shown in Figure 2.12. A photo showing a general view of the bridge after strengthening is given in Figure 2.13.

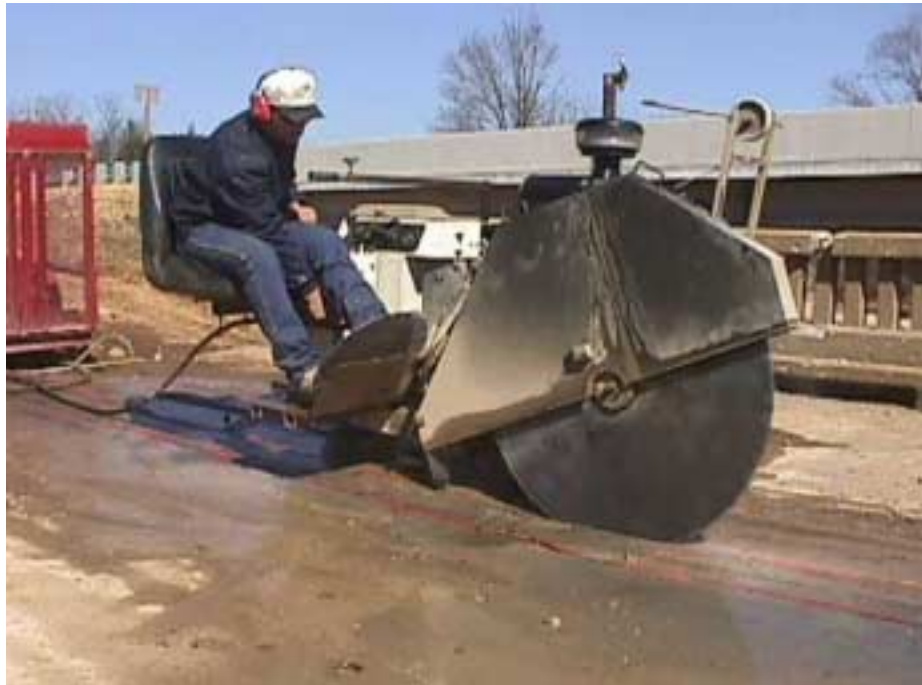
**Figure 3.1.** Cutting the bridge deck.

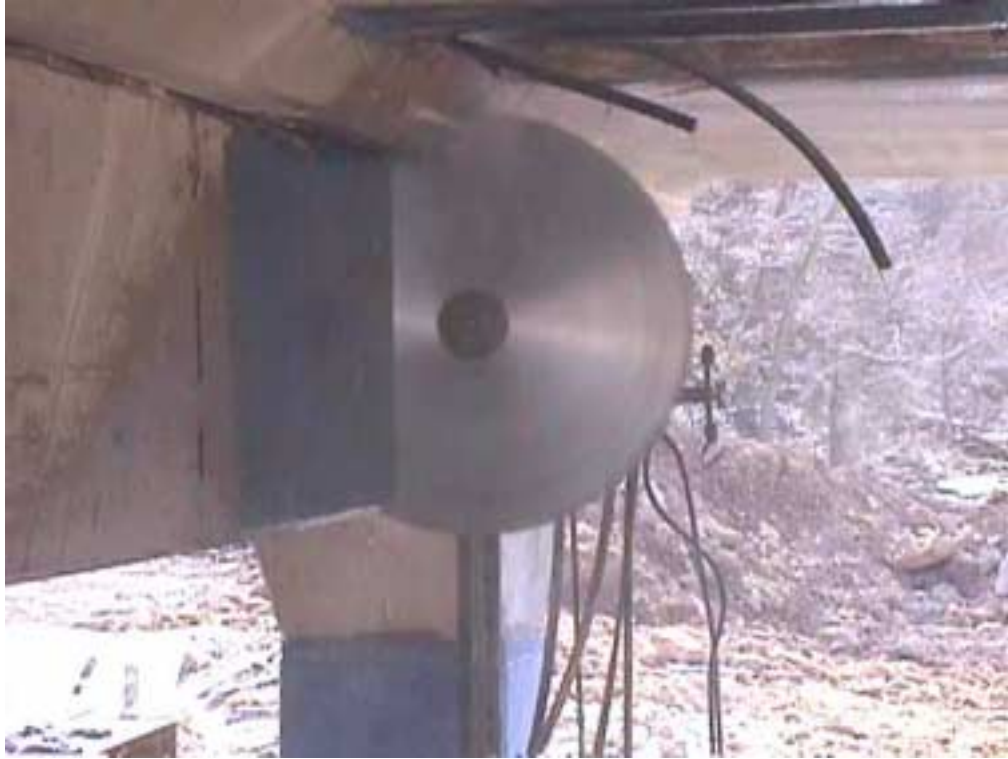
**Figure 3.2.** Cutting the cap beam.

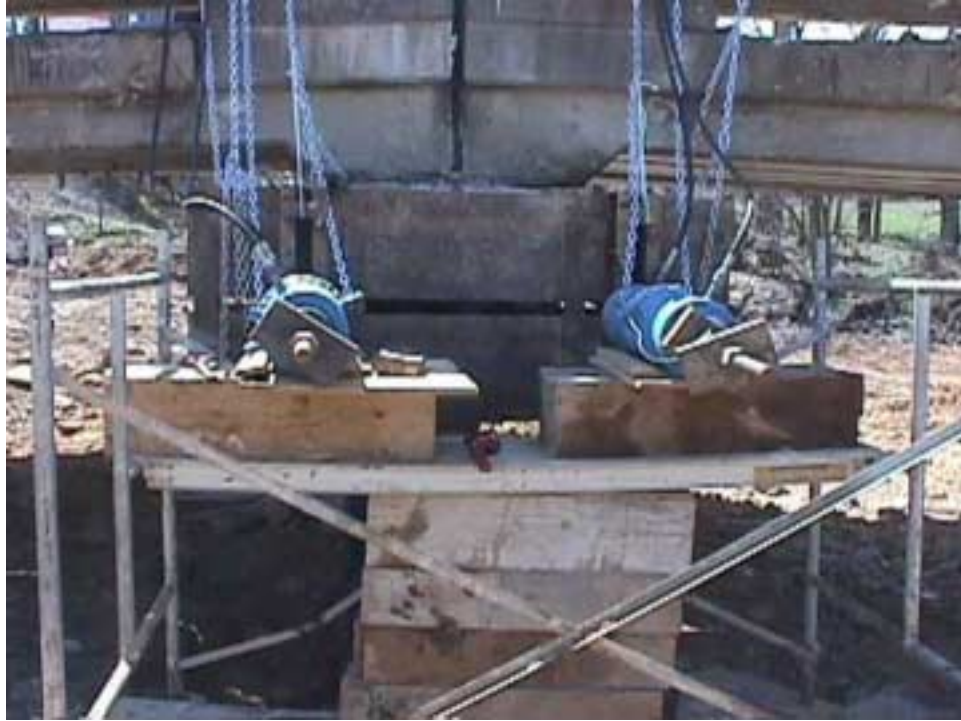
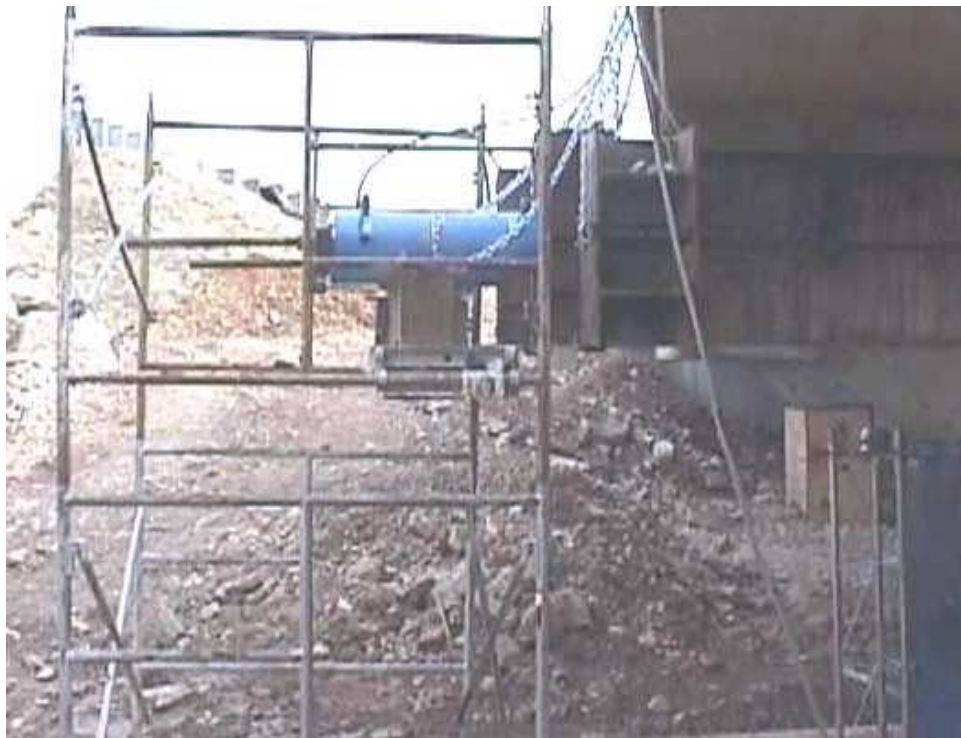
**Figure 3.4.** Confining frame assembly at one end of cap beam.

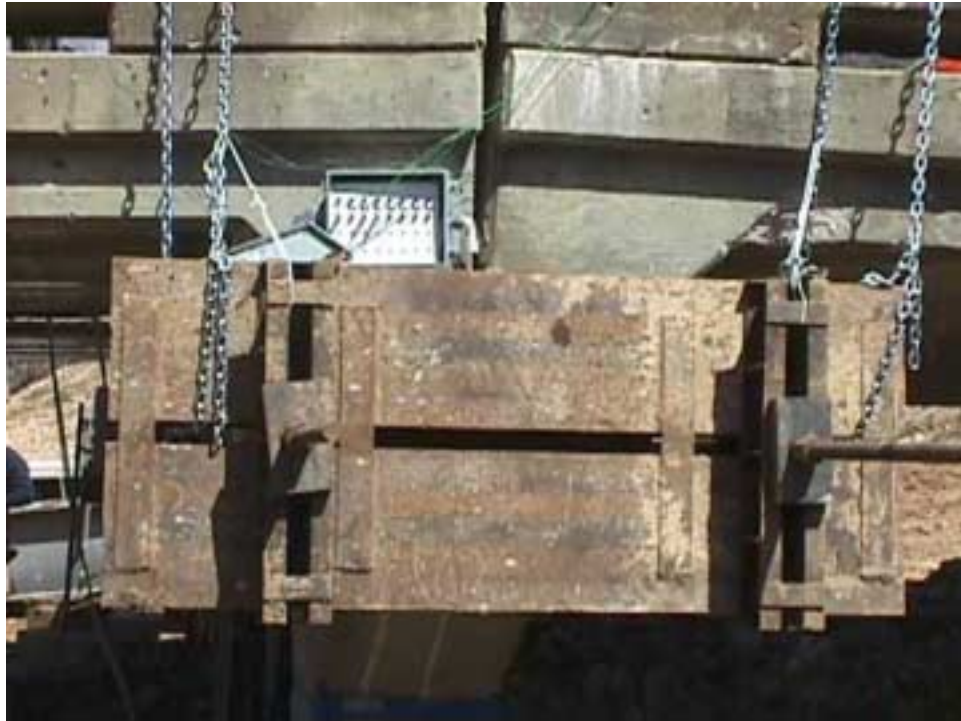
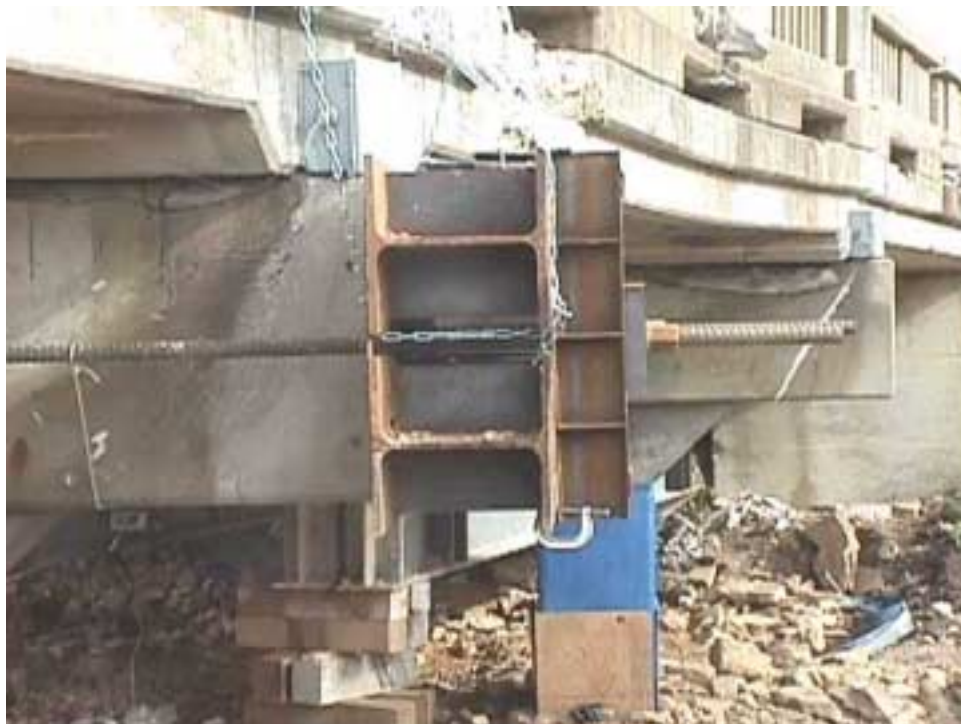
**Figure 3.5.** Confining frame assembly at the other end of cap beam.

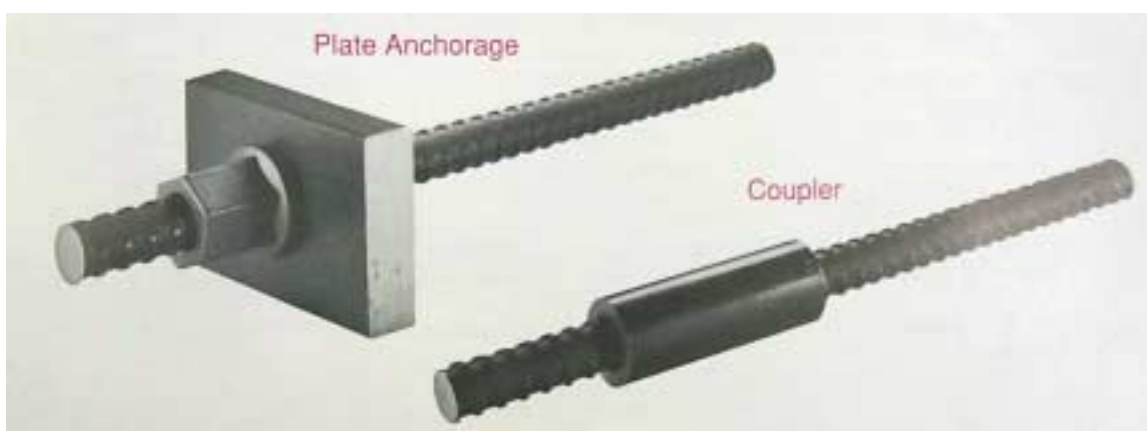
**Figure 3.7.** Dywidag rods and accessories.

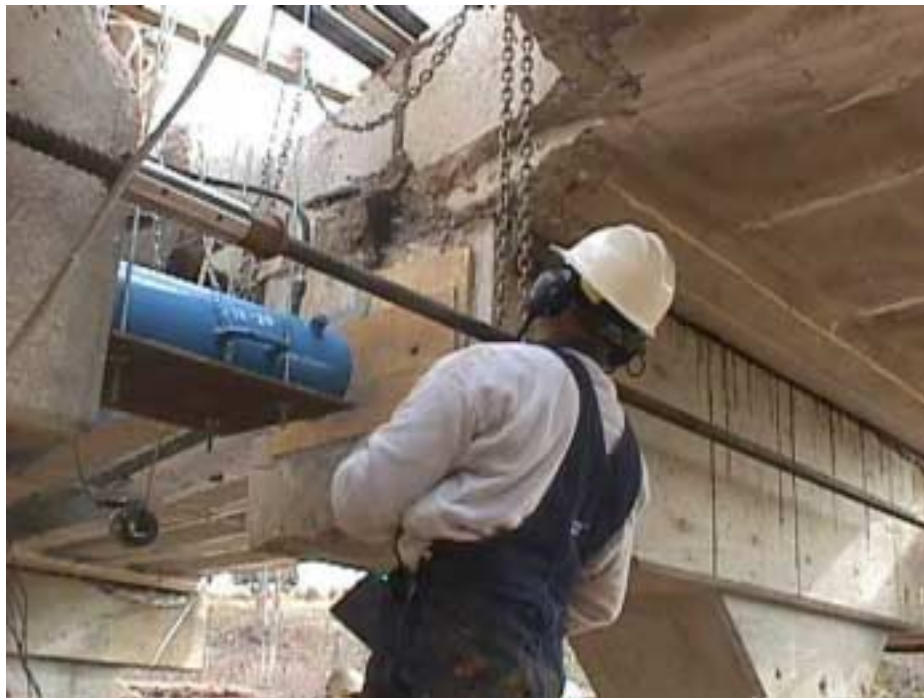
**Figure 3.9.** Placing the middle jack.

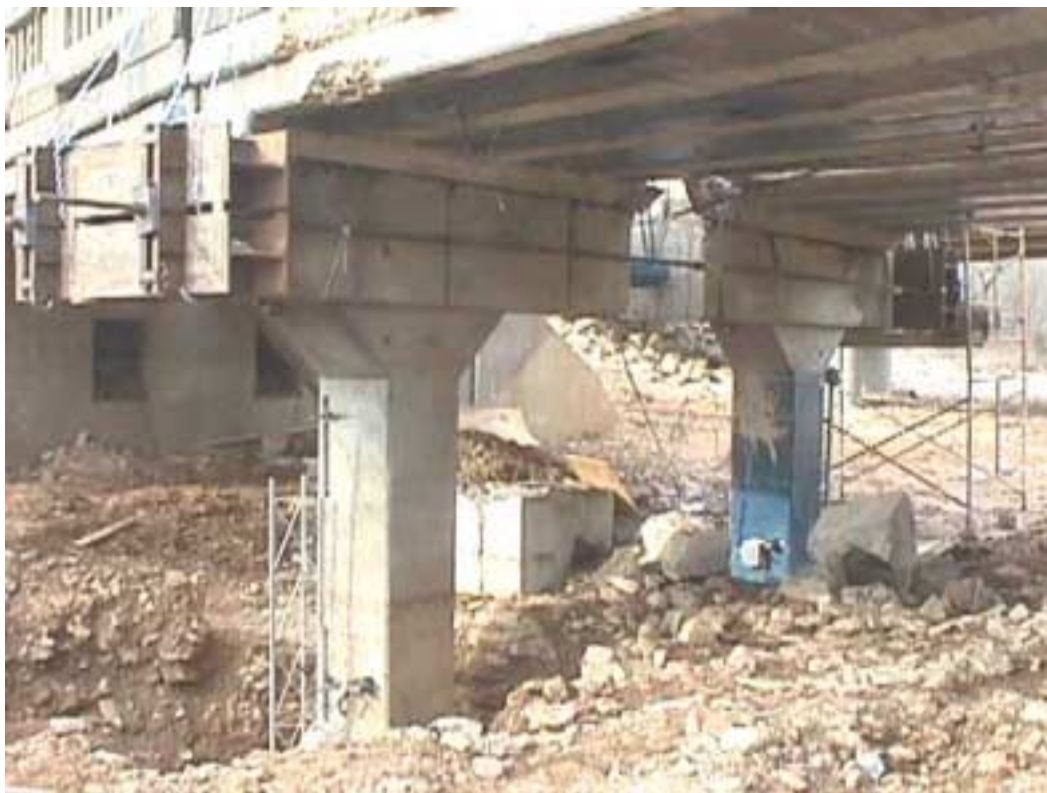
**Figure 3.10.** Photo showing piers test setup.

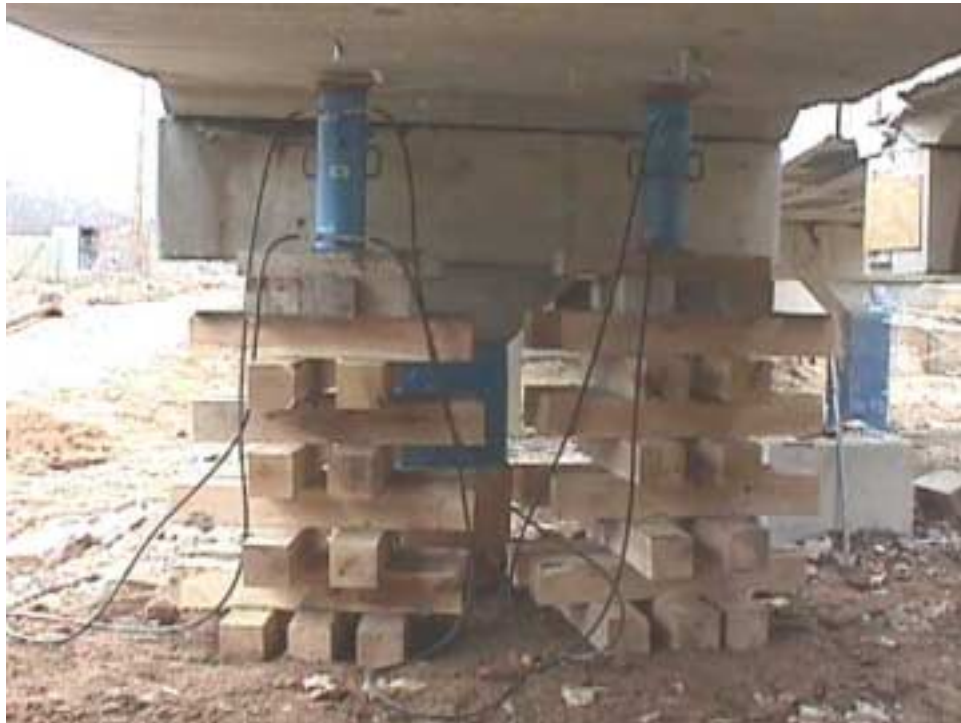
**Figure 3.12.** Set up for jacking the decks.

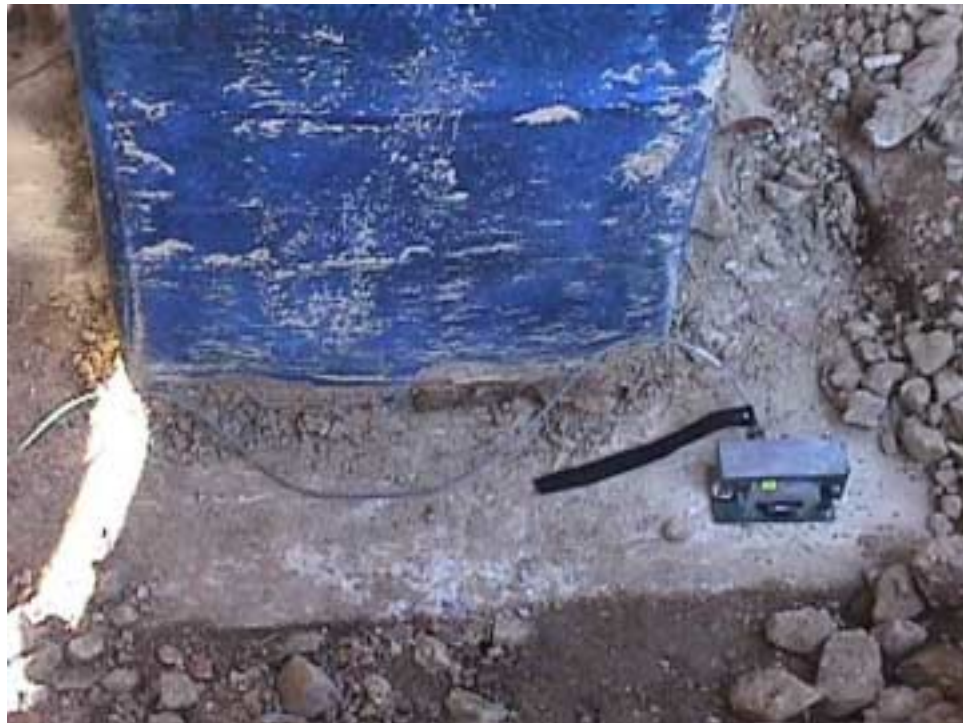
**Figure 3.17.** Inclinometer on the surface the footing.

Three inclinometers were used to measure the rotation at the top, mid-height, and the footing of each column. The inclinometers used in this project have a range of  $\pm 3$  degrees. The top inclinometer was attached to the cap beam while the bottom inclinometer was attached to the surface of the footing. Figure 3.16 depicts a schematic of inclinometer locations. Figure 3.17 shows a photo of an inclinometer on the surface of the footing.

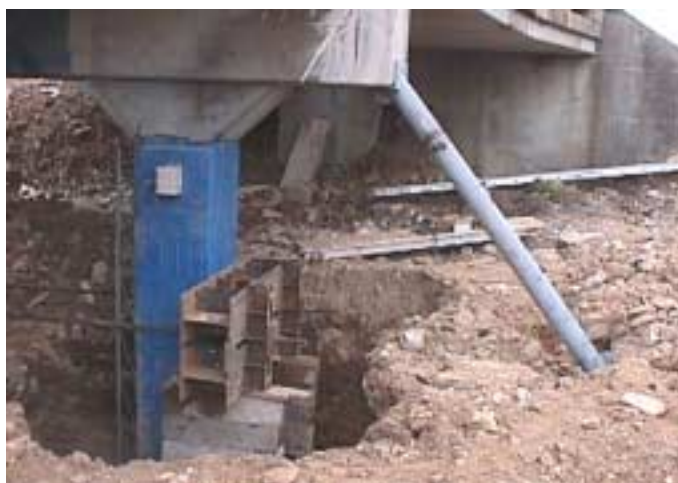
**Figure 3.18.** Diagonal bracing of the failed column.

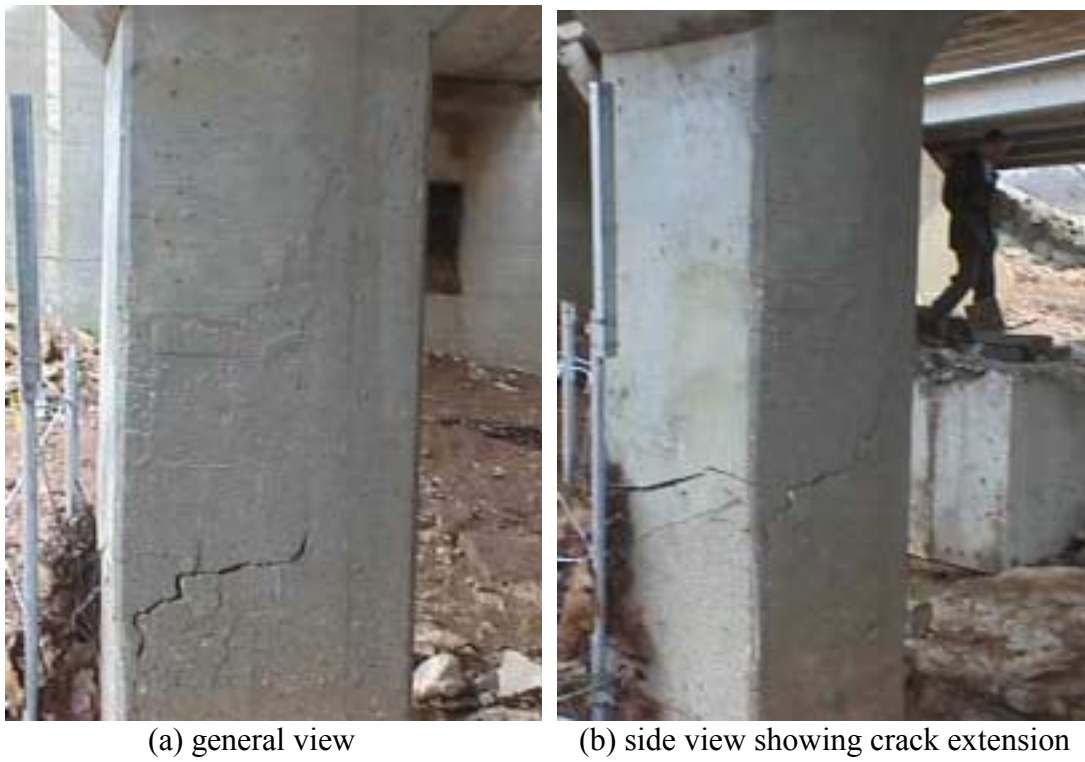
**Figure 4.7.** Crack on Column B2P1.

The load was increased gradually until it reached 80 kips (356 kN) where the top crack started to widen significantly and the column started to undergo continuous deformation. Similar behavior was observed at the base of the column. The continuous rotation of the footing under constant load indicated that the soil under the footing had failed. A final pull-in load cycle was applied. The load could not be increased beyond 59 kips (262 kN).

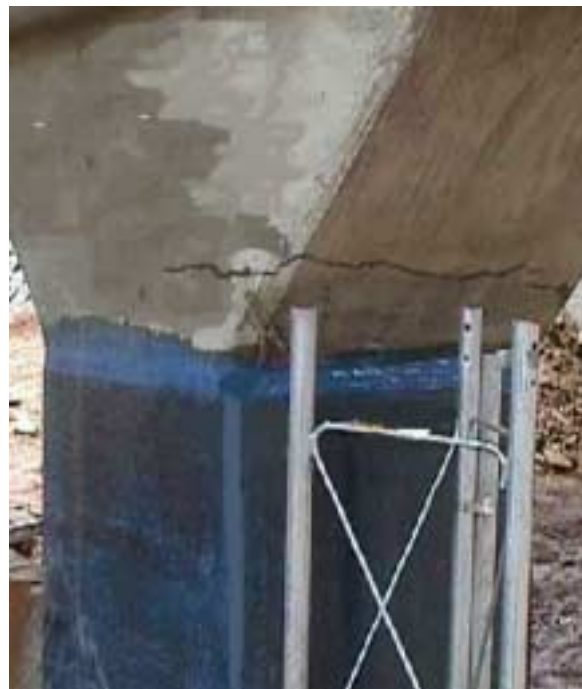
**Figure 4.13.** Crack at failure of column B2P2.

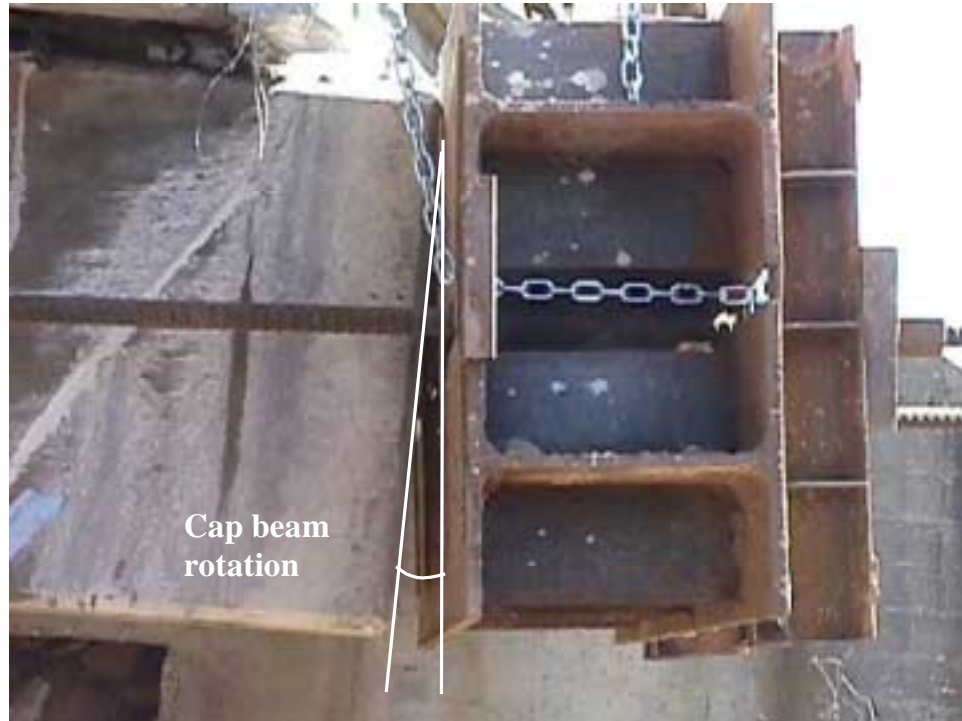
**Figure 4.17.** Cap beam rotation

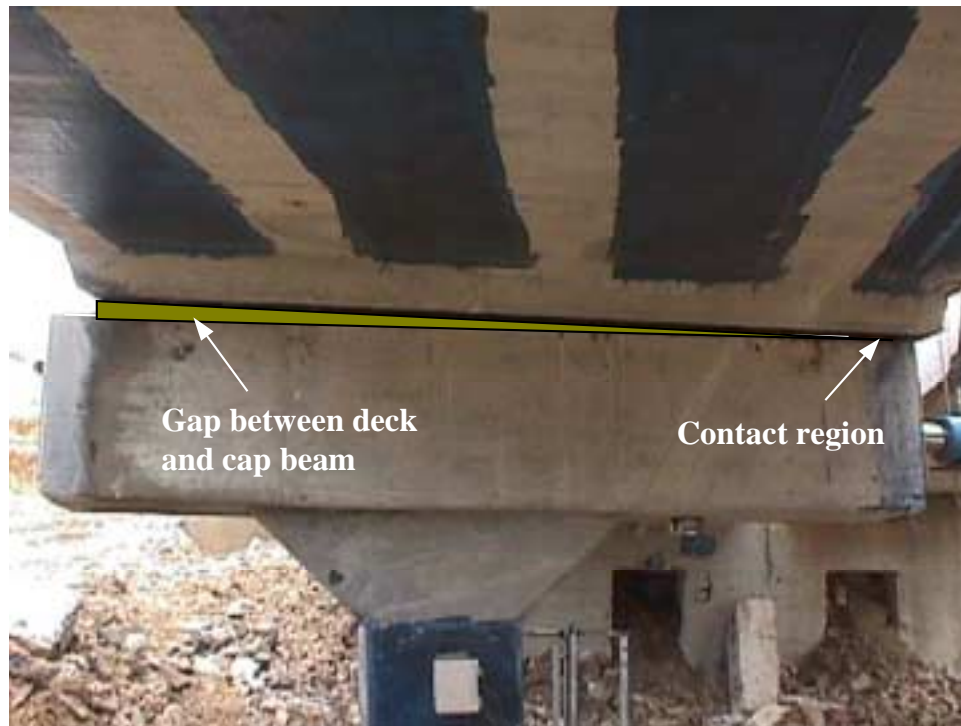
**Figure 4.32.** Rotation of the cap beam relative to the topping deck.

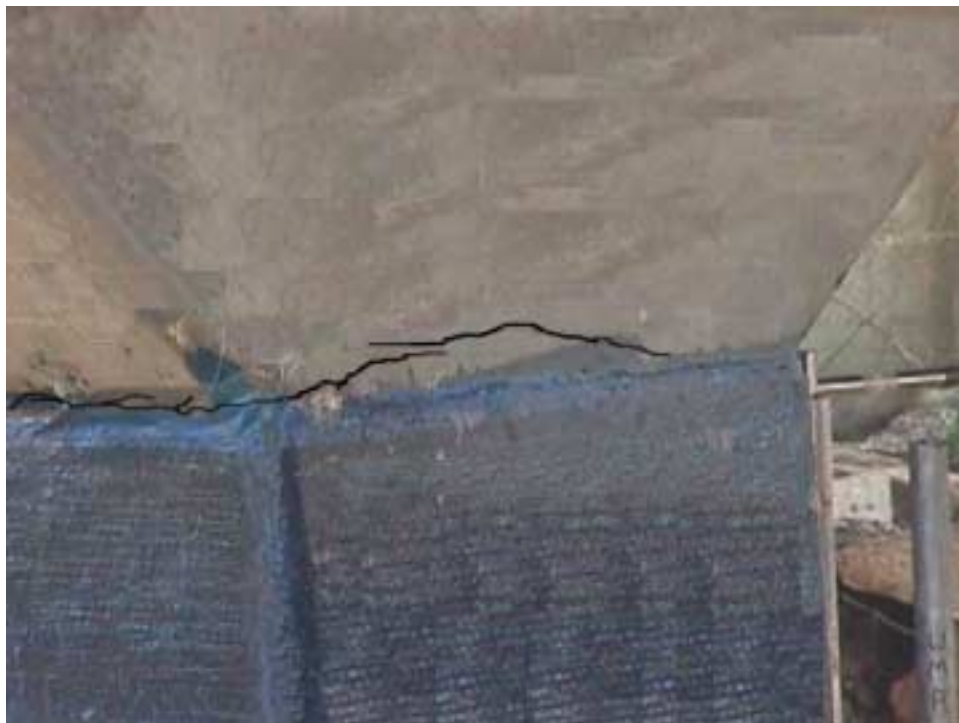
**Figure 4.33.** Crack at column/haunch intersection at failure.
