## Impact of Environmental Conditions on a Structural Damage

**SYNOPSIS:** This paper deals with a case history of a structural damage of college buildings lie in a nearly developed area at the north-east of Cairo. The building behavior and the factors cause the damage are contributed. As a result, the light on the importance of topographical condition of the site is sighted and recommended for such similar cases.

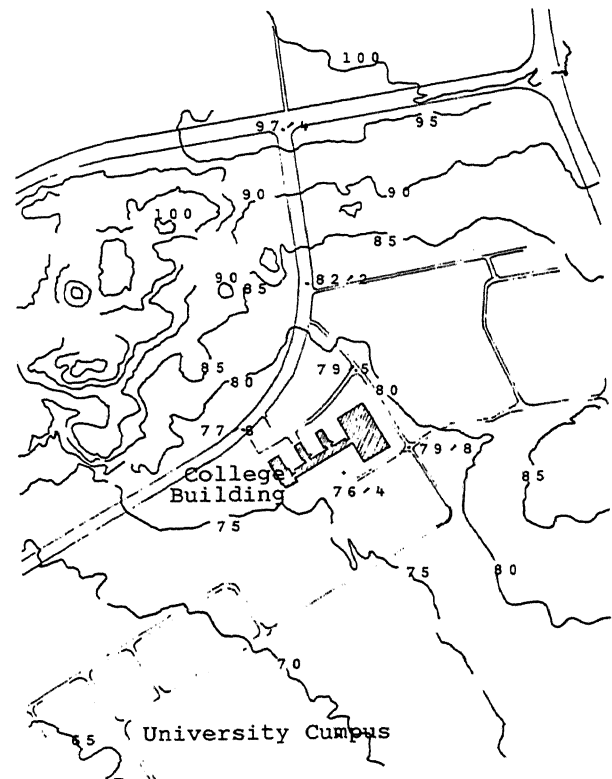
Fig. 1 shows the site stratigraphy where the college buildings lie as illustrated by the hatched mark. It can be seen from this figure that the campus of the university exists on an undulant topographical area between 65 and 100, showing a different in level equal to about 35 m. The college buildings lie on a relatively flat area underlying a steep boundary road surrounding the campus.

Fig. 1 Stratigraphy of Site at the Location of University Campus.

The site topography as illstrated in Fig. 1 enhanced the collection of streams of water in the wet season around this area, where the campus exists on undulant topographical area and the college buildings lie on a relatively flat area underlying a steep boundry road surrounding the campus.

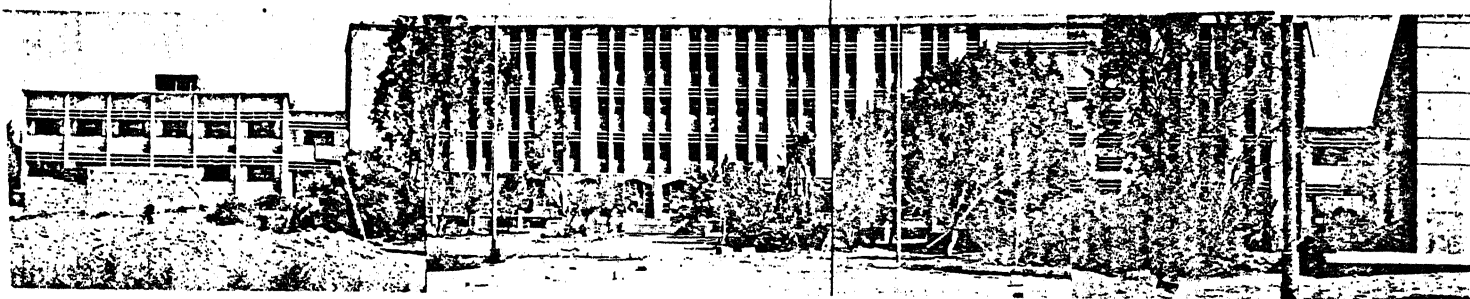
Photo 1 Front View of College Buildings.

Even the foundation levels far below the shallow clayey layers, severe cracks were noted on many of building structural elements few years after their use. Photo 1 shows a front view of college buildings.

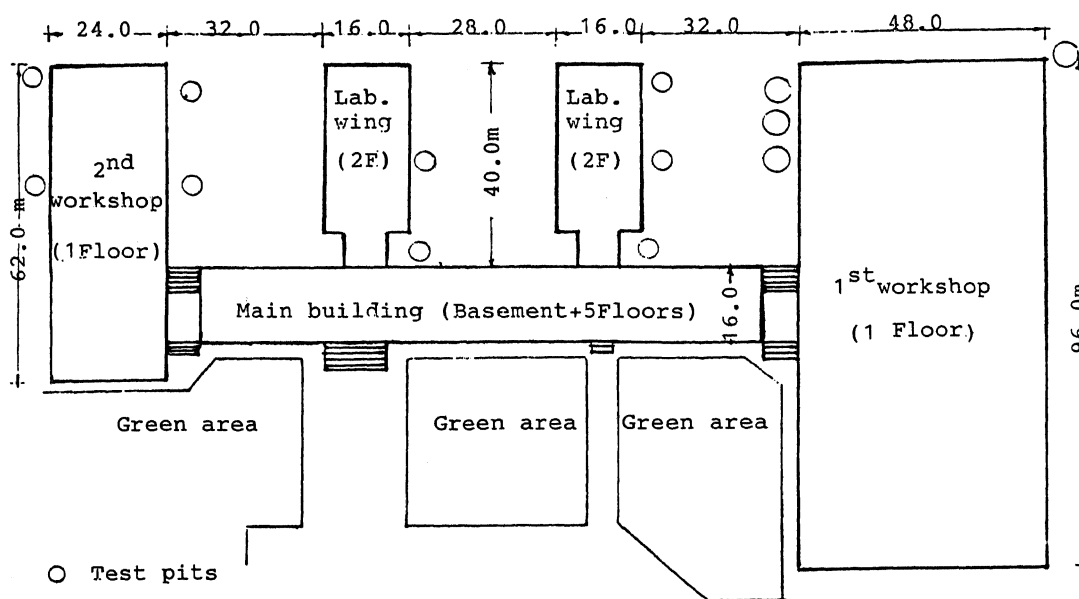
Fig. 2 shows the layout of the building under investigation and the locations of test pits carried out before and after construction. The average soil profile at the college site can be summarized as: 2.0 m top soil of sand and gravel followed by laminated layers of hard grey silty clay interfered by thin layers of fine to medium sand up to about 11.0 m below the ground surface. Then, clean medium to coarse sand is existed up to the end of the boring at about 16.0 m below the ground surface. The ground water table did not appear along all boring depths.

Fig. 2 Layout of Building Under Investigation and Test Pits Locations.

As can be seen in Fig. 2, the building consists of two parts of relatively flexible and rigid parts. The main building consists of a basement, and four stories, while the workshops and laboratory wings consist of ground floor and only one story for the laboratory wings.

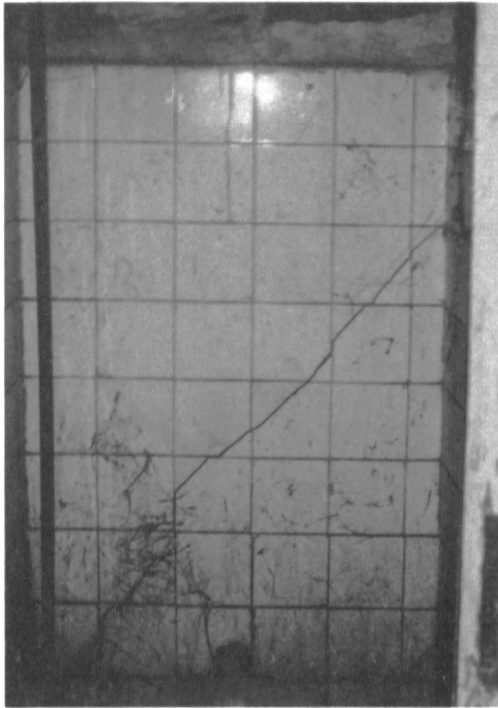
Firstly, cracks in the walls inside the water closets were observed to separate the ceramic diagonally as shown in Photo 2. Then, at the beginning of 1970 the cracks appeared in the internal walls of flexible parts and spreaded to cover some parts of the rigid main building as can be sighted from Photos 3, 4 and 5.

**Photo 2** Example of Diagonal Cracks Inside Water Closets.

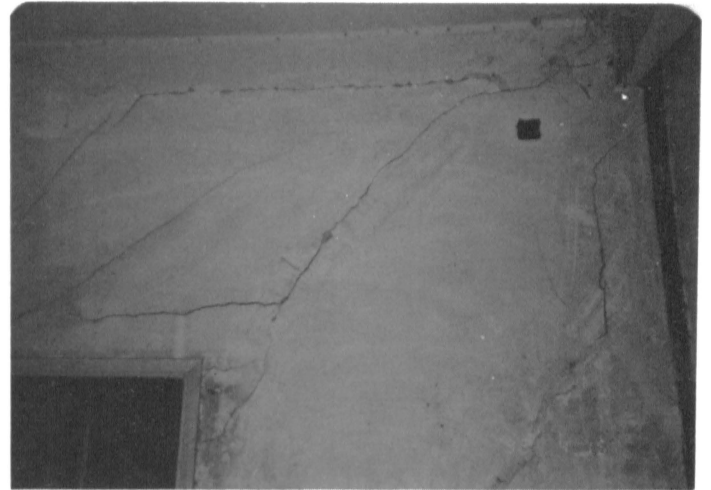
**Photo 4** Example of Diagonal Cracks in Internal Walls of Main Building.

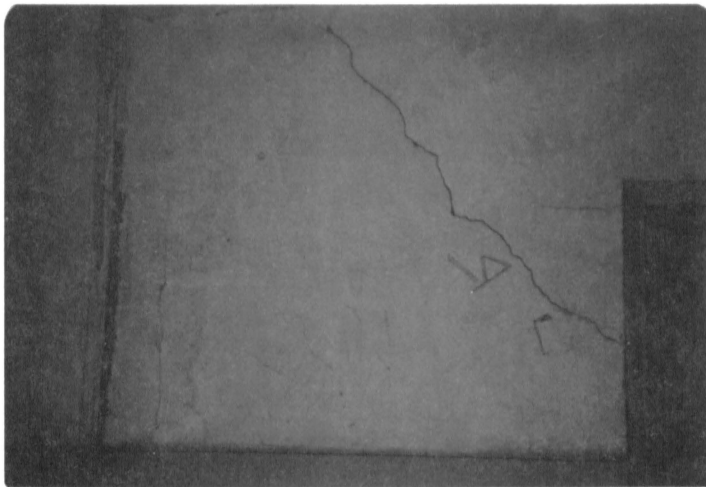
**Photo 3** Example of Cracks in Internal Walls of Laboratory Wings.

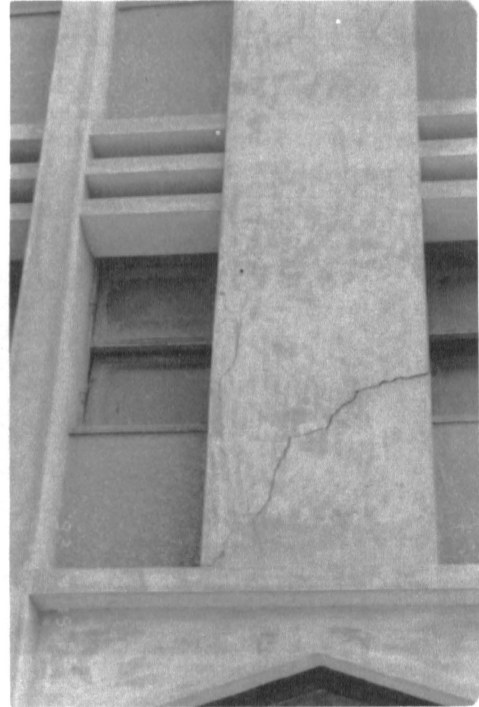
**Photo 5** Example of Cracks in External Walls of Main Building.

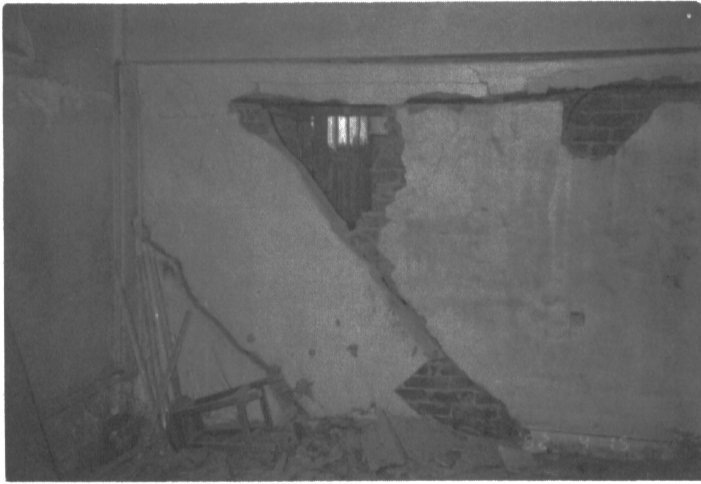
Afterwards, cracks and damage were clearly noted for the basement of main building and inside the first workshop. Most severe cracks were reported for the left part of main building, in which damage spreaded to many of internal walls and beams as can be sighted from Photos 6 and 7. Besides, soil unequilibrium in the shallow layer caused ground movement and lefted walls from the underlying supports (Photo 8). This phenomenon was also reflected on the basement floor in which large rise at the mid point of

**Photo 6** Example of Severe Cracks in the Internal Walls at the Basement of Main Building.

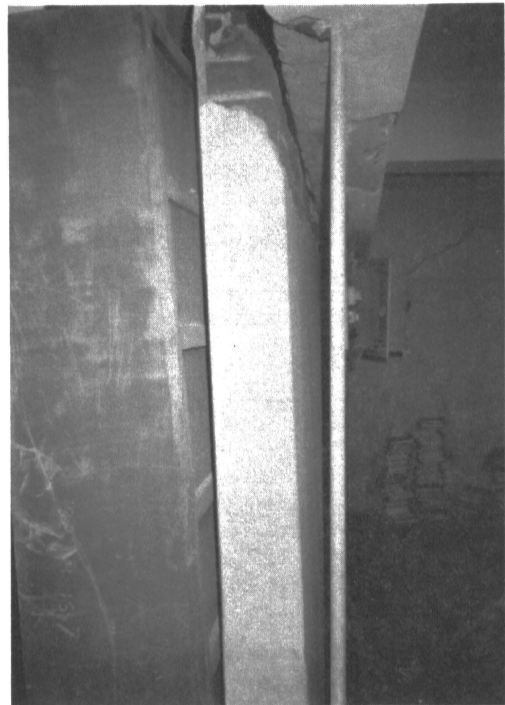
**Photo 8** Example of Left Walls from the Underlying Support at the Basement of Main Building.

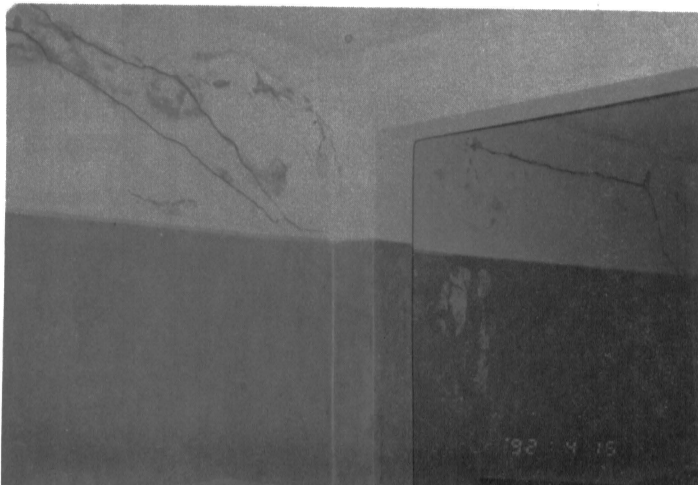
**Photo 7** Example of Cracks in Beams at the Basement of Main Building.

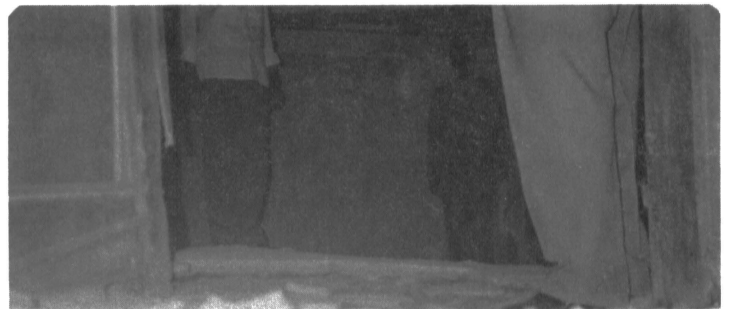
**Photo 9** Example of Floor Rise at The Basement of Main Building.

the floor was easily noticed (about 40 cm) as can be seen from Photo 9. Moreover, as can be sighted from Photo 10 complete separation at the location of expansion joints between different parts along the buildings was also reported. The separation was recorded to, be widely at the top and narrow at the bottom (approximately 5 to 1 cm, respectively).

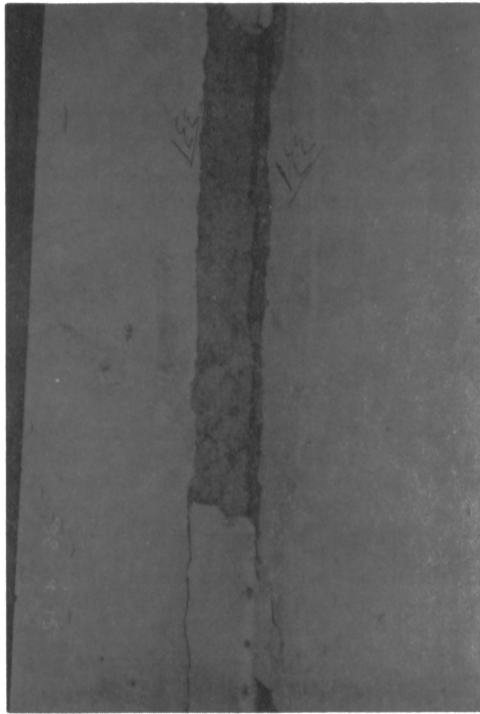
Photo 10 Example of Separation at the Location of Expansion Joints.
