## FOUNDATION WORKS FOR AKTAU PORT

**I. Rasin Duzceer**

*Kaskas Piling, Drilling Co.,  
Istanbul, Turkey*

The purpose of this paper is to review the design, installation and performance of steel tubular piles and steel sheet piles in the Port of Aktau, Kazakhstan. Due to steady increase in the level of Caspian Sea since 1977, the level of the existing quay was increased. The works consisted of rehabilitation of quay frontage including general raising of the port working areas by about 2 meters. The subsoil consists of 5 m medium dense to dense fine sand underlain by 6 m thick very stiff silty clay. Fractured limestone were encountered at a depth of 14 m. A total 592 vertical and raked piles of 660 mm diameter and 106 piles of 865 mm diameter were installed under the new quay. Two compression and one tension load tests were carried out on 660 mm piles to verify the design criteria and installation procedure. At a distance of 3,50 m from the existing quay wall a new sheet pile wall was formed by driving Larssen type sheet piles.

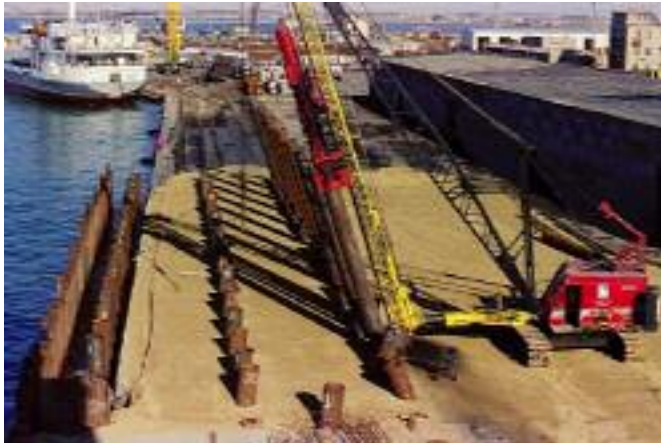
Fig 4. Installation of Raked Piles

The project at the Port of Aktau involved driving open ended steel pipe piles. Grade 43A spirally welded steel tubes complying with BS 4360 and BS 3601 were supplied to site in 12 m lengths. Piles were driven with a Delmag D-36 single acting diesel hammer mounted to Link Belt LS 118 crawler crane. Pile driving was continued until either driving resistance criteria or the desired tip elevation was obtained. The pile tips were protected from buckling by a stiffening ring. Internal rings were used for piles subject to tension where support to the pile is provided by skin friction. Installation of raked piles is shown in Figure 4.
