## DEEP BASEMENT CONSTRUCTION THROUGH AN EXISTING BASEMENT AT THE CENTRAL BUSINESS DISTRICT OF HONG KONG

**Stephen TM Young PE**  
Associate Principal  
Arup, New York, USA

**James WC Sze CEng MICE MHKIE MStructE**  
Senior Geotechnical Engineer  
Arup, Hong Kong

### ABSTRACT

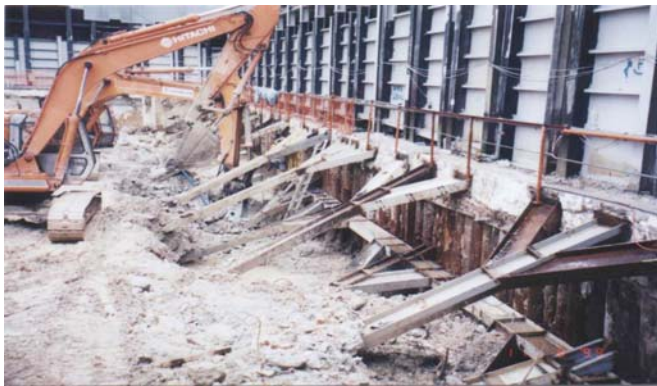
Plate 1 : Existing Basement Trimming Works

Local trimming/demolition of the existing basement structures and foundations formed part of the advance work in the Swire House demolition contract to facilitate the construction of the new peripheral diaphragm wall and bored piles construction. Where the existing basement wall could not be used to support the local trimming/demolition, pipe pile wall was installed along the perimeter of the site to enable the trimming works, as shown in Figure 3. The pipe pile wall also acted as the outer guide wall for the subsequent diaphragm wall construction. In some areas, the existing pile caps and raft were located along the pipe pile wall alignment and diamond coring through the reinforced concrete caps was required to permit penetration of the pipe piles. A grout curtain was installed by performing chemical grouting through the slotted pipe piles. The pipe pile wall was supported by raking steel struts prior to trimming of the existing basement wall, piled raft and pile caps (Plate 1). Where pumping of water was required, local sump pumps were used.

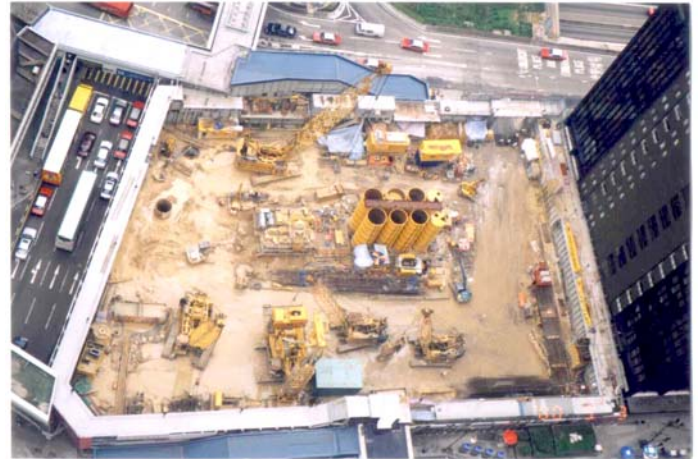
Plate 2 : Aerial View of Foundation Construction

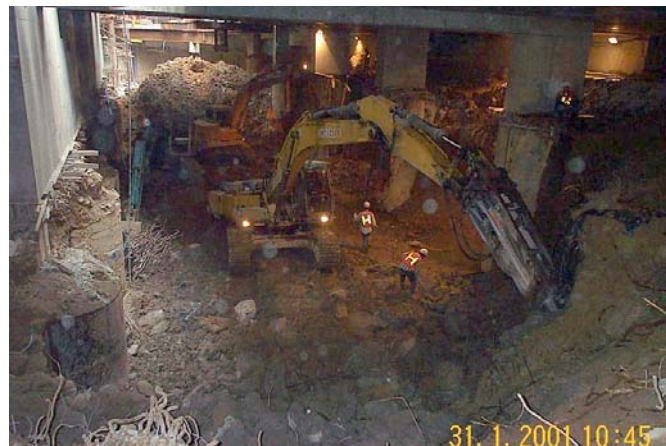
Plate 3 : Basement Excavation

During the Chater House basement excavation, demolition of the existing basement structures was carried out using backhoe and hydraulic breaker (Plate 3). Since the majority of the existing Swire House basement structures and piles were to be removed, the Chater House basement excavation program was relatively long compared to normal excavation works. The new basement structure, together with the superstructure, was completed in December 2001. This was followed by the building services work and the occupation permit was obtained in June 2002.

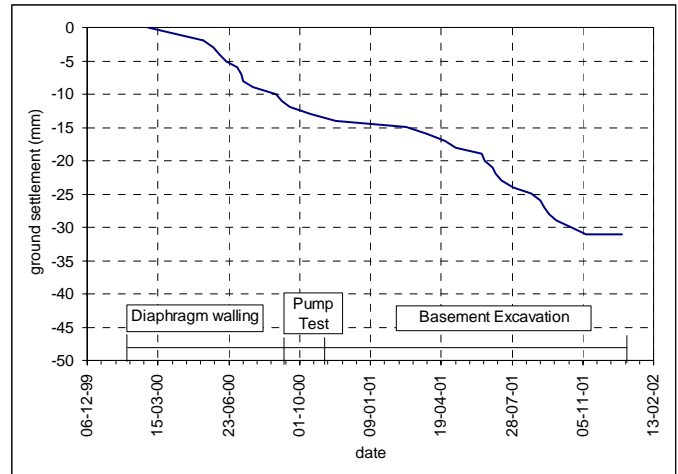
Figure 4 shows the trend of ground settlement at different stages

of construction. The ground settlement caused by the diaphragm wall installation attributed about 40% of the total ground settlement, while the basement excavation attributed to 50% of the total ground settlement.

Fig. 4 : Ground Settlement Trend

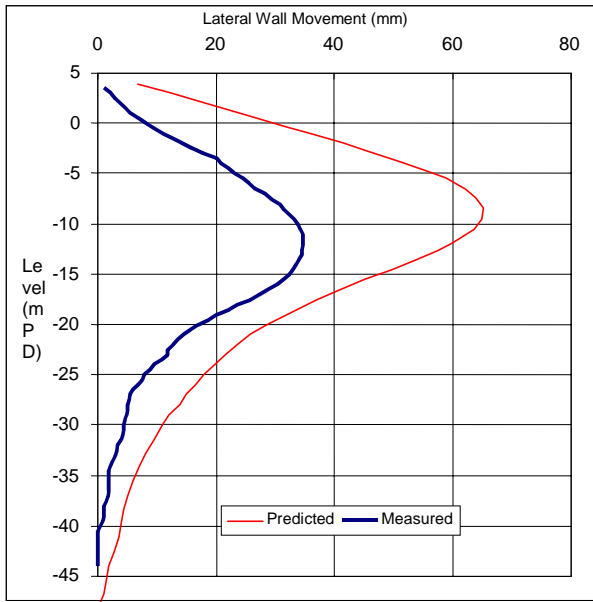
Fig. 5 :

The predicted and measured diaphragm wall lateral movement at Pedder Street during basement excavation is shown in Figure 5. The predicted and measured displacements at the adjacent ground and structures are compared and summarized in Table 2.

Diaphragm Wall Movement at Pedder Street

The measured movements are well within the predicted values. There are several reasons attribute to the differences :-

- Heaving of ground occurred during demolition of Swire House and offset part of the settlement;
- Only 2-D analyses were carried out and the 3-dimensional effect was ignored;
- Soil small strain stiffness has not been considered;
- Soils at the site and the surrounding areas are well pre-loaded due to substantial groundwater drawdown in the past, and due to loading of Swire House;

- No account has made for the influence of existing Franki piles within and around the site.
