## Excavation of Open Pit “Zagrad” in Rijeka, Croatia, A Case History

## EXCAVATION OF OPEN PIT “ZAGRAD” IN RIJEKA, CROATIA, A CASE HISTORY

### ABSTRACT

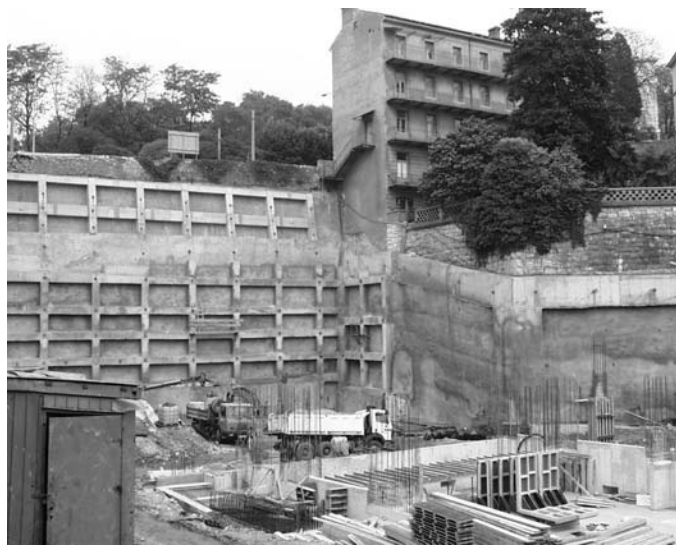
*Fig. 2. Cut "North" and "East", in an excavation phase of the bottom of the open pit*

On the south part of the open pit, with lower height of rock cuts, usual methods of reinforcement of rock mass by rock bolts and multi-layered reinforced sprayed concrete, were used, Fig. 2,3.

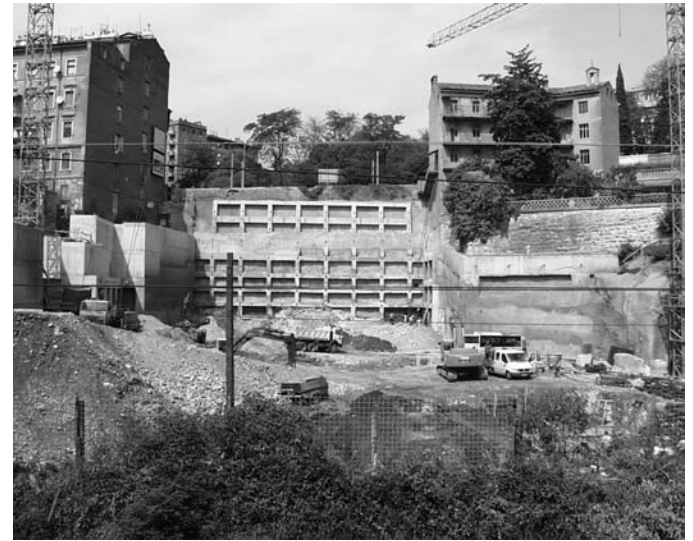
*Fig. 3. A view of the open pit during the execution*

In other parts of the open pit, complicated requests to secure rock cuts were also dealt, particularly in the excavation under the building Pomerio St. No. 19, Fig. 3.
