Managing Sinkholes at Project Site, A Saudi Arabian Case History

Syed Faiz Ahmad, M. ASCE
Saudi Oger Ltd
Riyadh, Saudi Arabia

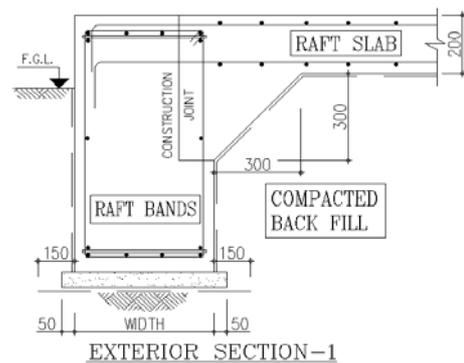
Fig: 1 A typical Section of Semi-Rigid Raft Foundation

Semi-Rigid Raft Foundation, adopted for the Project Site, is a proposition. It is a Mat like foundation with thickened edges or Raft Bands. This was used in the Project to circumvent the problems of Cavities and Sinkholes at the Site. This is rigid enough to bridge over the Cavities. PCA-MATS was used to analyze & design the same. As per the Geotechnical Report a Bearing Capacity of 150 KN/m² was used to design the Foundations. A comparatively low value of Bearing Capacity was recommended keeping in mind the weathered conditions of the rock and the Karstic Terrain. A typical detail of the subject system is attached as Fig: 1.

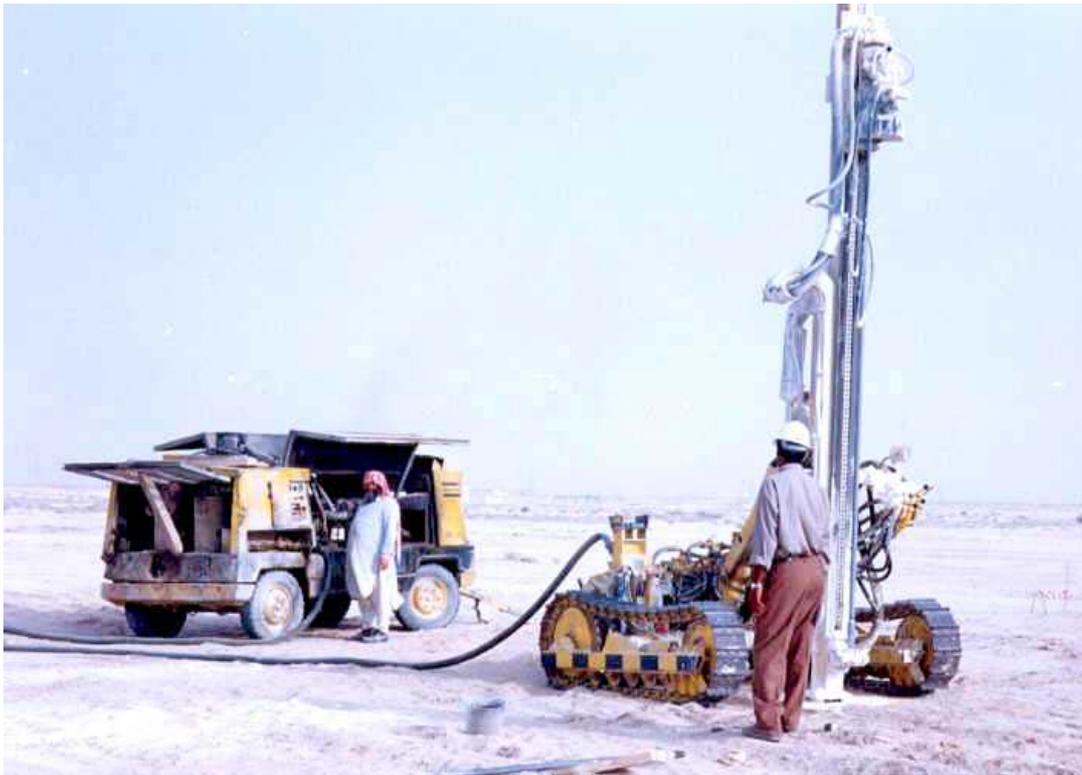
Plate: 1 Cavity Probing in progress at the Site

or absence of the cavities, before going ahead with pouring of foundations. A total of 5,610 nos. of Probe holes (in 166 facilities in 06 zones) were performed. This included an additional 219 nos. around the problem areas in 18 nos. of facilities. The Cavity search program was very detailed & extensive. The Probing was carried out by means of pneumatic driving of a rock probe into the rock using a Wagon Drill. Compressed air was used to clean the hole as advanced. The time of penetration of probe through each consecutive depth of 20 cm was carefully recorded which indicated the resistance of rock to penetration. In case of occurrence of cavity/loose zones in underlying strata, the time for penetration records will be comparatively small. A duration of less than 10 seconds for 20 cm penetration is considered the presence of loose zones, while in case of cavity, there will be no resistance to rock penetration and it occurs all of a sudden.

- Time taken for 20 cm penetration
- Air escape in the finished boreholes
- Sudden fall of drill rod
- Boreholes, where time was 10 seconds or less

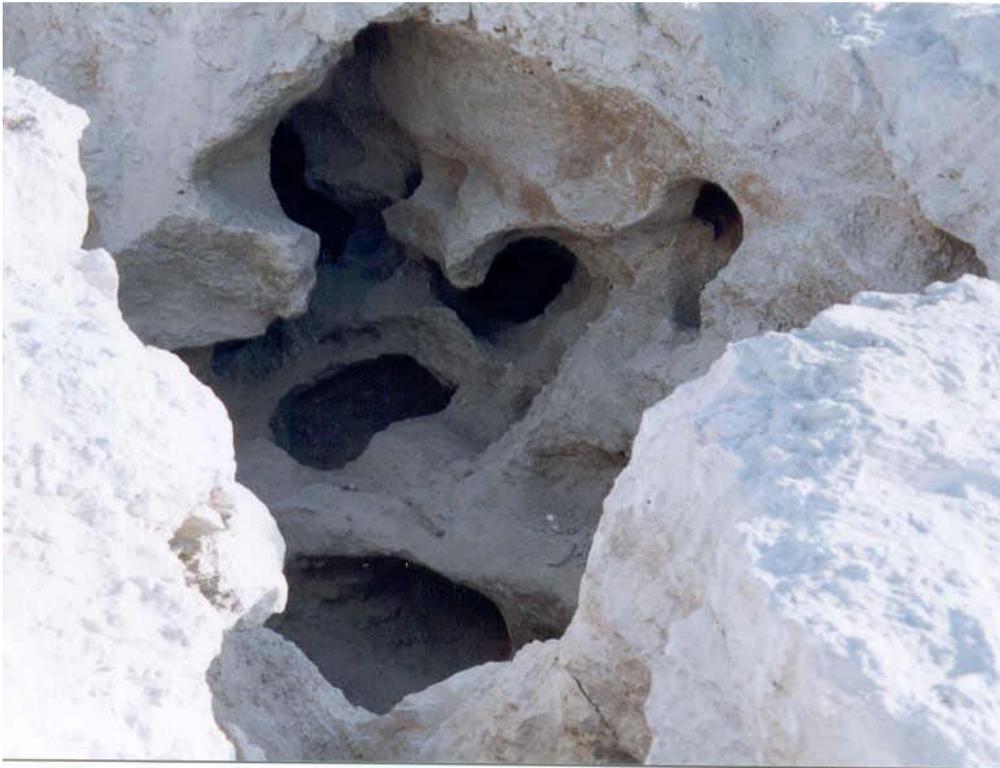
Plate: 2 A Typical Sinkhole at the Site

At the Project Site, Sinkholes identified ranged from “small dropouts” or simply trenches to large sized (about 2-m wide) irregular depressions. At some places, luckily outside the buildings, some cave like holes were found which had multi-lateral solution channels like features. Some of the pictures of these Sinkholes, discovered at the Project Site, are attached.

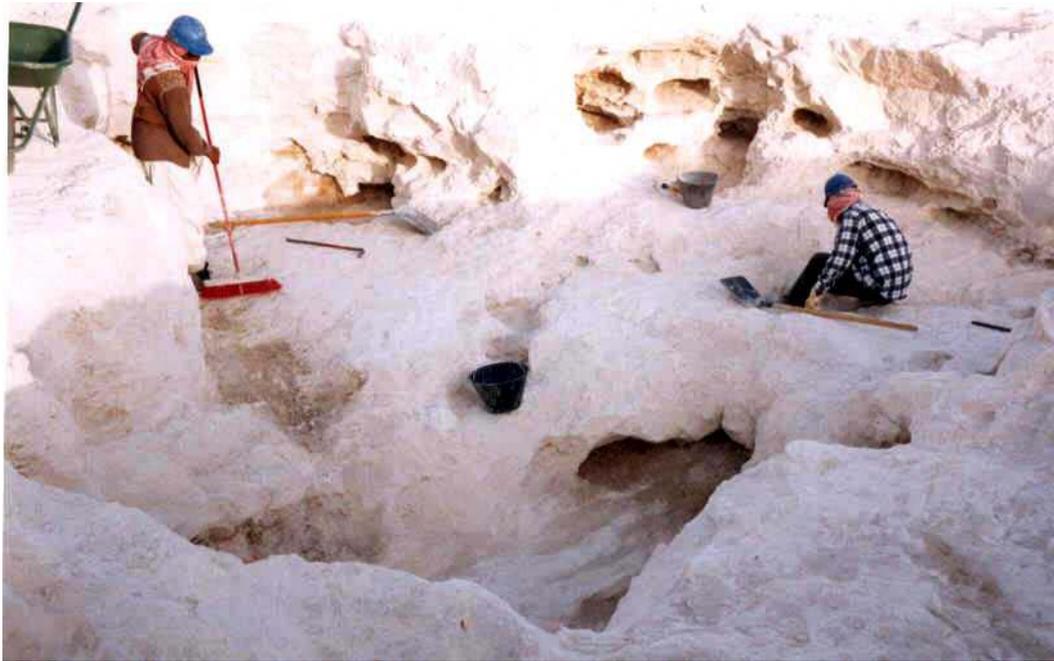
Plate: 3 Preparation being made for Treatment of Sinkhole at the Site
