## Restoration of PATH Service to Lower Manhattan

### ABSTRACT

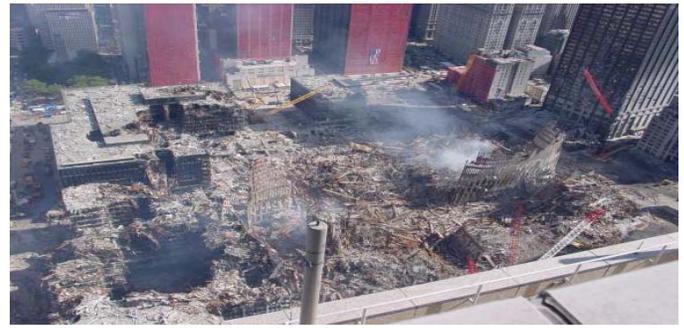
Fig. 3 WTC Devastation

The destruction at the WTC site was nearly complete (Fig. 3). The PATH station was situated immediately east of Tower 1 and the tracks leading into the station passed directly under Tower 2. Although portions of the station were still intact after the towers had collapsed, these could not be preserved during the massive removal process. The track work within the WTC site was also a loss, either being crushed or totally fouled with debris materials.

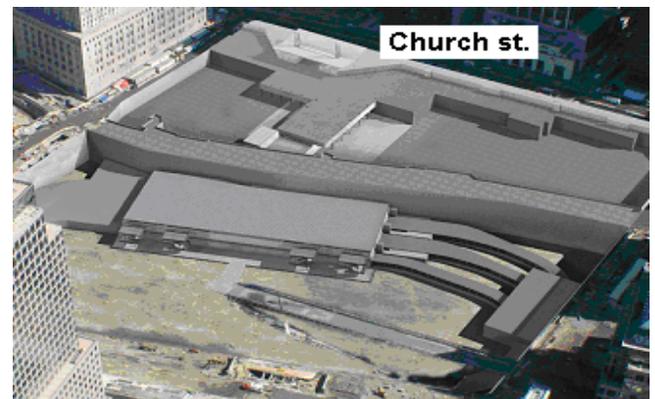
Fig. 4 Temporary PATH Station

The temporary PATH Station is being built at the same location as the destroyed facility within the WTC basement (Fig. 4). This site selection greatly expedited the track alignment and configuration design, and mitigated the need for property acquisition. The temporary station is a three platform and five-track configuration, similar to the former WTC station. Above the platforms, a mezzanine level has been constructed with stairs and elevators connecting the two levels. The original escalator passageway from the PATH station was found intact and has been incorporated (with new escalators) into the temporary station for egress.

The original column grid and foundations have been reused wherever possible to minimize additional excavation and foundation work. The new PATH station platforms are founded on spread footings bearing on bedrock. The mezzanine and pedestrian corridors, leading from the station to the main entrance on Church Street, are supported on the caissons that once supported the WTC Plaza levels and WTC 5 Building.

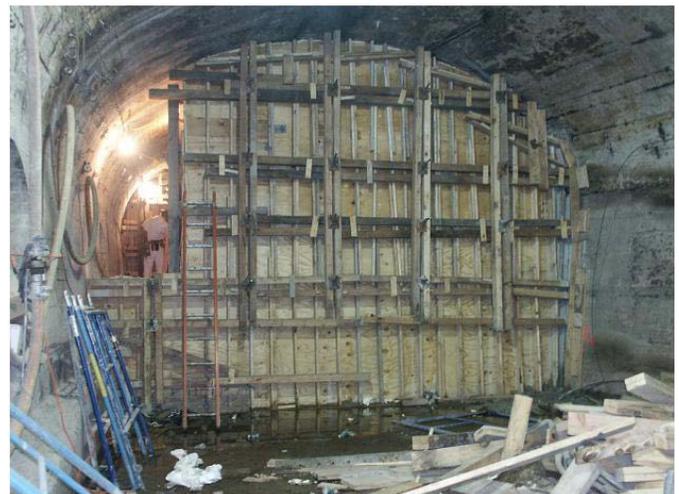
Fig.10 Formwork for Tunnel Backfilling

The combination of the rock removed for the original tunnels and the required rock removal for this project would have created rock cavern dimensions in excess of the rock span capacity. In order to keep rock arch and pillar stresses within acceptable limits, sections of the existing tunnels were backfilled with mass concrete (plugs). This required that voids above the tunnel, between the lining and rock, be contact grouted. Then mass concrete backfill was formed and placed, followed by contact grouting of any voids that may have formed between the concrete backfill and the lining (Fig. 10).

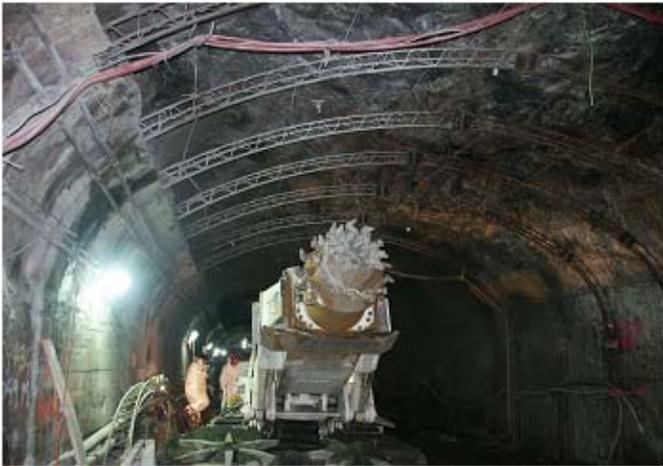
*Fig. 11 Roadheader*

Traditionally, the Manhattan Schist has been mined using blasting, the schist being considered too hard to be mined economically with roadheaders (Fig. 11). With compressive strengths averaging 30 mN, this region of the Manhattan Schist appeared suitable for roadheader excavation. A small roadheader was brought in from West Virginia and tested. The machine was very productive when it was operating, but required an inordinate amount of repair work to keep running. However, it demonstrated that roadheaders could effectively remove the rock.

Orders were immediately sent out for two higher capacity machines and by the time the project reached completion a total of three roadheaders were in operation.
