Restoration of PATH Service to Lower Manhattan

Raymond E. Sandiford, P.E.
Chief Geotechnical Engineer
The Port Authority of NY & NJ

ABSTRACT

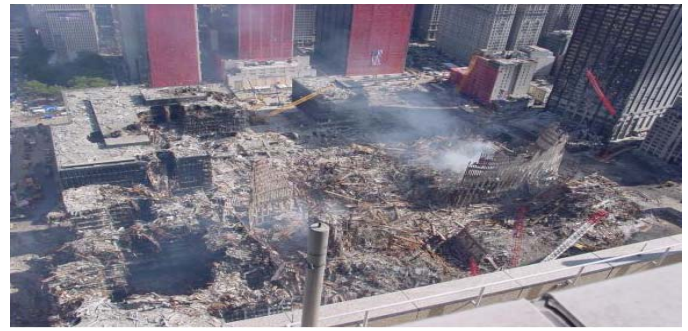
Fig. 3 WTC Devastation

The destruction at the WTC site was nearly complete (Fig. 3). The PATH station was situated immediately east of Tower 1 and the tracks leading into the station passed directly under Tower 2. Although portions of the station were still intact after the towers had collapsed, these could not be preserved during the massive removal process. The track work within the WTC site was also a loss, either being crushed or totally fouled with debris materials.

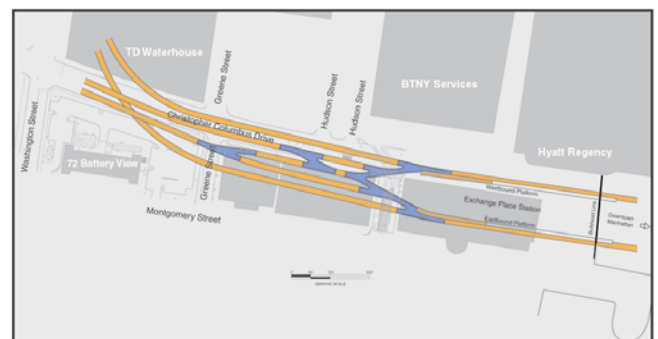
Fig. 7 Exchange Place Cross-Overs

The construction of the track crossovers on the New Jersey side of the Hudson required the merging of five existing rock tunnels (Fig. 7). These were situated beneath three office buildings near the waterfront in Jersey City, NJ.

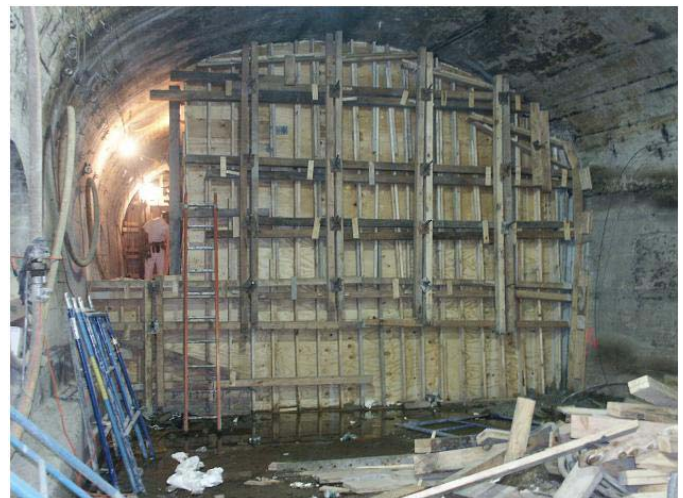
Fig.10 Formwork for Tunnel Backfilling

The combination of the rock removed for the original tunnels and the required rock removal for this project would have created rock cavern dimensions in excess of the rock span capacity. In order to keep rock arch and pillar stresses within acceptable limits, sections of the existing tunnels were backfilled with mass concrete (plugs). This required that voids above the tunnel, between the lining and rock, be contact grouted. Then mass concrete backfill was formed and placed, followed by contact grouting of any voids that may have formed between the concrete backfill and the lining (Fig. 10).

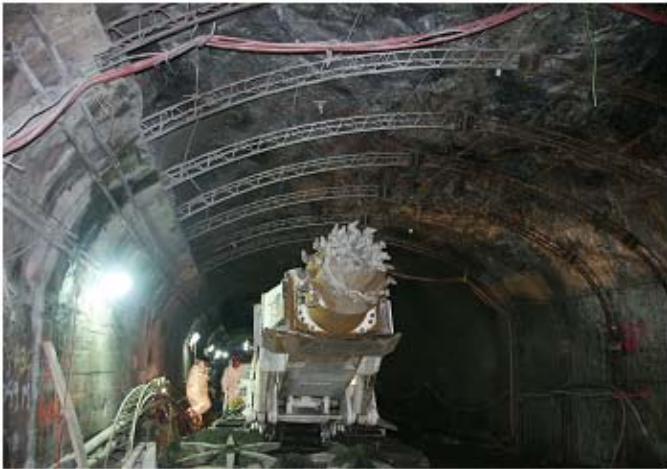
Fig. 11 Roadheader

Traditionally, the Manhattan Schist has been mined using blasting, the schist being considered too hard to be mined economically with roadheaders (Fig. 11). With compressive strengths averaging 30 mN, this region of the Manhattan Schist appeared suitable for roadheader excavation. A small roadheader was brought in from West Virginia and tested. The machine was very productive when it was operating, but required an inordinate amount of repair work to keep running. However, it demonstrated that roadheaders could effectively remove the rock.

Orders were immediately sent out for two higher capacity machines and by the time the project reached completion a total of three roadheaders were in operation.

In addition, sufficient muck had to be kept on hand to create embankments for the roadheaders to reach the higher arch levels. The other major challenge was dust control. Aside from health considerations, which required workers to use respirators on nearly a continuous basis, a number of dust suppression measures had to be taken to prevent dust from migrating down the tunnels and into stations in the active portion of the system. The measures included foam sprays at the roadheader cutter-heads, scrubber and bag house, temporary tunnel bulkheads, and water curtains.
