## A Field Test Study on Instrumented Soil Nail Installed in Cut Slope

## **A FIELD TEST STUDY ON INSTRUMENTED SOIL NAIL INSTALLED IN CUT SLOPE**

### **ABSTRACT**

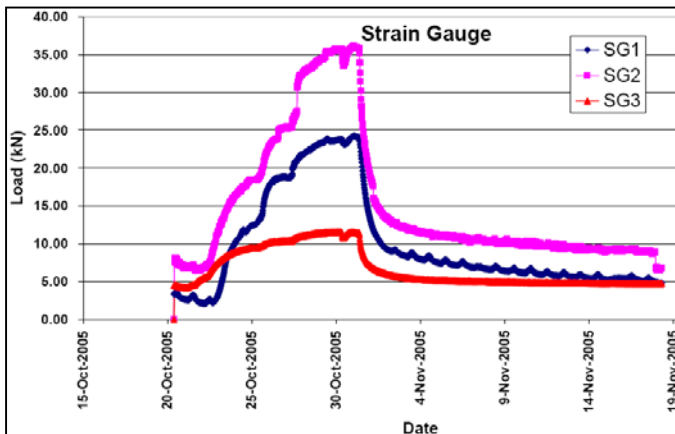
Figure 9. Load recorded in soil nails during induced rise in groundwater table.

Figure 8 shows the maximum pore water pressure recorded in the piezometers (P2, P5, P5 and P8 location refers to Figure 5) and Figure 9 shows a typical plot of the maximum load developed in the nails (N9 location refers to Figure 10) between 20 Oct. and 31 Oct. 2005.

and the load developed in the nails were spontaneous and synchronized, as reflected by the gradient of the curves in Figures 8 and 9.

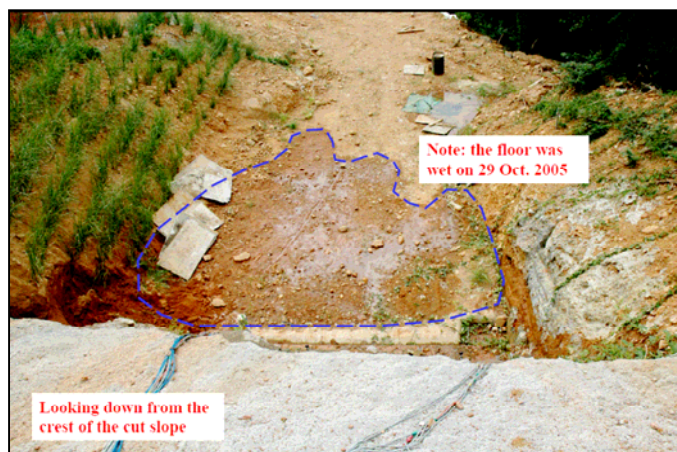
Figure 13. The floor of the slope was wet on 29 October 2005.

The purpose of the grout curtain was to retain the injected water within the soil masses and to induce a rise in piezometric elevation. Its construction was successful as demonstrated by the piezometer readings described and the seepage observed. With a very close spacing of 0.5 m c/c at the base of the slope, the grouted holes have formed a relatively impermeable layer and allowed the water level to rise. As noted earlier, a U-channel was constructed at the toe of the slope to receive the surface runoff and to divert it away from the toe of the slope. It was very interesting to note that the floor was wet on the morning of 29 October 2005 (see Figure 13). Water could not have come from the slope surface because they were intercepted by the U-channel. The water was in fact came from below the base of the slope, as demonstrated by the water path indicated by the arrows in Figure 14. When the water level was very high on 29 October 2005, there was significant water pressure built up within the soil masses. Water eventually passed through the spaces between the bottom grouted holes, entered below the bottom of the slope and exit to the floor.
