## Application of Screening Analyses for the Stability of Landslide in Seymareh Dam Project

## APPLICATION OF SCREENING ANALYSES FOR THE STABILITY OF LANDSLIDE IN SEYMAREH DAM PROJECT

Seymareh dam and hydropower plant project is located in western province of Ilam, in Iran. This concrete arch dam with 178m height and 196 m crest length is to be placed on Seymareh River, the axis of which is located on the north wing of an anticline including Asmari limestone layers. The dramatic variation of dip angle of beddings in this part of anticline has created many fractures that result in slides. In October 1<sup>st</sup> 2003, when excavation in the left bank was being operated to construct an access road to the valley, a large landslide triggered on the top of power tunnel intake. The landslide completed in November 10<sup>th</sup> 2003 few hours after an intensive rainfall by leaving some 300000 m<sup>3</sup> mass of debris. The sliding was a planar failure on a thin marly limestone of 26° dip and 40 cm thick. Due to the future location of water intake structure at the entrance part of power tunnel, it was quite vital to save this structure from any further movements of the debris left

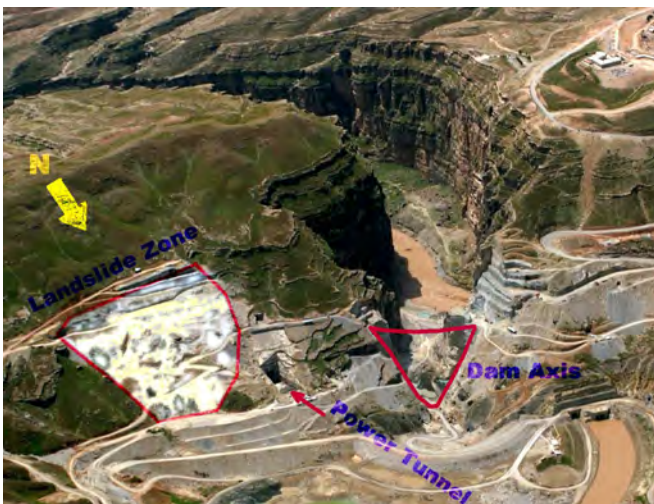
Fig. 1. Situation of landslide zone adjacent to the power tunnel entrance

In October 1<sup>st</sup> 2003, when the excavation in the left bank was being operated in order to construct an access road to the valley, a large landslide triggered on the top of power tunnel intake. Figure 1 shows the landslide zone in the project area.

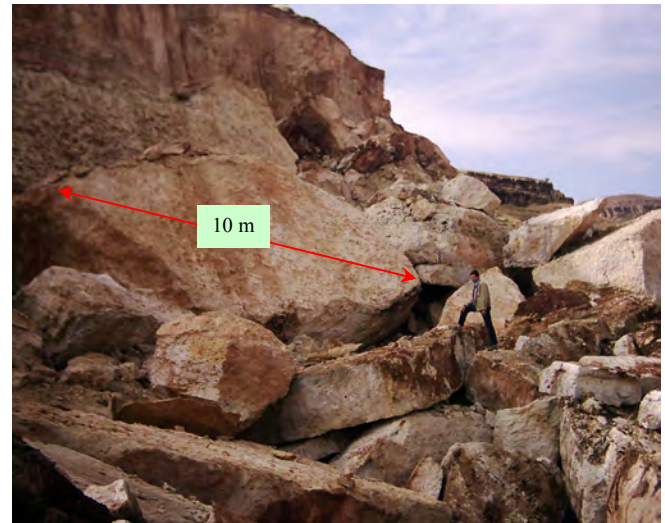
Fig. 2 The large blocks left by landslide

The landslide completed in November 10<sup>th</sup> 2003 few hours after an intensive rainfall. The event created a huge mass of debris by 300000 m<sup>3</sup>, in which the size of some rock pieces could exceed 10 m (Fig. 2). The scope of area before and after final collapse is displayed in Fig. 3. The sliding mass can be defined by a tension crack of 20 m height and 200 m long in the above and a sliding planar surface of 26° dip and with about 100 meters horizontal lengths. In the west part of failure zone, where the power tunnel entrance is located in the bottom, many large blocks were stopped unstably. Because of the future location

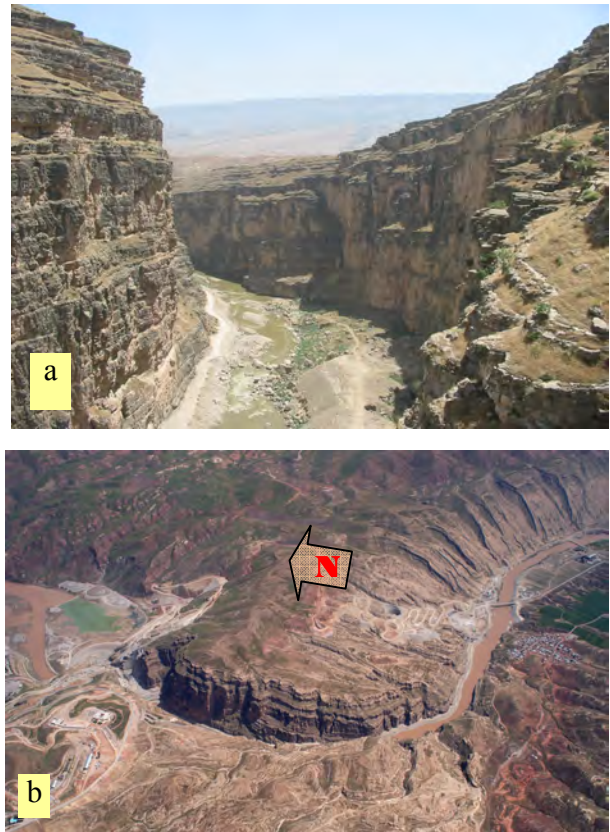
Fig. 4. The morphology of Seymareh site, a) U shaped valley, b) Ravandi anticline

The morphology of the site includes a U shaped nearly symmetrical valley with steep and someplace negative slopes at abutments, crossing the bedding strike perpendicularly. At the gorge of dam site the width of river varies from 40 to 50 m and its trend varies from NW-SE to NE-SW. To the downstream direction, beyond the anticline axis and its southern limb, the river again adopts a NW-SE trend and flows in to the Talkhab plain and finally joins Karkheh River (Fig. 4).

Ravandi anticline is the main geological structure in this area. As mentioned before, the Seymareh dam site lies in the northern limb of Ravandi anticline. The axis of the anticline trends E-W and plunges E at the dam site. In fact, Ravandi anticline is a double plunge fold which its another plunge in the reservoir area is NW. The axis of anticline in dam downstream has been turned due to tectonic forces. Because of this, the E-W trend of anticline has changed to NW-SE as illustrated in Fig.

4b. This situation has caused more abundant fracturing & crushing relative to that of the northern limb in which the dam body will be situated. The emergence of a great number of springs in the southern limb of the Ravandi anticline can be attributed to this.

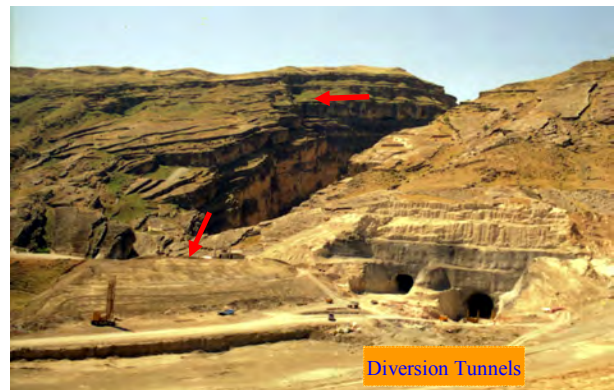
Fig. 5. Dramatic variation of bedding dips at the northern limb of Ravandi anticline

The northern limb of Ravandi anticline, where the dam will be constructed, consists of slopes with varying dips, ranging from 45-50 degrees at the start of gorge, to 10-15 degrees at the downstream of dam (Fig. 5). At dam abutments there are small gullies with steep walls formed along the bedding planes and fractures. Lack of vegetation around the dam site has made a rocky nature with a surface showing resistance against erosive factors. The overburden materials in Seymareh dam site include alluvial deposits, Lacustrine deposits, Talus and Old alluvial deposits. The main part of the materials is Lacustrine deposits, which have a 35 m thickness. This deposit consists of greenish gray silty clay with high plasticity & sandy intercalations resulted from the formation of natural lake due to the huge Kabir Kuh landslide. The well-known Kabir Kuh landslide, sometimes so called as Great Seymareh landslide is the largest in the world located 50 km far from the dam site.

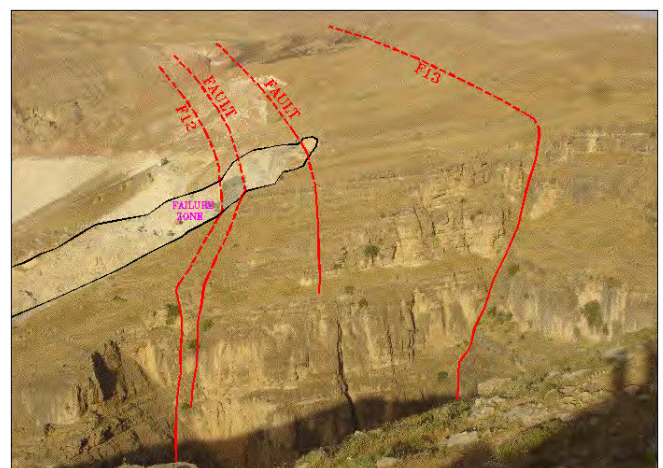
Fig. 7. The extension of tension faults and major joints in the left bank (view from the west)

In northern limb which the layers are dipper, many tension faults have been created due to the bending action of anticline. Figure. 7 shows the scope of such faults in the left bank which extended to the east. The failure zone arising from the landslide is seen in the Figure. The pre-existing fault F12 played the role of main tension crack for the landslide of Seymareh project. Several normal faults & main joints are recognized in Seymareh dam site, most of these fractures are parallel with strike of bedding & anticline axis. Two sets of major joints and one set of minor joints excluding bedding planes constitute the discontinuities of the rock masses. In the Upper Asmari unit at a distance 200 m east of the gorge and upstream of the dam axis there were dislocated rock masses covered an area of about 250\*300 m at elevations 620 to 800 m.a.s.l. These have been brought by old slides occurred along the bedding planes. The event of landslide on October 1st 2003 has occurred in the top of this area.

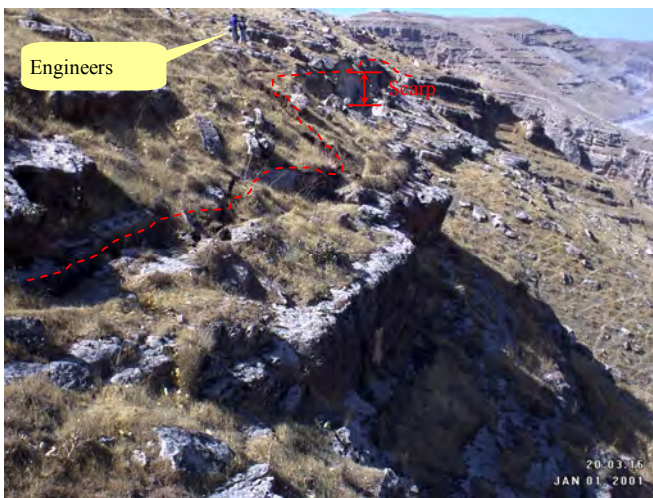
Fig. 8. Trace of main tension joint of the sliding mass on ground surface and resulting scarp

The landslide commenced by appearing a 20m high vertical joint in the top of the region in October 1<sup>st</sup> 2003. The sliding happened when the excavating operation of an access road to the valley was underway in the left bank at level of 730 m.a.s.l. In this excavation the toe of sliding mass was partially cut. After creation of the main joint and movement of the total mass some other joints were also detected gradually on the lower elevations so that the total area were subdivided into smaller pillars. Figure. 8 shows how the main joint has opened on ground surface during the progressive sliding.

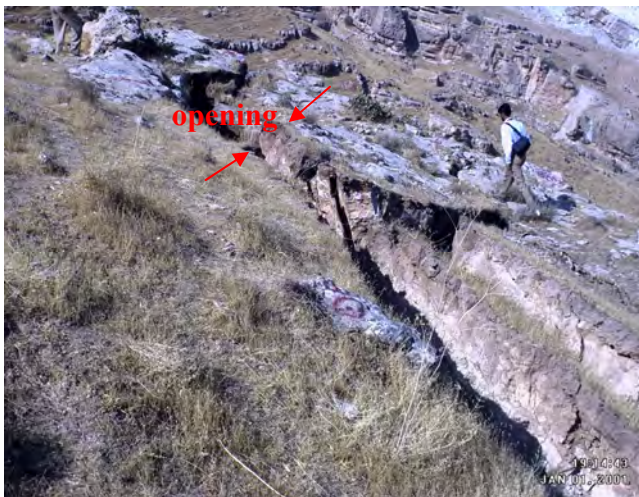
Fig. 9. The appearance of vertical joints in the southern wall of affected area and on the ground surface

The total displacement of sliding mass before the global collapse happened reached approximately to 4m on the main joint location. Figure. 9 illustrates the trace of main tension joint on the ground surface and the resulting large scarp. In the last hours of November 9<sup>th</sup>, 2003 an intensive rainfall caused the total mass to be saturated. Finally, at the midday of November 10<sup>th</sup> the whole mass collapsed totally and remained a huge mass of debris estimated by 300000 m<sup>3</sup> as shown in Fig. 2 and Fig. 3b. After this final failure, the fault F12 wall was clearly seen in a length of some 200 m with variable elevation from 20 to 40 m (refer to Fig. 3b). It was also observed that a clay filling material by 50 cm thickness is pasted to the most parts of fault F12 face. This indicated that the fault F12 was an old tension crack filled during a long history. After the total collapse of sliding zone some of the big dislocated blocks moved towards the power tunnel intake and stopped unstably on the above of this area as illustrated in Fig. 10.

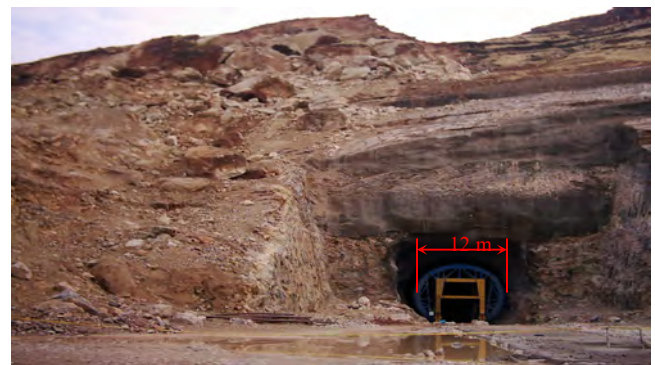
Fig. 10. The view of power tunnel intake and unstable rock blocks in the above after intensive rainfall leading to final collapse

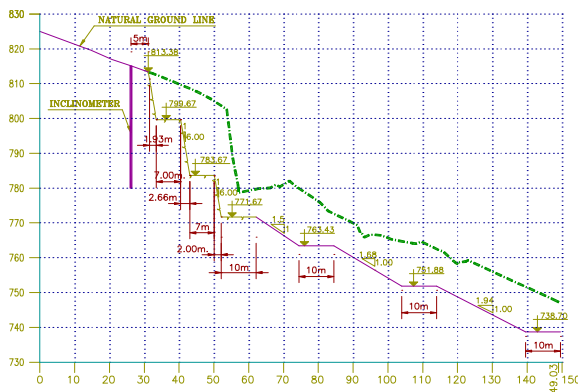
Fig. 11. The critical section of slope

The most critical section of slope which was selected for stability analyses is shown in Fig. 11. On the basis of exploratory boreholes and site visits before and after landslide occurs, three different layers were considered in two dimensional geometric model (Fig. 12).

Based on the above results, it was concluded that designed slopes and berms in Fig. 11 will be stable under static and seismic conditions.

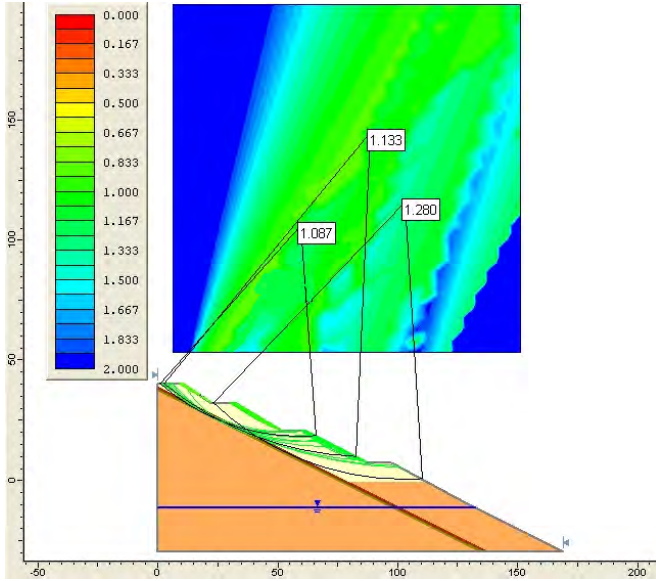
Fig. 14 Calculated factor of safety in Seed criteria by  $K_{eq}=0.15$

For seismic safety evaluation of slope, the simple proposed method of Seed (1979) was adopted in first step. The results shown in Fig. 14, illustrates a safety factor of 1.087 under seismic horizontal force with  $K_{eq}=0.15$ . Since the minimum allowable safety factor of 1.15 in Seed method (and even recommended minimum F.S=1.10 of Los Angeles method) is not obtained, the slope design should be changed or another analysis approach must be used.

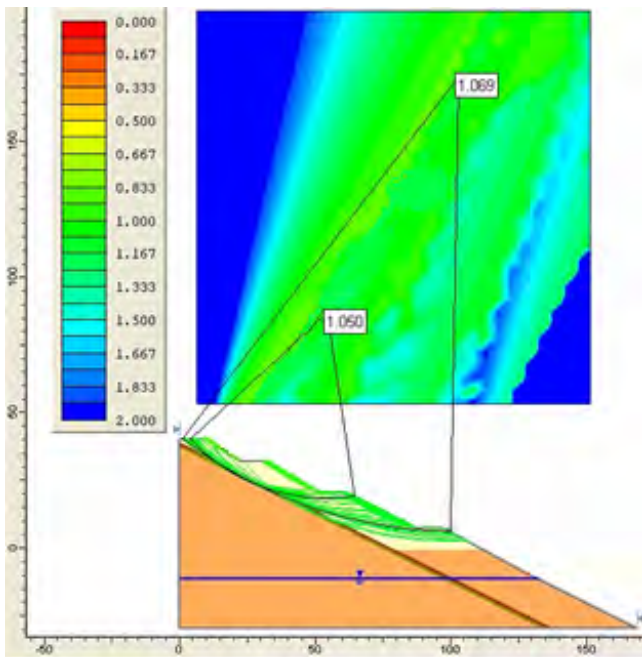
Fig. 16 Calculated factor of safety for threshold displacement of 5 cm and  $K_{eq}=0.154$

Pseudo stability analysis was then carried out with these two seismic coefficients showing minimum safety factor of 1.05 and 1.153 respectively for  $u=5$  cm and  $u=15$  cm (Figs. 16 and 17) Therefore,  $FS > 1$  and site passes the screen.
