Case Study of Failure of a R.C.C. Counterfort Retaining Wall

CASE STUDY OF FAILURE OF A R.C.C. COUNTERFORT RETAINING WALL

The present study through light on a failure of a recently constructed R.C.C. counter fort Retaining wall. The wall is located near Sangli city in Maharashtra state of India. The wall was constructed in 2003 and there was a heavy rainfall occurred in all over the Maharashtra state continuously in the year 2005 and 2006 subsequently in the catchments of river Krishna. The wall could not sustain the flood impact and there was a sliding, collapse and even rotational failure at some portion of wall was observed. Basically this wall was constructed to protect a village road about 1800m along a stream from flood water.

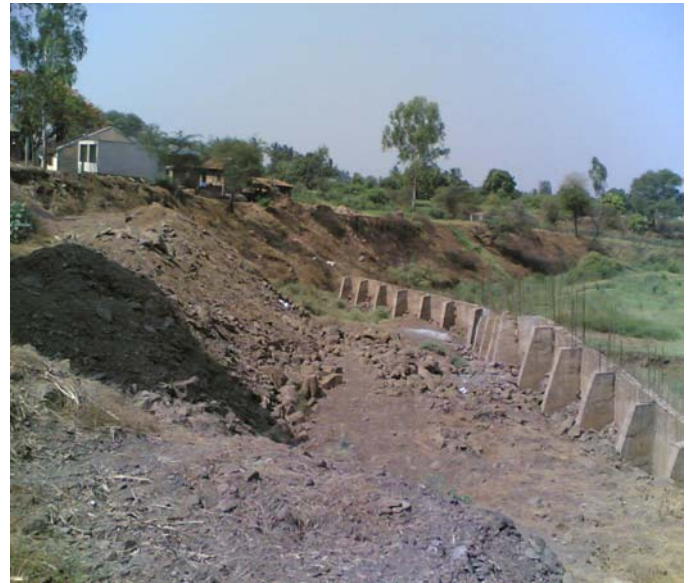
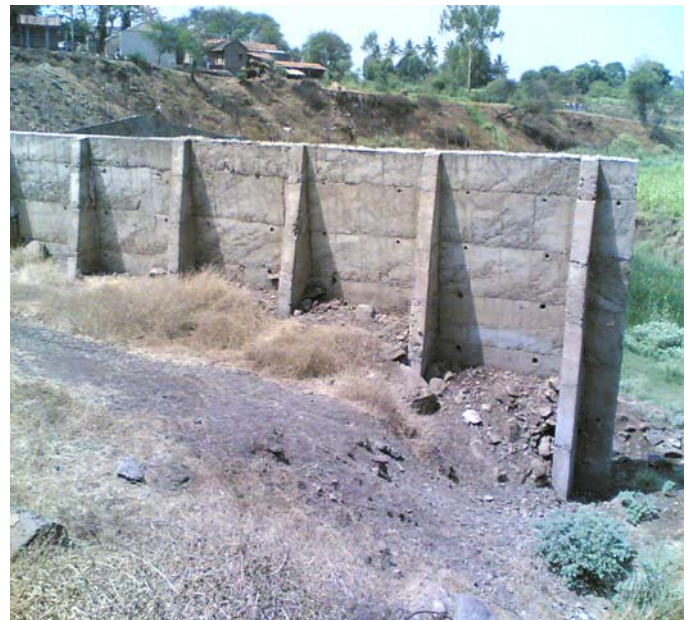
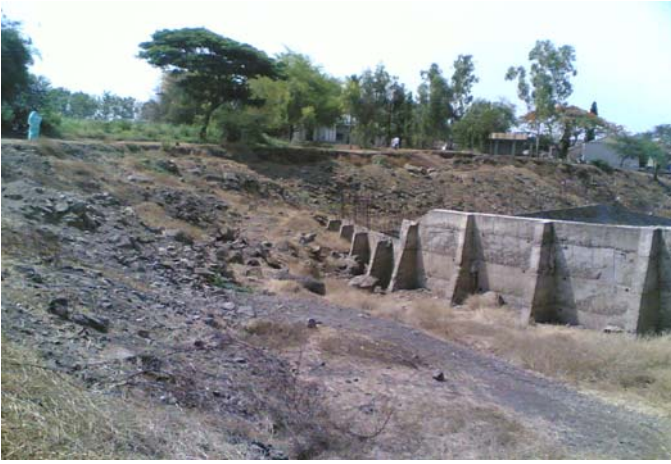
Photograph No.1,2 and 3 shows the total shifting of wall from its original position. The counterforts get exposed. The road along the stream is found to be completely damaged. The backfill material spread abruptly due to flood. The alignment of the wall is found to be changed completely. The entrance to the village Bamani is completely disturbed.

There was a lot of water pressure (Pore pressure) behind the wall during flooding was developed. This water pressure and velocity from the higher water level would have been sufficient to cause ground erosion in the river bank. With the erosion and saturation of the soil behind the wall which allowed the backfill material to move and remove support from the above material. This water found its way from under the footings, washing away the finer soil particles resulting in reduction of coefficient of friction.

The finer soil particles in the backfill were rendered into a semi-liquid condition increasing the active pressure. Thus the thrust at the back, helped by a large reduction in the frictional resistance, pushed out the wall bodily.

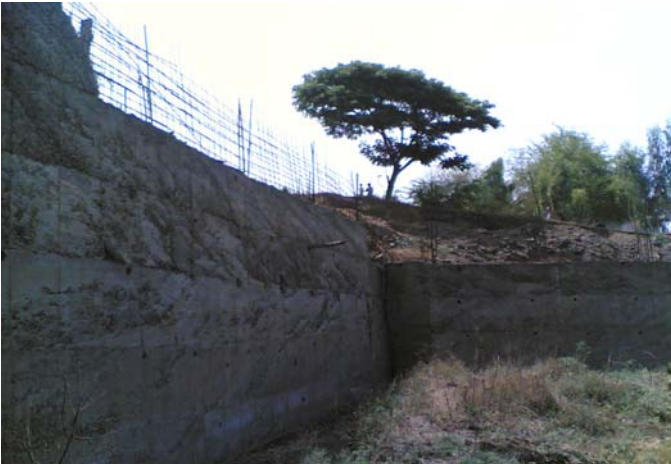
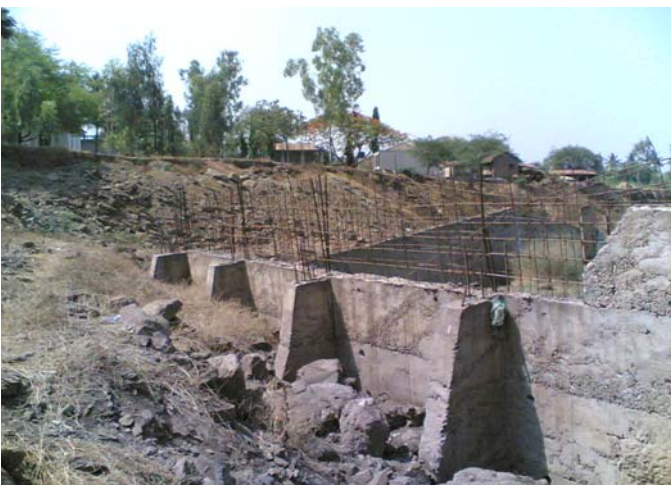
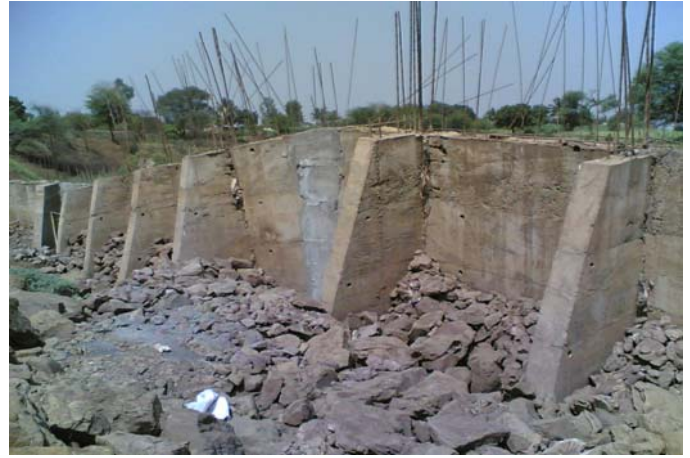
Photographs 4, 5 and 6 show the exposed reinforcement of the wall. The reinforcement is found to be completely damaged and lost the bond strength with concrete. Some patchwork is found in photograph 5.

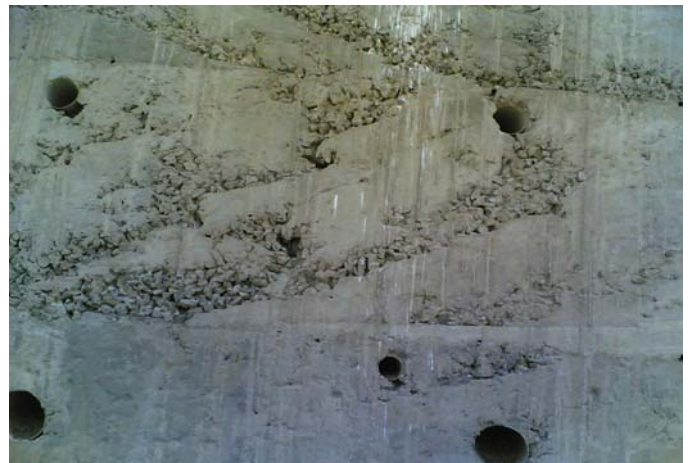
Photo 7

Photograph 7 shows the honeycombing in concrete and the bad workmanship and quality of the work. The weep wholes are also seen in the photograph.

Improper workmanship and inferior quality of work.

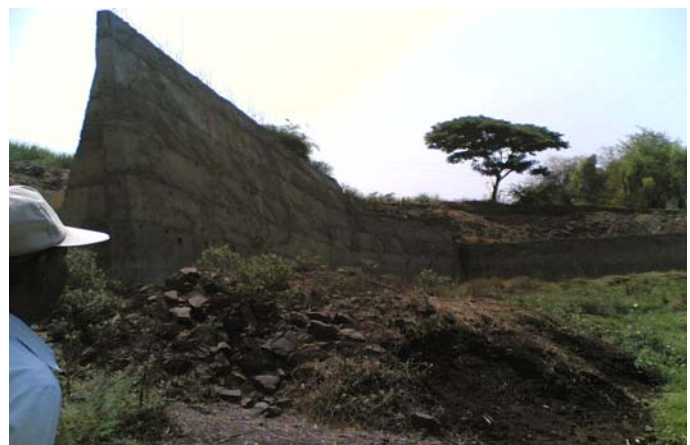
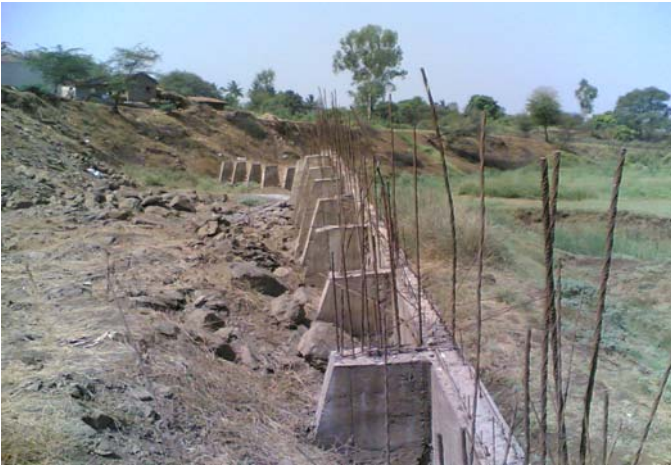
Photograph 8 and 9 shows a cross section and the longitudinal section of the damaged wall and some portion of the stream.
