## Case Study of Landslide in NH –13 at Kethikal Near Mangalore – India

### **Paper No. 2.69**

### **Abstract**

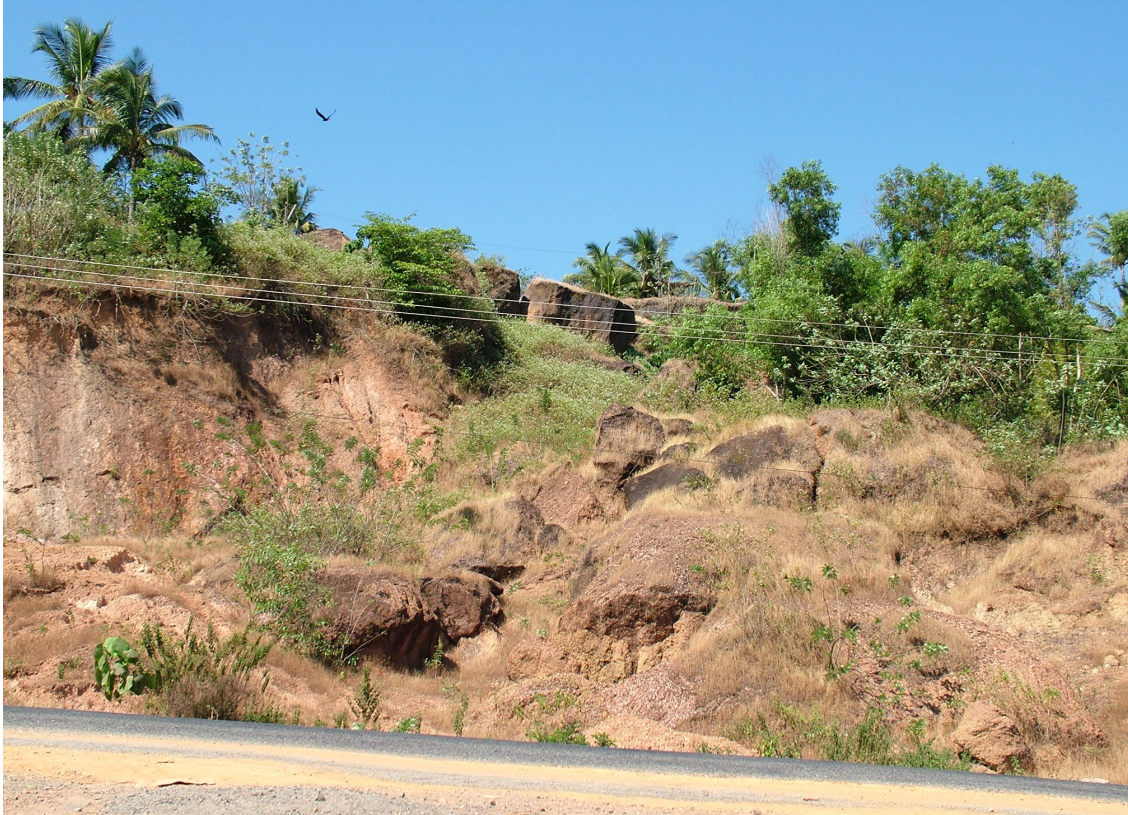
*Fig5: View of Kethikal land slide from the road level.*

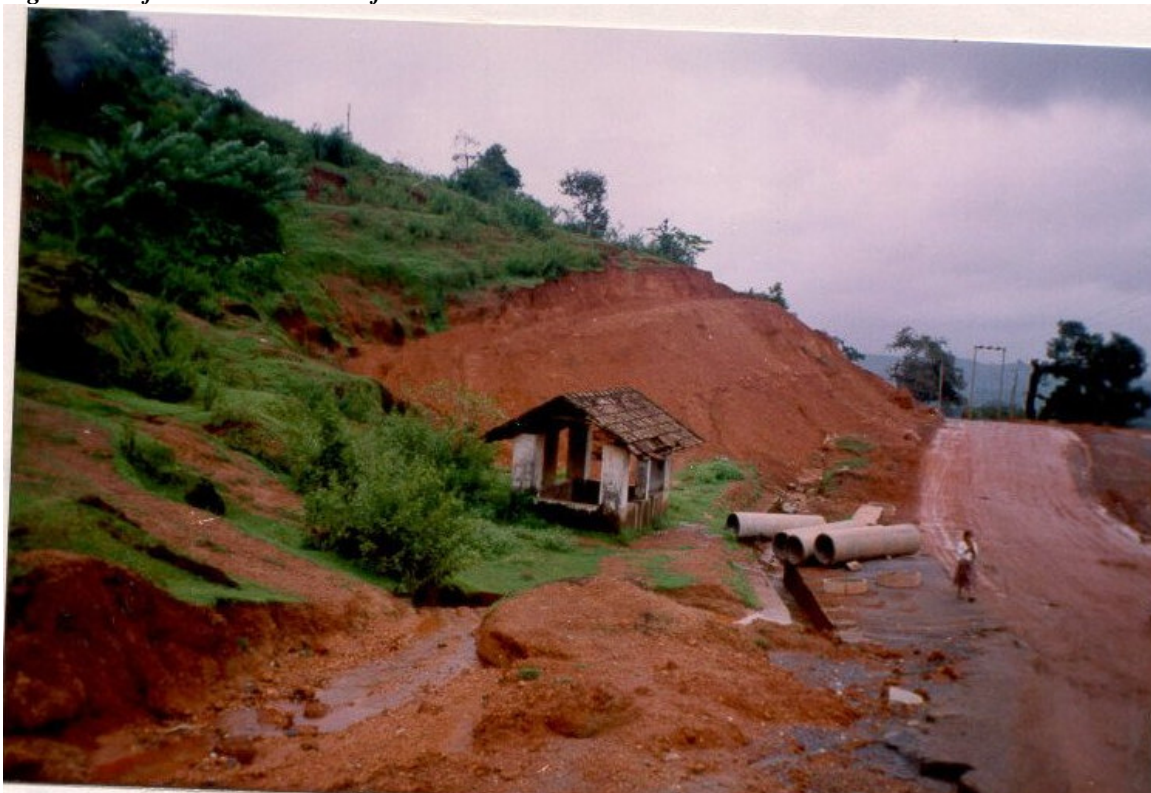
*Fig 6: Another view of Kethikal land slide from the top of hill.*
