International Conference on Case Histories in Geotechnical Engineering (2008) - Sixth International Conference on Case Histories in Geotechnical Engineering

Lessons Learned from Slope and Trench Failures in Japan

LESSONS LEARNED FROM SLOPE AND TRENCH FAILURES IN JAPAN

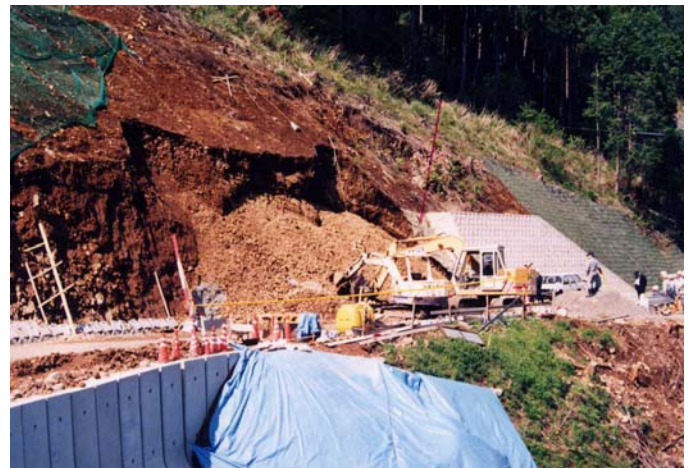
Fig. 1. Labor accident caused by slope failure.

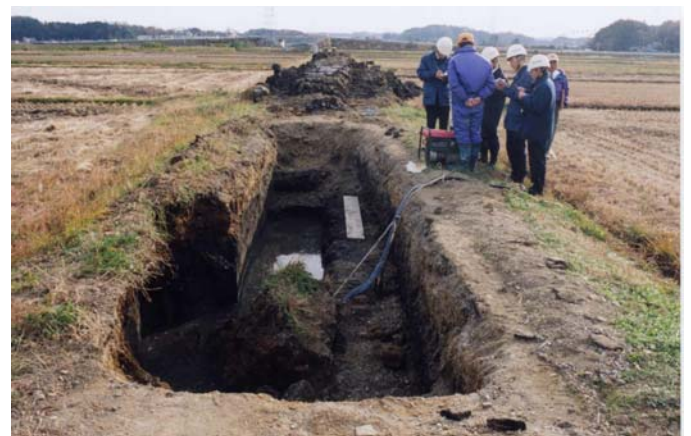
Fig. 2. Labor accident caused by trench collapse.

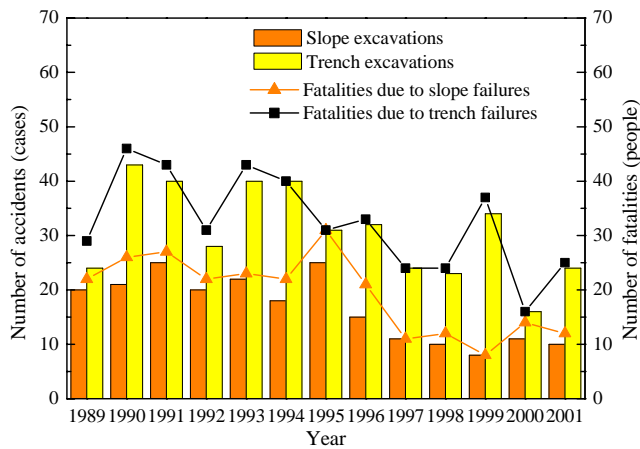
Fig. 3. Number of labor accidents caused by slope and trench excavations in Japan during 1989-2001.

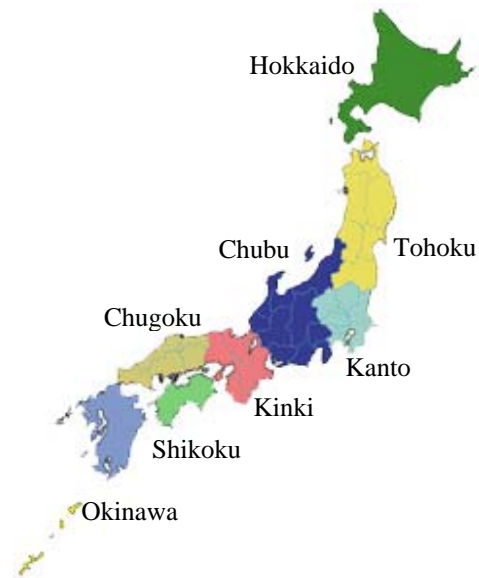
Fig. 4. Geographical regions of Japan.

Japan is officially divided into 8 main geographical regions: Hokkaido, Tohoku, Kanto, Chubu, Kinki, Chugoku, Shikoku and Kyushu (including Okinawa) regions as presented in Fig. 4. Figure 5 shows the distribution of the location of labor accidents in slope and trench excavations, the region with the highest percentage of accident was Chubu, followed by Kanto, Kinki and Kyushu regions. Since no data were available on the total number of slope and trench excavations in each region, so it was not possible to determine that slope and trench excavations in these regions were statistically more or less safe than other regions. However, it should be noted that most of natural landslides and slope failures in Japan commonly occur in these regions.

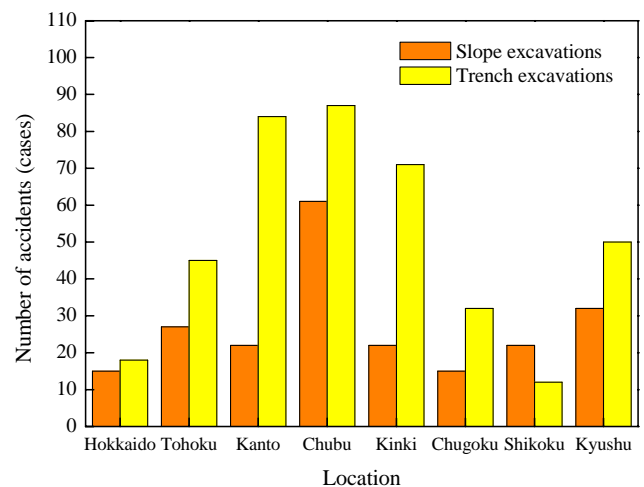
Fig. 5. Location of slope and trench failures.

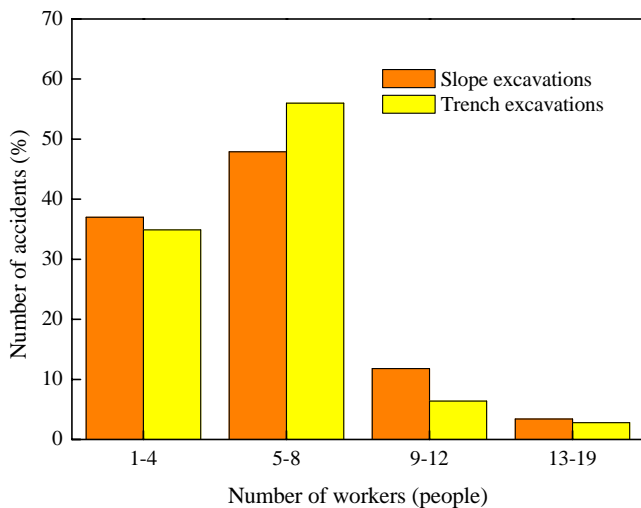
trench excavations the possibility of labor accident was higher in the construction work with a lower amount of project cost and relatively short construction period. Figure 8 shows the number of workers presented at the time of slope and trench failures; approximately 85% and 91% of the accident occurred in slope and trench excavation projects with less than 8 workers on the construction site. Because the number of workers can be related to the size of the contractor, so the possibility of accident is higher with the small contractor. This may be explained by the fact that the small contractors may not have operation chief and/or worker with appropriate knowledge concerning construction safety and they may not have sufficient budgets to provide adequate safety equipments.

Fig. 8. Number of workers presented at the time of failure.

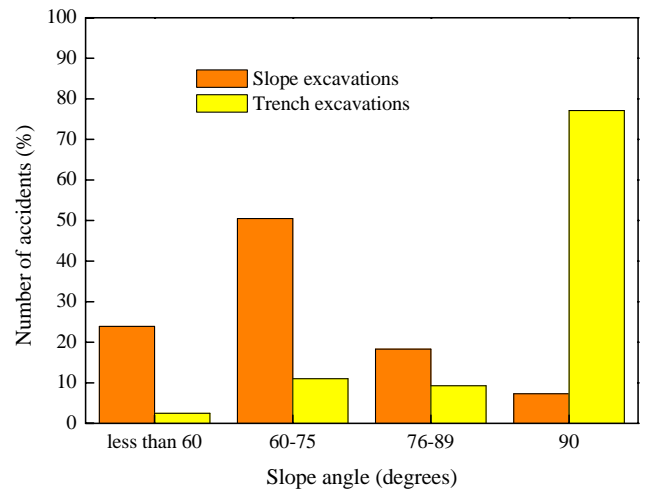
Figure 9 shows the number of slope and trench failures according to the slope angle. In case of slope excavation, most of slope failure (50%) occurred when the slope angle was 60 to 75 degrees. Because the minimum construction cost for trench excavation is generally achieved by adopting the steepest possible trench wall slope angles, unsurprisingly, about 77% of the accidents occurred in trenches with the slope angle of 90 degrees as shown in the figure. According to the study on natural slope failures in Japan by Monma *et al.* (1999), the slope failures occurred most frequently with the slope angle of about 40 to 49 degrees. Therefore, the frequency of failure of steep slope during slope and trench excavations is higher than that of the natural slope. Figure 10 shows the labor accidents caused by slope excavations classified by slope height. It was found that most of slope failures (55%) occurred with the slope height of 2 to 10m. Figure 11 shows the number of accidents according to trench depth, about 80% of trench collapses were reported in trenches shallower than 3m and only 2% of accidents occurred in trenches deeper than 5m. It should be noted that only 4% of slope failures occurred in slope height less than 2m, however, in case of trench excavation about 40% of trench collapses was observed in trenches shallower than 2m.

Fig. 9. Number of slope and trench failures by slope angle.

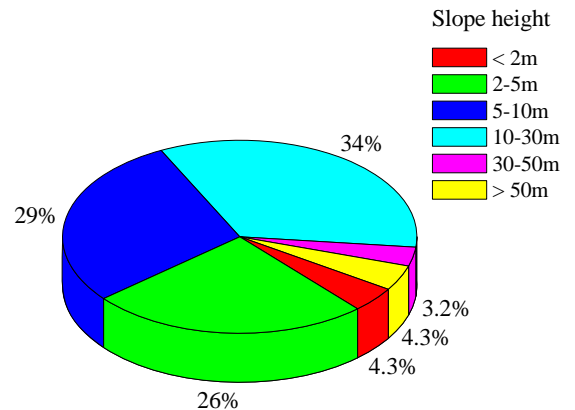
Fig. 10. Number of slope failures by height of slope.

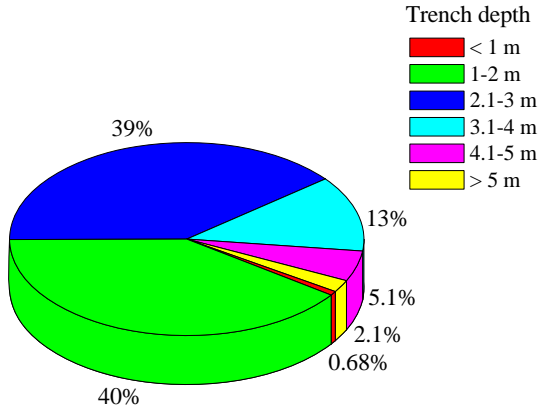
Fig. 11. Number of trench failures by depth of trench.

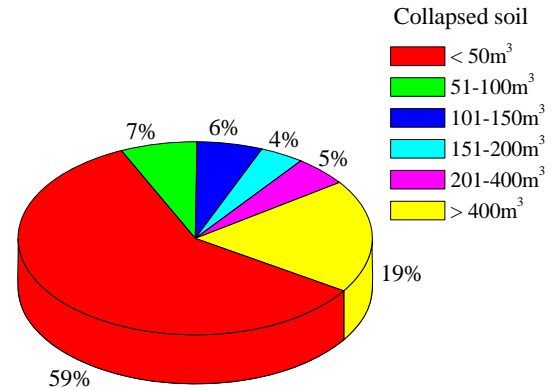
Figures 13 and 14 show the estimated amount of collapsed soil that observed in the slope and trench failures, respectively. As expected, the amount of collapsed soil in the slope excavation is generally larger than that of the trench excavation. It was found that 59% and 55% of slope failures occurred when the amount of collapsed soil was less than 50m³ and 2m³ for slope and trench excavations, respectively. By comparing to the size of excavations, the amount of collapsed soil is generally small, therefore, the scale of slope failure at the time of accident could be classified as small-scale slope failure. Because the small-scale slope failure generally occurs rapidly, so the workers tend to suffer from the labor accidents since they have almost no time to escape from the working area especially in the confined space environment in the retaining wall construction and the trench excavation.

Fig. 13. Number of slope failures by collapsed soil volume.

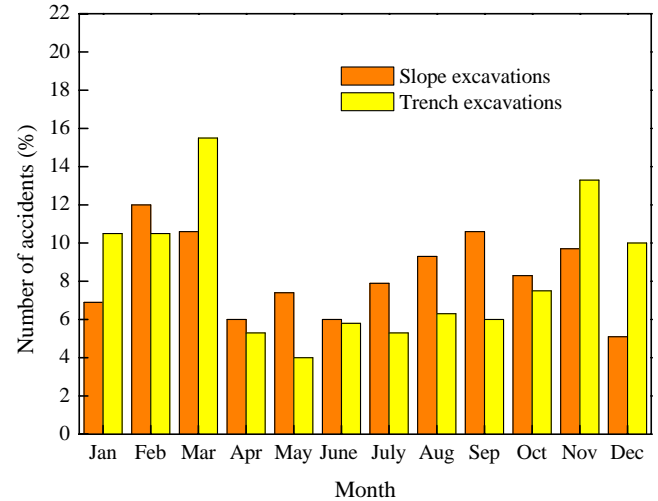
Fig. 15. Number of slope and trench failures by month.

The distribution of accidents based on month of the year is shown in Fig. 15. It is also possible that the economic pressure to complete the projects before the end of budget and before the winter can lead the high number of accidents as shown in March and November, respectively. Figure 16 shows the number of slope and trench failures by the time of occurrence, the accidents mainly occurred before lunch break (10-11 a.m.), after lunch break (2-3 p.m.) and before the end of working time (4-5 p.m.). However the reason for this situation is unclear.

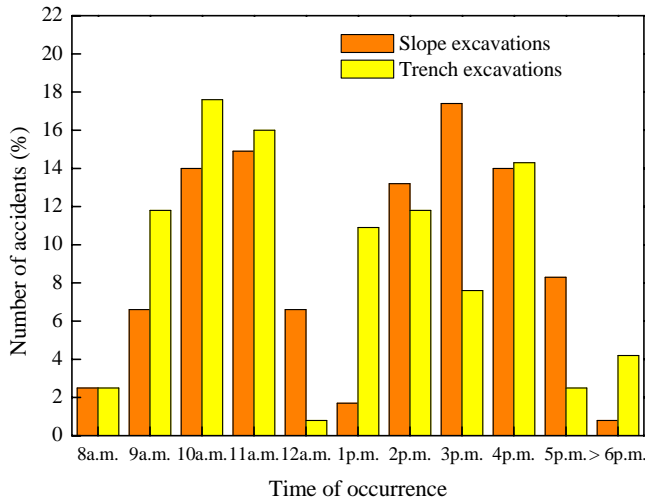
Fig. 16. Number of slope and trench failures by time.

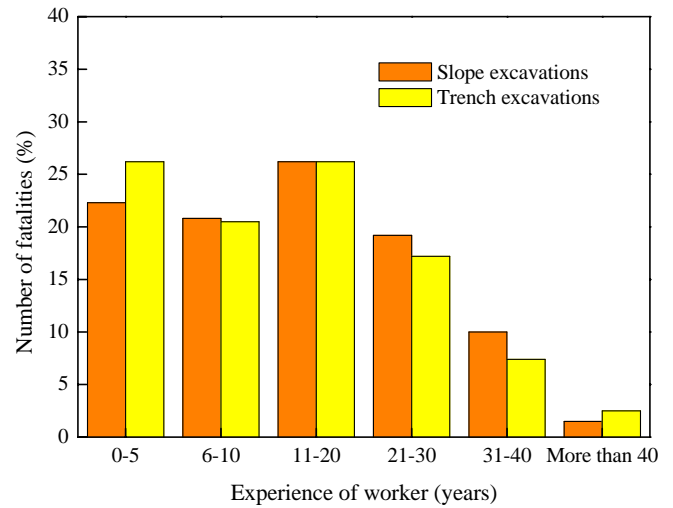
Fig. 18. Number of fatalities by experience of worker.

The distribution of worker age observed in the labor accidents is shown in Figure 17. It was found that about 78% and 72% of the accidents involving workers older than 45 years for slope and trench excavations, respectively. This indicated that the older workers tend to be involved in the labor accidents. In addition, inexperienced workers tend to have more accidents compared to experienced workers as shown in Fig. 18. Because experienced workers can sometimes detect the instability of slope for example from tension cracks and changes in soil texture, however, inexperienced workers are less likely to detect these signs. Although the experienced workers may have received more training concerning construction safety, it was found that about 30% of workers working in construction site at least 21 years before they were involved in the slope and trench failures. Because the experienced workers could be related to the older workers and in many cases the experienced workers tend to take unnecessary risks.
