Lessons Learned from the Performance of a Degradable Shale Embankment: Case Study

LESSONS LEARNED FROM THE PERFORMANCE OF A DEGRADABLE SHALE EMBANKMENT: CASE STUDY

The U.S. 220 Transportation Improvement Project consisted of the construction of a new four lane limited access highway extending from the northern end of the existing Tyrone Expressway to the western end of Mount Nittany Expressway (U.S. 322). As part of this project, structure bridges No. 111 and 112 were designed to carry the northbound and southbound lanes over the Nittany & Bald Eagle Railroad. The north and south embankments are common for both bridges. The bridges are located in Worth Township approximately 1.2 miles (1.9 km) southwest of Port Matilda, Centre County, Pennsylvania (USA).

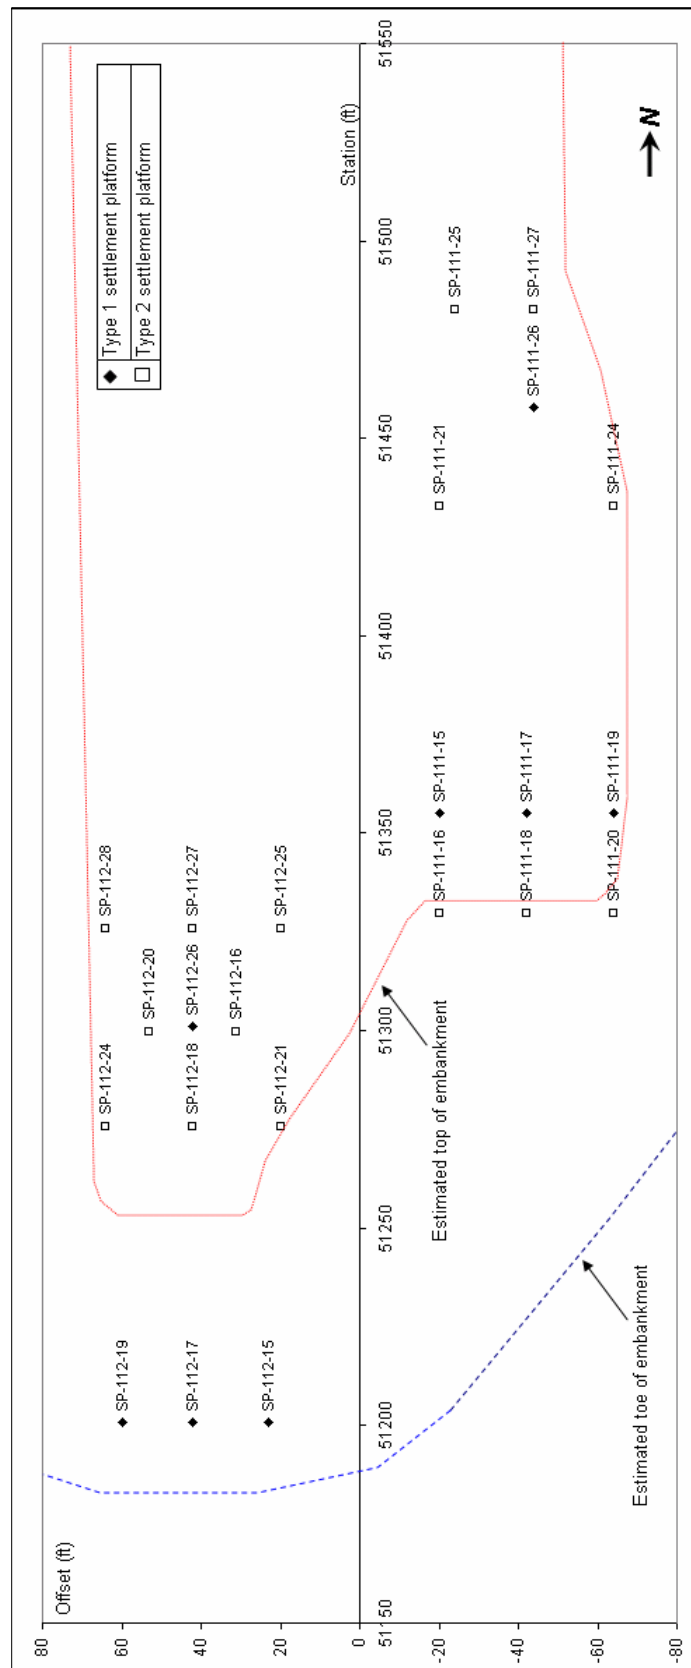
Fig. 1. Location of the settlement platforms ($1\text{ft}=0.305\text{m}$)

This case study focuses on the settlement recorded on the north embankment. The approximate height of the embankment was 40 feet (12.2 m), having a 1.5H: 1V slope. It was recommended to construct a rock core of Best Available Rock (BAR) to provide a stable slope. Provisions for a construction of a rock toe and a rock blanket were also specified. Settlement platforms were installed at several locations divided into two categories: Type 1 located at the existing ground before the construction of the embankments, and Type 2 located at the top of the embankment (Fig.1).

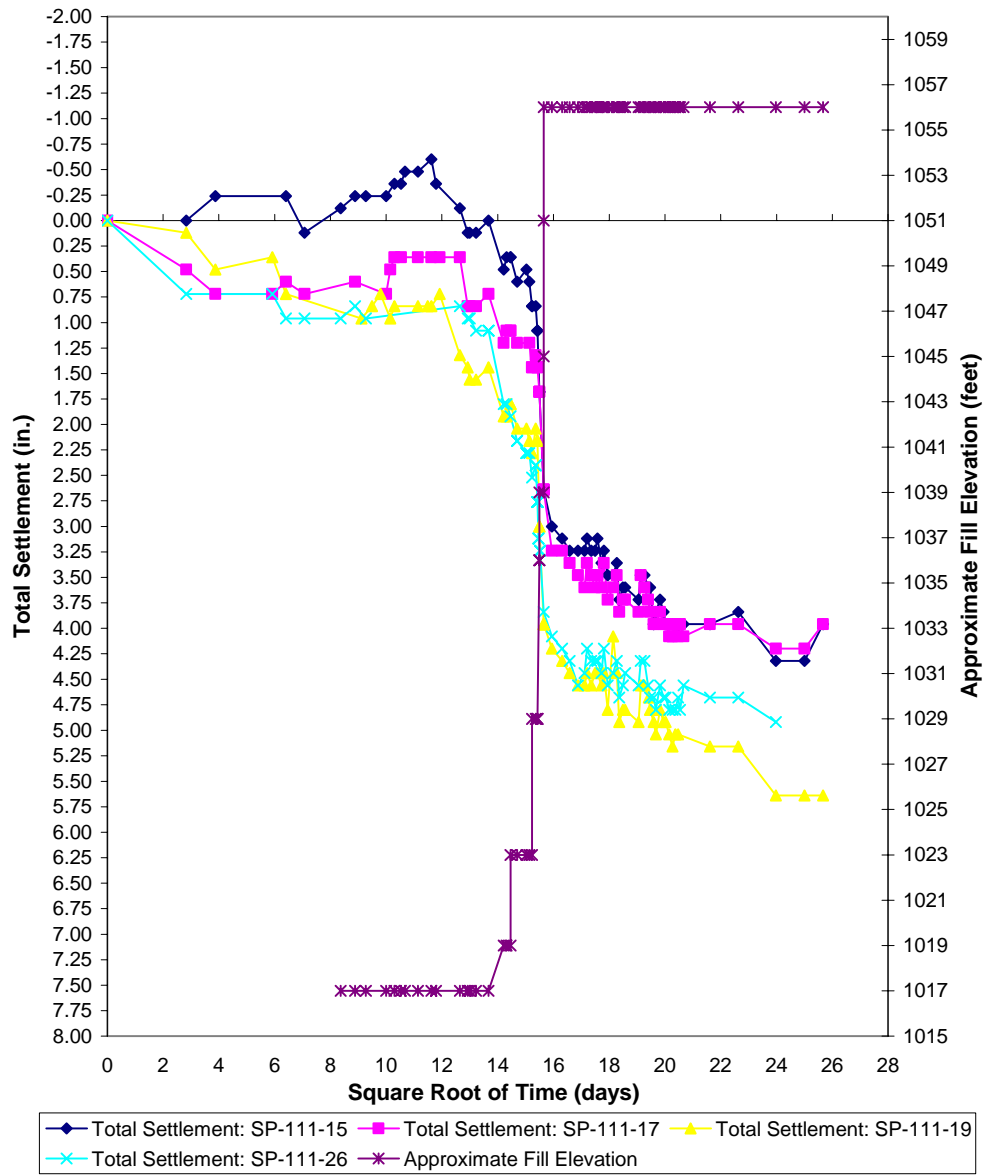
Structure 111 - North Abutment Type-1 Settlement Platforms

Fig. 2. Structure 111 – North Abutment Type 1
(1 inch= 2.54cm, 1 feet= 0.305m)

Figures 2 to 5 show the measured deformation at the settlement platforms during a period of approximately 676 days (26² days) since construction started. Two different time scales are used for the settlement platforms since Type 1 platforms were installed before the construction of the embankment. For the Type 1 platforms, the time presented on the graphs is absolute time while for the Type 2 platforms time starts at 0 on a relative scale, this starting point corresponds with approximately 256 days (16² days).

The graphs for Type 2 platforms show the total settlement at the top of the embankment which includes the settlement of the original ground surface. To obtain the compression of the embankment, the settlement recorded for the Type 1 platforms should be subtracted from the measurements of the Type 2 platforms. The scattering of the results presented in Figures 2 to 5 is not fully explained by trends such as smaller settlement at the toe or near the edge of the embankment. The conditions of the original soil and the embankment randomly changed in a close proximity. The data is better analyzed as average and maximum values.

Table 2 presents a summary of the deformations. As predicted during the design phase, the average settlement of the original ground surface was close to 4 inches (0.10 m). On the other hand, the maximum net settlement of the shale embankment was greater than 1 foot (0.305m), corresponding with a net compression greater than 3% of the original embankment height.

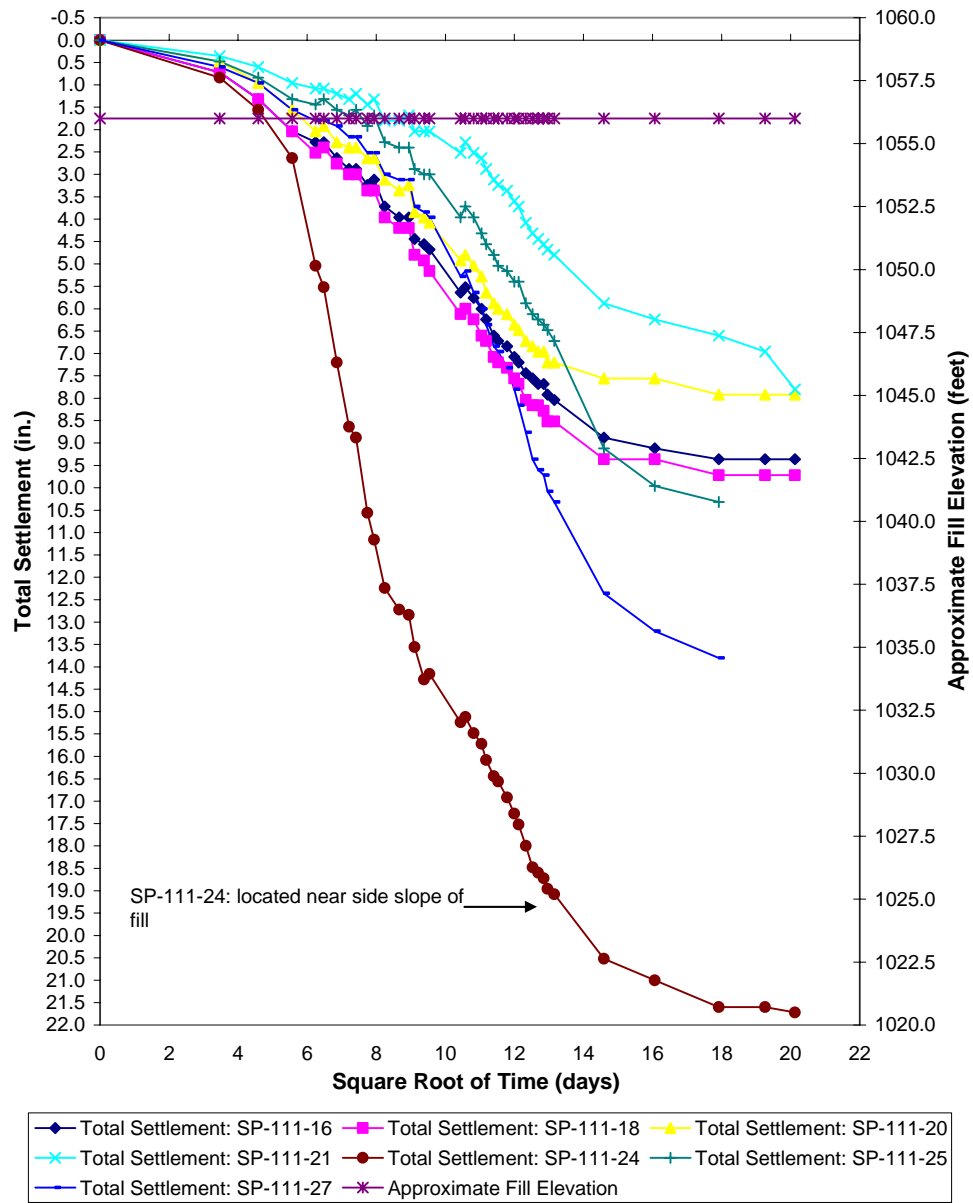
Structure 111 - North Abutment Type-2 Settlement Platforms

Fig.3. Structure 111 – North Abutment Type 2
(1 inch= 2.54cm, 1 feet= 0.305m)

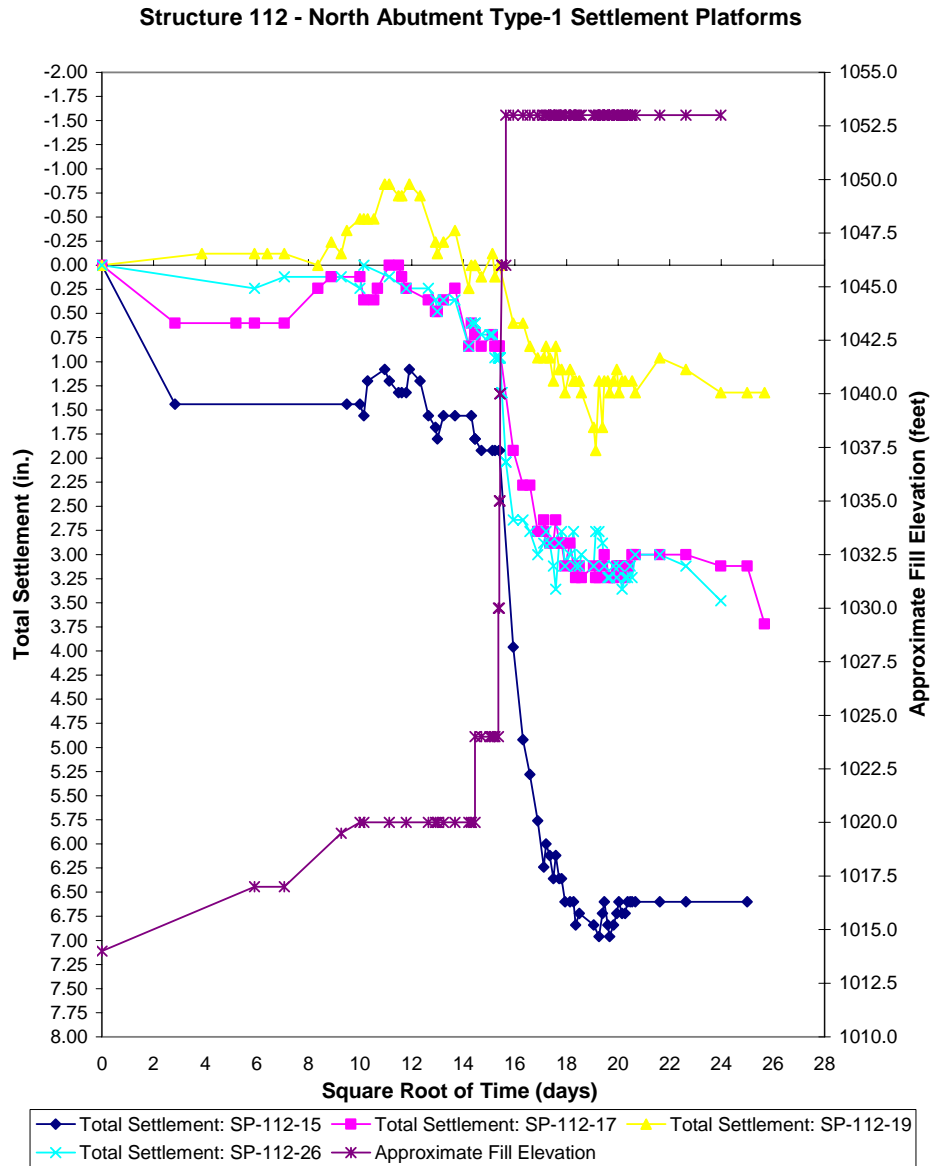
Fig. 4. Structure 112 – North Abutment Type 1
 (1 inch= 2.54cm, 1 feet= 0.305m)

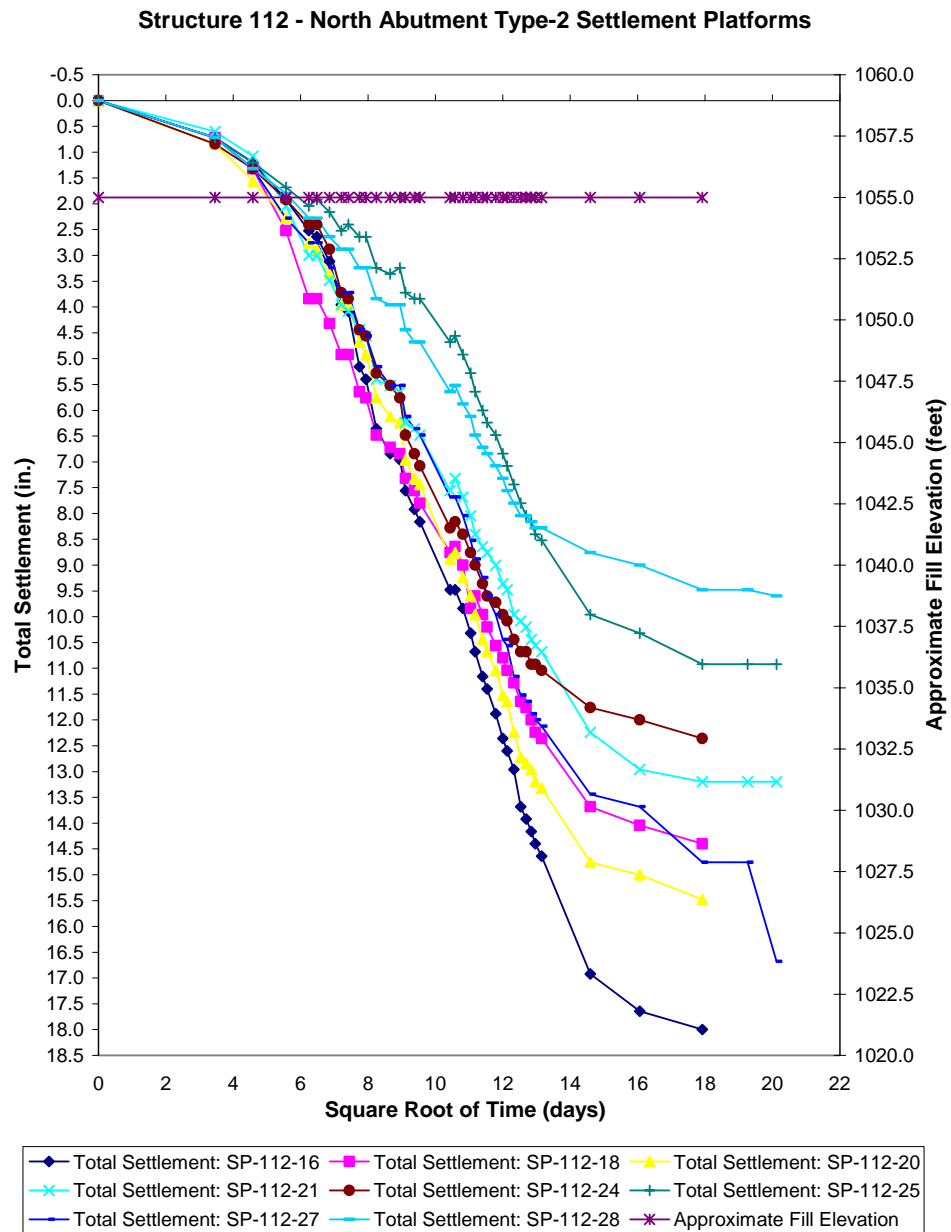
Fig.5. Structure 112 – North Abutment Type 2
(1 inch= 2.54cm, 1 feet= 0.305m)

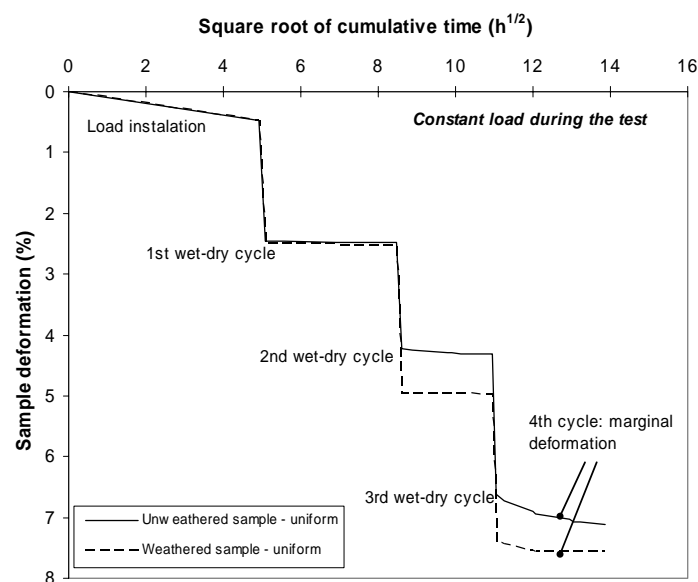
Fig. 6. Deformation vs. time

Deformation is presented as a percentage of the initial height of the sample. Square root of time is used as it is commonly employed for consolidation plots. As a result of the load installation, a small settlement was recorded on both samples (less than 0.5%). After the samples stabilized, the first wetting/drying cycle took place. The samples were kept saturated until they stabilized, after this the water was allowed to drain out and the samples were again allowed to stabilize. Almost all the deformation took place rapidly during the wet part of the cycle. The same procedure was repeated for the second, third, and fourth cycles. The fourth cycle produced marginal settlement. The tests were stopped since the samples reached a stable state independent of wetting/drying cycles. The behavior of the samples was identical up to the second cycle, when the weathered sample exhibited more deformation than the unweathered sample. At the end of the fourth cycle the unweathered sample had a total settlement of 7.1% while

the weathered sample had a total settlement of 7.6%. In general for the two samples, the deformation occurred during the first hours of the wet part of each cycle and was insignificant during the drying stages.

cylinder with an inside diameter of 6 inches (15.2 cm) and a height of 7 inches (17.8 cm). During each test, a rigid metal disk with a diameter slightly smaller than the diameter of the cylinder was placed at the top of the tested sample. The load was then applied on the metal plate and kept constant for the remaining part of the test. The mold was inside a metal container, which allowed saturating the sample. The water from the container could be removed allowing the tested sample to drain (the mold had some small holes that drain water out from the sample). Each sample was subjected to several wetting/drying cycles while keeping constant the applied vertical load. The applied pressure was 2400 psf (114.9 kPa) which roughly corresponds with the vertical stress at the middle height of a 40 feet (12.2 m) embankment. The samples had an initial uniform grain size distribution with an average size of 0.87 inches (2.21 cm). The results are shown on Fig.6.

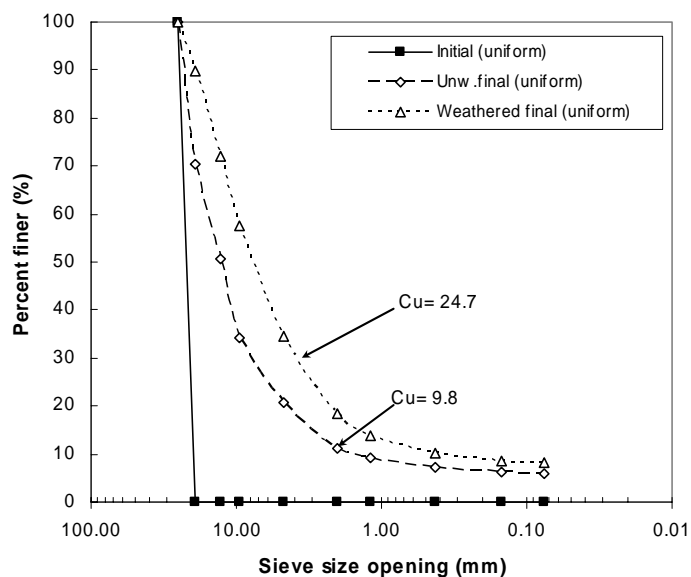
Fig.7 shows the results of the sieve analyses performed at the end of the tests. The samples became a well graded mixture of particle sizes. The weathered sample was subjected to more degradation than the unweathered sample as reflected on the coefficients of uniformity.

Fig.7. Grain size distribution of the initially uniform samples
